**DEPARTMENT OF TRANSPORTATION**

Contract #: 04-0120F4Cty: SF/ALA Rte: 80 PM: 13.2/13.9File #: 1.28**WELDING INSPECTION REPORT****Resident Engineer:** Casey, William**Address:** 333 Burma Road**City:** Oakland, CA 94607**Report No:** WIR-026843**Date Inspected:** 08-Dec-2011**Project Name:** SAS Superstructure**OSM Arrival Time:** 700**Prime Contractor:** American Bridge/Fluor Enterprises, a JV**OSM Departure Time:** 1730**Contractor:** American Bridge/Fluor Enterprises, a JV**Location:** Jobsite

**Bridge No:** 34-0006**Summary of Items Observed:**

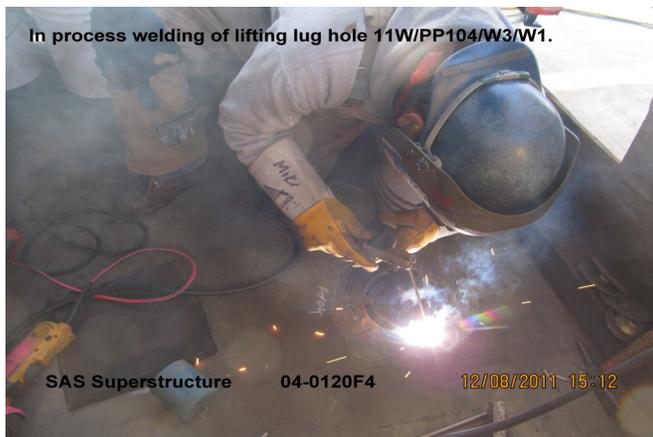
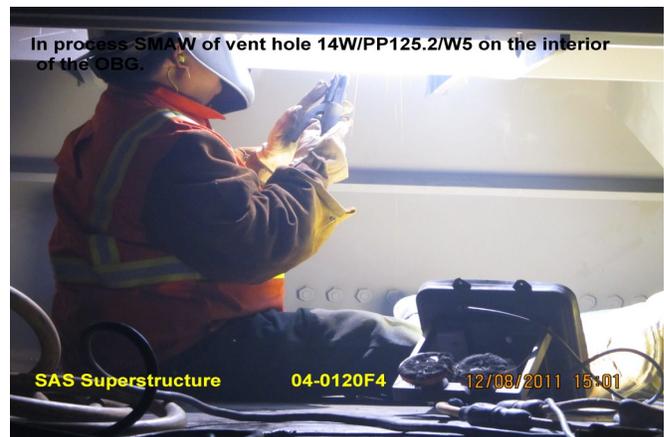
This QA Inspector randomly observed ABF welder Jorge Lopez performing the back-gouge operation of an ultrasonic rejectable indication on "A" deck Lifting Lug Hole 14W/PP126.7/W5. The dimensions of the completed excavation were: "Y" 160 mm: (20 mm wide; 80 mm length; and 10 mm in depth). This QA Inspector observed QC Inspector Sal Merino perform a Magnetic Particle Inspection (MT) of the excavation to determine the soundness of the metal. Upon completion of the testing this QA Inspector verified that no rejectable indications were present.

This QA Inspector randomly observed ABF welder Jorge Lopez (Welder ID 6149) performing the repair welding operation of one (1) ultrasonic indication as pertaining to the Shielded Metal Arc Welding (SMAW) process in the (4G) overhead position on "A" deck vent hole 14W/PP126.7/W5. This QA Inspector observed the use of E7018-H4R electrodes and QC Inspector Sal Merino verify that the preheat temperature was at the minimum of 150 degrees F and that the welding parameters (Amps=135) were in accordance with WPS D1. 5-1004- Repair. The welding parameters observed at this location appeared to be in general compliance with approved WPS and the contract specifications. Upon completion of the repair, a thermal induction blanket was placed over the area for Post Weld Heat Treatment (PWHT) at 450 degrees F for 1 hour.
