Contract #: 04-0120F4Cty: SF/ALA Rte: 80 PM: 13.2/13.9File #: 1.28**WELDING INSPECTION REPORT**

Report No: WIR-027016
Date Inspected: 12-Jan-2012

Project Name: SAS Superstructure
Prime Contractor: American Bridge/Fluor Enterprises, a JV
Contractor: American Bridge/Fluor Enterprises, a JV

CWI Name:	Bernie Docena	CWI Present:	Yes	No
Inspected CWI report:	Yes No N/A	Rod Oven in Use:	Yes	No N/A
Electrode to specification:	Yes No N/A	Weld Procedures Followed:	Yes	No N/A
Qualified Welders:	Yes No N/A	Verified Joint Fit-up:	Yes	No N/A
Approved Drawings:	Yes No N/A	Approved WPS:	Yes	No N/A
		Delayed / Cancelled:	Yes	No N/A
Bridge No:	34-0006	Component:	OBG Components

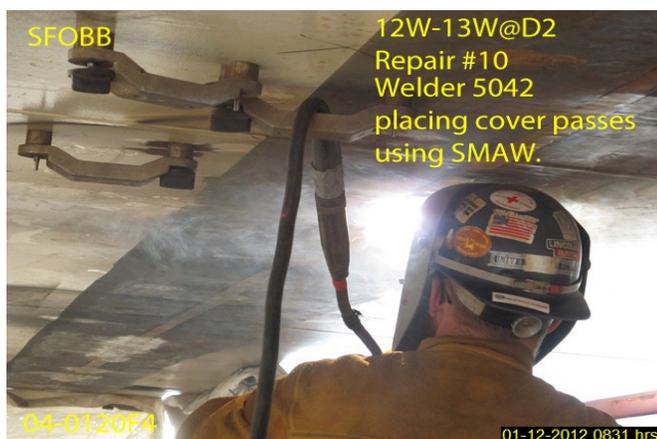
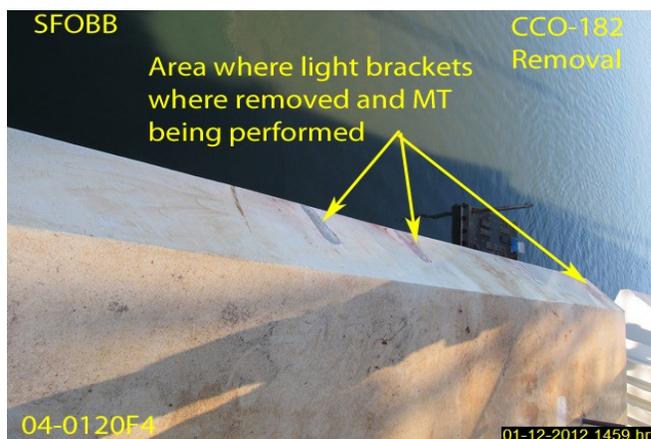
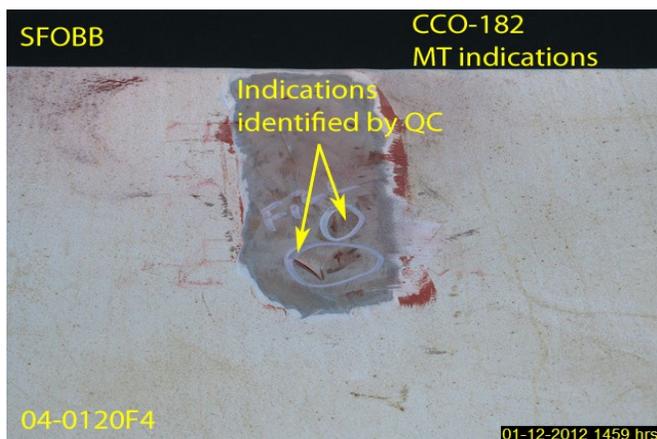
- A) CC0-182 Removal
- B) Lifting Lug Holes Repairs
- C) Field Splice 12W-13W

The QAI observed that welder Mike Jimenez, was pre-heating the area to be fit up to a temperature of 20 degrees Celsius (50 degrees F) that was verified using a tempstik and infrared gun by the QC. The welder was preparing the area by using a copper back up bar and placing the 20mm thick deck insert into place. The fit-up was checked by the QC inspector assigned to this location and was found to be within compliance. The welder then proceeded with the Shielded Metal Arc Welding (SMAW) using electrode E7018 under Welding Procedure Specification (WPS) ABF-WPS-D15-1050A-CU for the Complete Joint Penetration weld. The electrode used for the root pass was 3.2mm (1/8") diameter with welding amps verified as 136. The location of the welding was on the west bound lane (WB) at PP114-W4@W1 hole. The QC inspector for this location was Salvador Merino and was observed verifying and documenting the welding parameters for this location, along with overseeing the welding operations. At the time of the observations no issues were noted by the QAI.

The QAI observed that welder Todd Jackson, was observed using a rosebud to pre-heat the weld area to 20 degrees Celsius (50 degrees F) that was verified using a tempstik and infrared gun by the QC. The welder then proceeded in performing the Shielded Metal Arc Welding (SMAW) using electrode E7018 under Welding Procedure Specification (WPS) ABF-WPS-D15-1050A-CU for the Complete Joint Penetration weld. The electrode used for the root pass was 3.2mm (1/8") diameter with welding amps verified as 128 by the QC inspector.

The location of the welding was observed by this QAI at the west bound lane (WB) at PP115-W3-W1 hole. The QC inspector for this location was Salvador Merino and was observed verifying and documenting the welding parameters for this location, along with overseeing the welding operations. At the time of the observations no issues were noted by the QAI.

The QAI observed that welder Jeremy Dolman ID-5042, was observed by the QAI as performing the Shielded Metal Arc Welding process (SMAW) using electrode E7018 under Welding Procedure Specification (WPS) ABF-WPS-D15-1001R for the Complete Joint Penetration. The location of this repair was on the bottom plate exterior of transverse weld splice 12W-13W at D2. The Y location was at 5020mm repair #10. The welder was observed as placing the cover passes at this repair which was measured at 210mm in length. The welder had used a rosebud to pre-heat the repair area to 65 degrees Celsius (150 degrees F) that was verified using a tempstik and infrared gun by the QC inspector assigned to this location. The electrode used for the root pass was 3.2mm (1/8") diameter with welding amps verified as 126. The QC inspector for this location was Salvador Merino and was observed verifying and documenting the welding parameters for this location, along with overseeing the welding operations. At the time of the observations no issues were noted by the QAI.
