**DEPARTMENT OF TRANSPORTATION**

Contract #: 04-0120F4Cty: SF/ALA Rte: 80 PM: 13.2/13.9File #: 99.28**WELDING INSPECTION REPORT****Resident Engineer:** Casey, William**Address:** 333 Burma Road**City:** Oakland, CA 94607**Report No:** WIR-027151**Date Inspected:** 06-Feb-2012**Project Name:** SAS Superstructure**OSM Arrival Time:** 700**Prime Contractor:** American Bridge/Fluor Enterprises, a JV**OSM Departure Time:** 1530**Contractor:** American Bridge/Fluor Enterprises, a JV**Location:** Job Site**CWI Name:** Salvador Moreno**CWI Present:** Yes No**Inspected CWI report:** Yes No N/A**Rod Oven in Use:** Yes No N/A**Electrode to specification:** Yes No N/A**Weld Procedures Followed:** Yes No N/A**Qualified Welders:** Yes No N/A**Verified Joint Fit-up:** Yes No N/A**Approved Drawings:** Yes No N/A**Approved WPS:** Yes No N/A**Delayed / Cancelled:** Yes No N/A**Bridge No:** 34-0006**Component:** OBG**Summary of Items Observed:**

Quality Assurance Inspector (QA) Rene Hernandez was at the American Bridge/Fluor (ABF) job site at Yerba Buena Island in California between the times noted above in order to monitor Quality Control functions and the in process work being performed by ABF pe

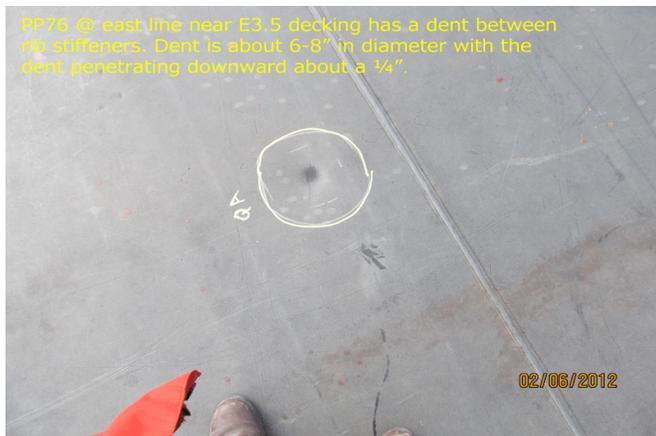
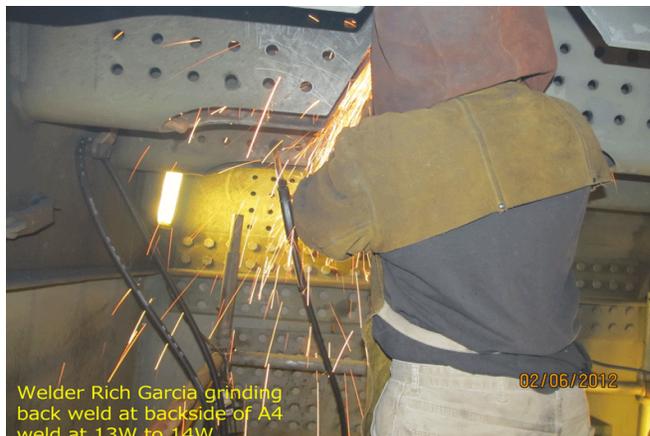
This QA observed, at random intervals, ABF/JV qualified welder Richard Garcia #3110-4 performing Flux Cored Arc Welding (FCAW) with .072" diameter NR232 electrode and implementing Caltrans approved Welding Procedure Specification (WPS) ABF-WPS-D15-2160-1-1G. This was a Complete Joint Penetration (CJP) weld connecting 13W to 14W top deck plate CJP weld A4. This work was located at West line connection joint 13W to 14W.

Conducted visual inspection of exposed deck surfaces between Lift 7E and 12E at PP47 through PP109. Between E3 and E6 lines were accessible. Walk was conducted with ABF QA personnel Steven Jensen. All areas were reviewed by both parties and both parties were mutually agreeable as to the location and repair areas as marked in the field and identified in the plan view drawings. The following were observations noted in the field and on the plan view drawings:
