Contract #: 04-0120F4Cty: SF/ALA Rte: 80 PM: 13.2/13.9File #: 99.28**WELDING INSPECTION REPORT**

**Project Name:** SAS Superstructure  
**Prime Contractor:** American Bridge/Fluor Enterprises, a JV  
**Contractor:** Lubrite Industries

**Bridge No:** 34-0006**Component:** Spherical Bushing Ring Bearing Hinge K**Summary of Items Observed:**

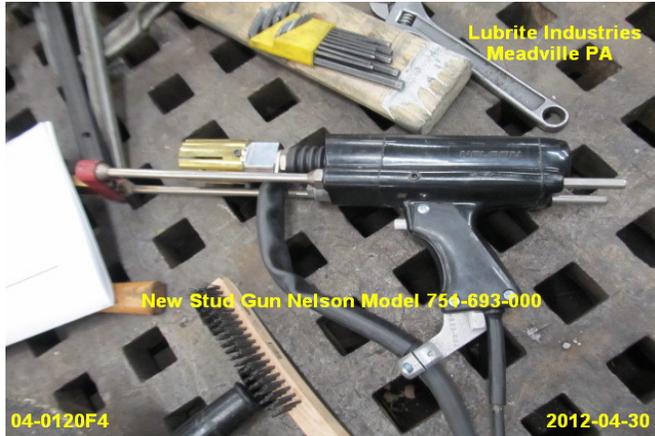
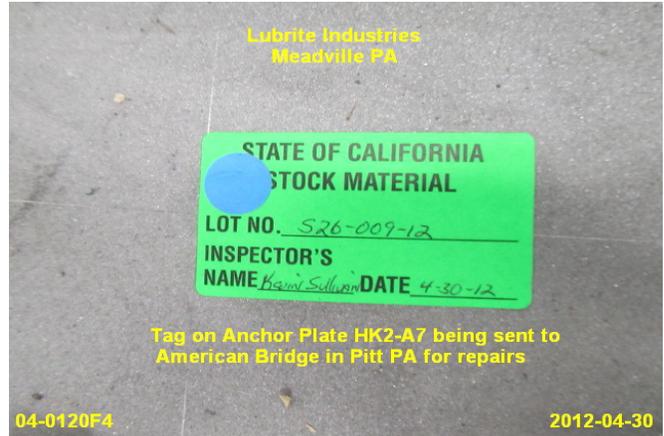
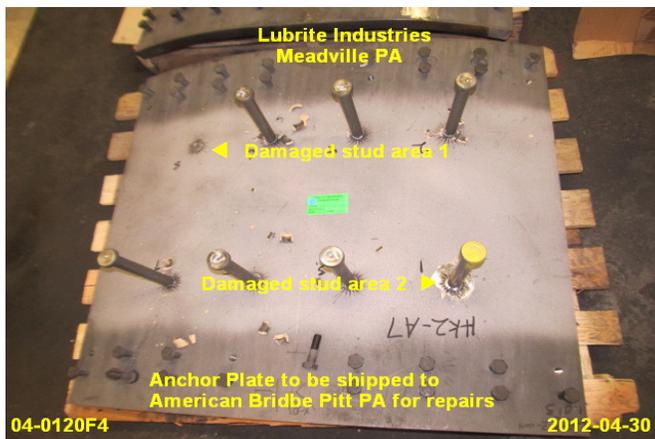
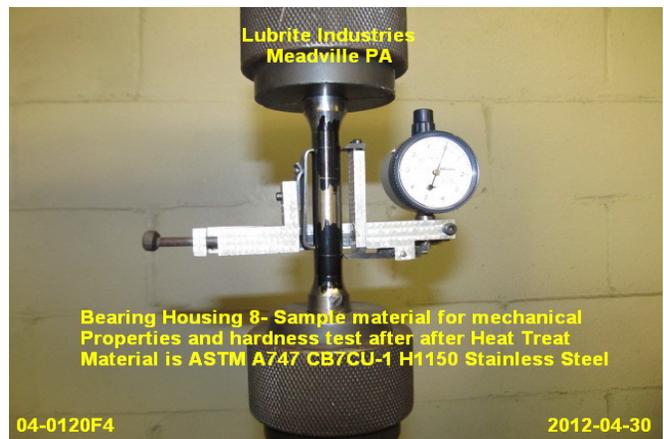
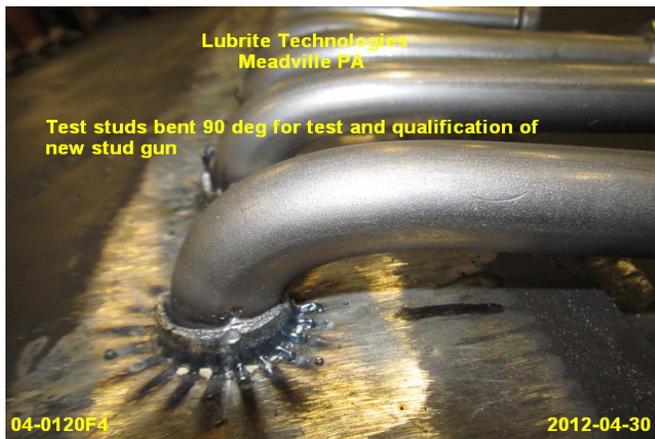
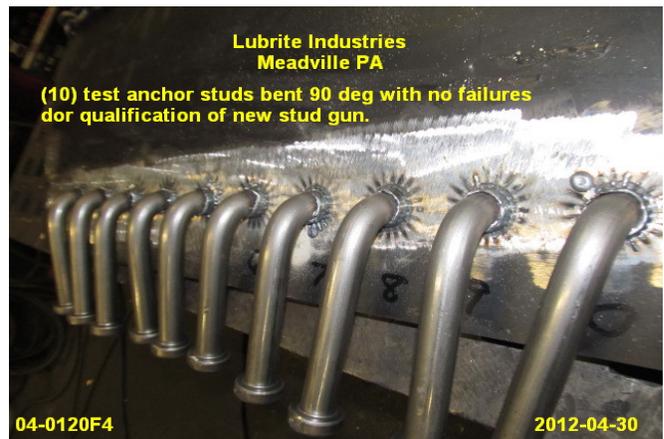
Welder then proceeded to weld (10) Anchor studs to Plate with no failure of new gun. Welds were inspected by TPQC and witnessed by this QAI. Visual inspection revealed no surface defects and studs were released for bend test as required for qualification of stud gun and WPS.

Studs were then bent 90 degrees with no failures during the test. Full fusion was noted at the base of each stud after bend test.

This Quality Assurance Inspector (QAI) arrived at Lubrite Industries (LI), Meadville PA, as requested to monitor welding Qualification of New Stud gun for attachment of Anchor Studs to Anchor Plates of Bearing Housings. Upon arrival this QAI met with Third Party QC Reno Davis KTA (TPQC), and Brad McWright (LIQC). Test piece of Anchor Plate was set up and locations marked for attachment of anchor studs to plate. The plate being used is a drop from the actual anchor plate being used on the job, ASTM A709 Grade 50 Heat 0502434.. Anchor studs are 1" x 8 1/4" ASTM A108/A29 Grade 1015 Heat 5093721.

The damaged Anchor plate from the 4/25/12 failed welding of anchor studs to plate was boxed, Green tagged with blue dot and shipped to American Bridge in Pittsburg PA for repairs. This plate had (2) bad welds at base of anchor stud to plate.

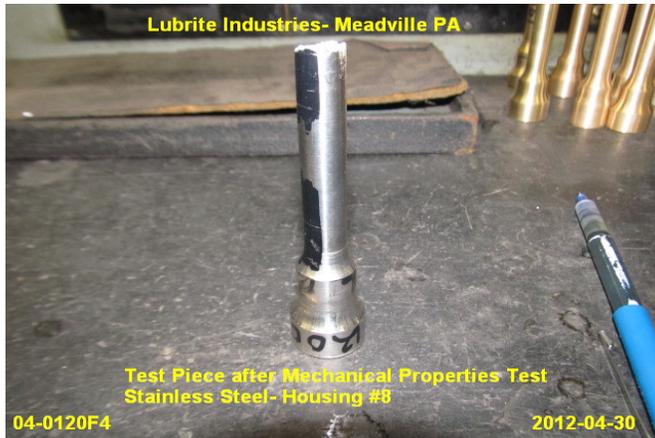
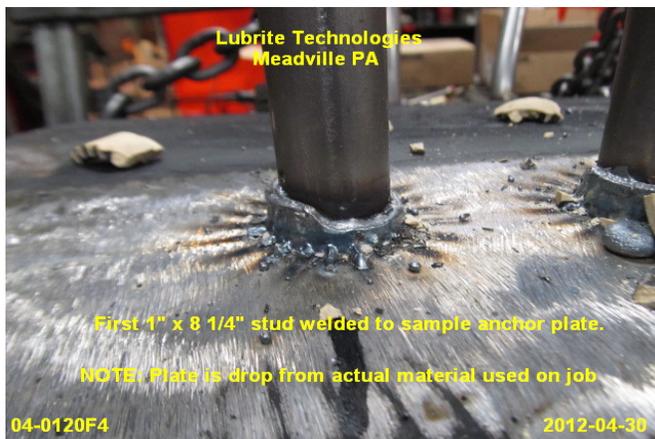
Also while at LI this QAI witnessed the Mechanical Properties and hardness test on the final housing samples sent for heat treat. This sample is for Housing #8. The material is Stainless Steel ASTM A747 CB7CU-1 H1150. All tests performed per ASTM A747. All results found acceptable and recorded on Material Test Report furnished to this QAI by LIQC.
