Contract #: 04-0120F4Cty: SF/ALA Rte: 80 PM: 13.2/13.9File #: 1.28**WELDING INSPECTION REPORT**

Report No: WIR-028009
Date Inspected: 19-Jul-2012

Project Name: SAS Superstructure
Prime Contractor: American Bridge/Fluor Enterprises, a JV
Contractor: American Bridge/Fluor Enterprises, a JV

| Bridge No: | 34-0006 | Component: | SAS Tower | |

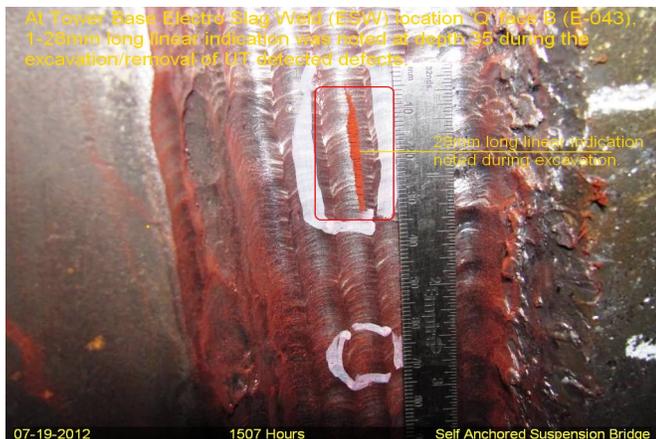
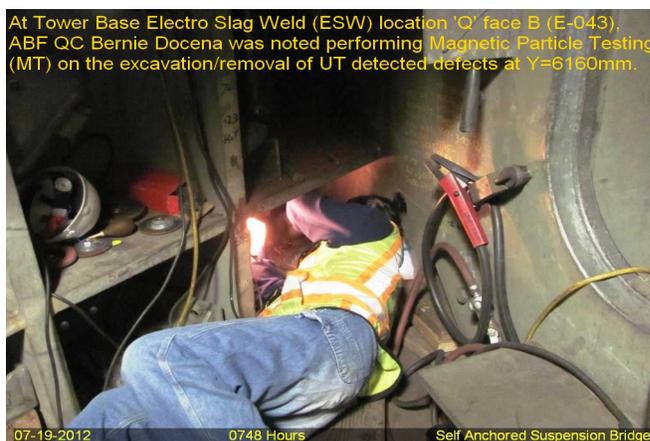
At Tower Base Electro Slag Weld (ESW), this QA observed ABF welder Lou Xiao Hua continuing to perform repair excavation at location 'Q' face B (E-043) Y=6160mm due to Ultrasonic Testing (UT) detected defect. The repair excavation is being undertaken per Caltrans approved Request for Weld Repair RWR #201206-084. The welder was noted using carbon air arc gouging followed by grinding using a die grinder. The excavation was alternately gouged and ground then Magnetic Particle Testing (MT) tested by ABF QC Bernie Docena and this QA. The following excavation events were noted during the repair excavation;

Since the reported depth of the UT defect was at 75mm from face A (5mm from face B) and no whatsoever indication found up to 20mm deep, ABF QC Bernie Docena has stopped the excavation and considered the excavation good enough. The final dimensions of the excavation after smooth grinding were from Y=6110mm to Y=6360 with 250mm long X 40mm wide X 20mm deep. The excavation was MT'd and accepted by ABF QC Jesse Cayabyab and this QA.

After the excavation completion of the ESW with the corresponding Y location mentioned above, the same welder went back to ESW 'P' face B Y=7250mm where he left off last Saturday. This excavation has Caltrans approval per RWR #201206-075. The welder continued excavation at depth more than 40mm and noted the following;

At Tower Base Electro Slag Weld (ESW), this QA observed ABF personnel continuing to perform repair excavation at location 'Q' face B (E-043) Y=3190mm and Y=3220mm due to Ultrasonic Testing (UT) detected defect. The combined repair excavation is being undertaken per Caltrans approved Request for Weld Repair RWR #201206-080 and #201206-081 respectively. The welder was noted using carbon air arc gouging followed by grinding using a die grinder. The excavation was alternately gouged and ground then Magnetic Particle Testing (MT) tested by ABF QC Bernie Docena and this QA. The following excavation events were noted during the repair excavation;
