DEPARTMENT OF TRANSPORTATION

Contract #: 04-0120F4Cty: SF/ALA Rte: 80 PM: 13.2/13.9File #: 1.28**WELDING INSPECTION REPORT****Resident Engineer:** Casey, William**Address:** 333 Burma Road**City:** Oakland, CA 94607**Report No:** WIR-028111**Date Inspected:** 05-Aug-2012**Project Name:** SAS Superstructure**OSM Arrival Time:** 700**Prime Contractor:** American Bridge/Fluor Enterprises, a JV**OSM Departure Time:** 1530**Contractor:** American Bridge/Fluor Enterprises, a JV**Location:** Job Site**CWI Name:** Julian Razo**CWI Present:** Yes No**Inspected CWI report:** Yes No N/A**Rod Oven in Use:** Yes No N/A**Electrode to specification:** Yes No N/A**Weld Procedures Followed:** Yes No N/A**Qualified Welders:** Yes No N/A**Verified Joint Fit-up:** Yes No N/A**Approved Drawings:** Yes No N/A**Approved WPS:** Yes No N/A**Delayed / Cancelled:** Yes No N/A**Bridge No:** 34-0006**Component:** SAS Tower**Summary of Items Observed:**

Caltrans Office of Structural Material (OSM) Quality Assurance Inspector (QAI) Joselito Lizardo was present at the Self Anchored Suspension (SAS) job site as requested to perform observations on the welding of components for the San Francisco Oakland Bay Bridg

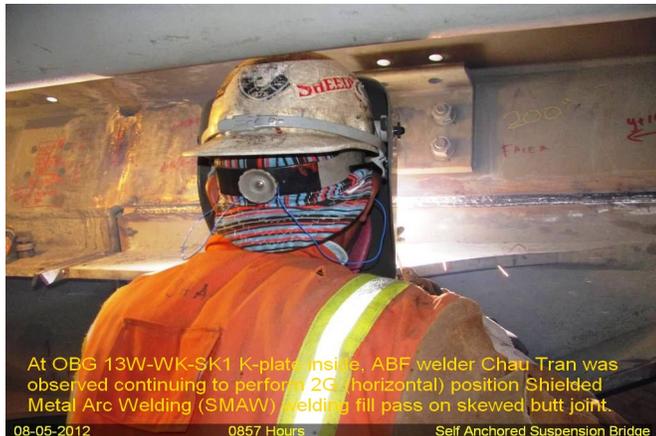
At OBG 13W-WK- SK1 plate inside, QA randomly observed ABF/JV qualified welder Chau Tran continuing to perform CJP groove welding fill pass on the K plate skewed butt joint. The welder was observed perform manual welding in the 2G (horizontal) position utilizing a Shielded Metal Arc Welding (SMAW) with 3.2mm diameter E9018H4R electrode and implementing Caltrans approved Welding Procedure Specification (WPS) ABF-WPS-D15-1072. The 18mm thick SK plate being welded to the 35mm thick 485W longitudinal stiffener has a single V groove butt joint preparation without backing that will be back gouged upon completion on one side. The plates were preheated to more than 200 degree Fahrenheit using Miller Proheat 35 Induction Heating System with the heater blanket put in place the back of the SK plate being welded. During welding, ABF Quality Control (QC) Julian Razo was noted monitoring the welding parameters of the welder with measured working current of 125 amperes. At the end of the shift, fill pass welding was still continuing and should remain tomorrow.

At OBG 13W/14W-LS5N deck stiffener flange inside, QA randomly observed ABF/JV qualified welder Lou Xiao Hua continuing to perform PJP groove welding root pass to fill pass on the deck stiffener flange T-joint. The welder was observed perform manual welding in the 4G (overhead) position utilizing a Shielded Metal Arc Welding (SMAW) with 3.2mm diameter E9018H4R electrode and implementing Caltrans approved Welding Procedure Specification (WPS) ABF-WPS-D15-1162-4. The stiffener flange plate has a bevel groove being welded PJP T-joint to the longitudinal stiffener. The plates were preheated to more than 200 degree Fahrenheit

At OBG 13W-PP121.6 @1900 drop-in top deck plate inside, QA randomly observed ABF/JV qualified welder Mike Jimenez perform CJP groove welding repair from location Y=0mm to Y=1000mm. The welder was observed welding in the 4G (overhead) position utilizing Shielded Metal Arc Welding (SMAW) with 3.2mm diameter E7018H4R electrode implementing welding procedure ABF-WPS-D15-1004-Repairs. Since the area from Y=0mm to Y=1000mm has numerous UT detected defects with various sizes and depths, the welder decided to excavate the whole length. The repair excavation was preheated to more than 225°F prior carbon air arc gouging. After the removal of the UT detected defects, the groove of the excavation was ground smooth then tested with Magnetic Particle Testing (MT) by ABF QC Julian Razo. The repair excavation was preheated to more than 325 degree Fahrenheit using Miller Proheat 35 Induction Heating System with the heater blanket put in plate on top of the deck prior/during welding. During the shift, ABF QC Julian Razo was noted monitoring the welder with measured working current of 130 amperes on 3.2mm E7018H4R electrode. At the end of the shift, repair welding at location mentioned above was partially completed and the welder performed the Post Weld Heat Treatment (PWHT) of 450°F where repair was completed and held it for one hour as required.

At OBG 13W-W2.8@12570 drop-in top deck plate inside, QA randomly observed ABF/JV qualified welder Richard Garcia perform CJP groove welding repair from location Y=11800mm to Y=12570mm. The welder was observed welding in the 4G (overhead) position utilizing dual shielded Flux Cored Arc Welding (FCAW-G) with 1.6mm diameter electrode implementing Caltrans approved welding procedure ABF-WPS-D15-3110-4. This repair has been excavated and being welded with Caltrans approved Request for Weld Repair (RWR) #201208-001. Since the area from Y=18000mm to Y=12570mm has numerous UT detected defects with various sizes and depths, ABF has decided to excavate the whole length. The repair excavation was preheated to more than 225 degree Fahrenheit using Miller Proheat 35 Induction Heating System with the heater blanket put in plate on top of the deck prior/during welding. According to ABF QC William Sherwood, ABF is using the normal overhead back welding procedure instead of repair procedure because ABF is considering the welded joint as reweld instead of repair. During the shift, ABF QC Julian Razo was noted monitoring the welder with measured working current of 255 amperes, 22.5 volts. At the end of the shift, repair welding at location mentioned above was still continuing and should remain tomorrow.
