DEPARTMENT OF TRANSPORTATION

Quality Assurance and Source Inspection

Contract #: 04-0120F4Cty: SF/ALA Rte: 80 PM: 13.2/13.9File #: 1.28**WELDING INSPECTION REPORT****Resident Engineer:** Casey, William**Address:** 333 Burma Road**City:** Oakland, CA 94607**Report No:** WIR-028119**Date Inspected:** 06-Aug-2012**Project Name:** SAS Superstructure**OSM Arrival Time:** 700**Prime Contractor:** American Bridge/Fluor Enterprises, a JV**OSM Departure Time:** 1930**Contractor:** American Bridge/Fluor Enterprises, a JV**Location:** Job Site**CWI Name:** Julian Razo**CWI Present:** Yes No**Inspected CWI report:** Yes No N/A**Rod Oven in Use:** Yes No N/A**Electrode to specification:** Yes No N/A**Weld Procedures Followed:** Yes No N/A**Qualified Welders:** Yes No N/A**Verified Joint Fit-up:** Yes No N/A**Approved Drawings:** Yes No N/A**Approved WPS:** Yes No N/A**Delayed / Cancelled:** Yes No N/A**Bridge No:** 34-0006**Component:** SAS Tower**Summary of Items Observed:**

Caltrans Office of Structural Material (OSM) Quality Assurance Inspector (QAI) Joselito Lizardo was present at the Self Anchored Suspension (SAS) job site as requested to perform observations on the welding of component

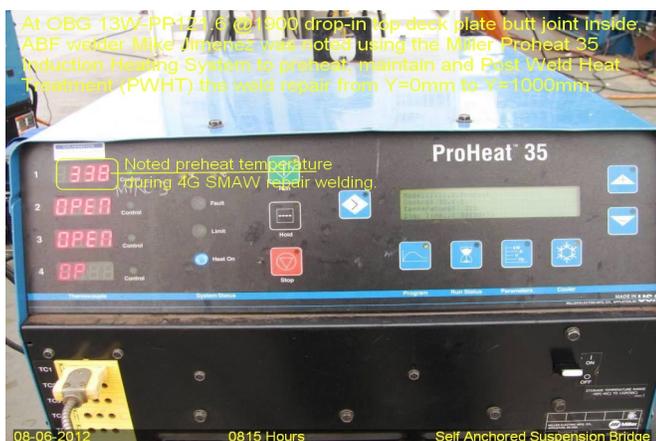
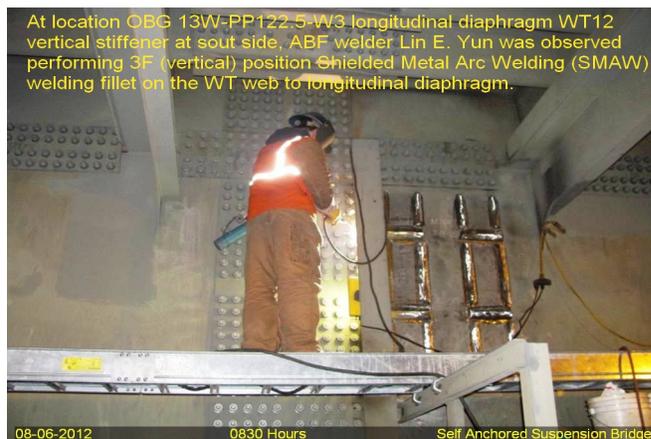
implementing Welding Procedure Specification (WPS) ABF-D15-F1200A. The vertical WT stiffener web is being welded to the longitudinal diaphragm on both sides of the web. The fit up was previously checked by ABF QC Julian Razo and randomly verified by this QA. During welding, the welder was noted preheating the plates to more than 150°F using propylene gas torch prior welding. ABF QC Julian Razo was noted monitoring the welding parameters with measured working current of 125 amperes during welding. At the end of the shift, fillet welding was completed on one side while the other side was still continuing.

At OBG 13W-PP121.6 @1900 drop-in top deck plate inside, QA randomly observed ABF/JV qualified welder Mike Jimenez continuing to perform CJP groove welding repair from location Y=0mm to Y=1000mm. The welder was observed welding in the 4G (overhead) position utilizing Shielded Metal Arc Welding (SMAW) with 3.2mm diameter E7018H4R electrode implementing welding procedure ABF-WPS-D15-1004-Repairs. The repair excavation was preheated to more than 325 degree Fahrenheit using Miller Proheat 35 Induction Heating System with the heater blanket put in plate on top of the deck prior/during welding. During the shift, ABF QC Julian Razo was noted monitoring the welder with measured working current of 135 amperes on 3.2mm E7018H4R electrode. At the end of the shift, repair welding at location mentioned above was partially completed and the welder performed the Post Weld Heat Treatment (PWHT) of 450°F where repair was completed and held it for one hour as required.

At OBG 13W-W2.1 @10,100 drop-in top deck plate inside, QA randomly observed ABF/JV qualified welder Rick Clayborn continuing to perform CJP groove welding repair from location Y=0mm to Y=1800mm. The welder was observed welding in the 4G (overhead) position utilizing Shielded Metal Arc Welding (SMAW) with 3.2mm diameter E7018H4R electrode implementing welding procedure ABF-WPS-D15-1004-Repairs. The repair excavation was preheated to more than 325 degree Fahrenheit using Miller Proheat 35 Induction Heating System with the heater blanket put in plate on top of the deck prior/during welding. During the shift, ABF QC Julian Razo

At OBG 13W-W2.8@12570 drop-in top deck plate inside, QA randomly observed ABF/JV qualified welder Richard Garcia continuing to perform CJP groove welding repair from location Y=11800mm to Y=12570mm. The welder was observed manually welding in the 4G (overhead) position utilizing dual shielded Flux Cored Arc Welding (FCAW-G) with 1.6mm diameter electrode implementing Caltrans approved welding procedure ABF-WPS-D15-3110-4. This repair has been excavated and being welded with Caltrans approved Request for Weld Repair (RWR) #201208-001. The repair excavation was preheated to more than 225 degree Fahrenheit using Miller Proheat 35 Induction Heating System with the heater blanket put in place on top of the deck prior/during welding. During the shift, ABF QC Julian Razo was noted monitoring the welder with measured working current of 260 amperes, 22.5 volts. During the shift, repair welding at location mentioned above was completed and the welder has moved to another location Y=10200mm to Y=11800mm of the same butt joint. The welder was noted using the same process and implemented the same WPS on this new weld location. The welder performed the FCAW-G repair until the end of the shift wherein he partially completed the repair welding. The welder held the same preheat and held it for three (3) hours after welding as required.

At OBG 13W-WK- SK1 plate inside, QA randomly observed ABF/JV qualified welder Chau Tran continuing to perform CJP groove back welding fill pass on the K plate skewed butt joint. The welder performed back gouging using carbon air arc gouging and ground smooth the groove of the weld joint after gouging. ABF QC Julian Razo was noted performing Magnetic Particle Testing (MT) after the completion of the back gouging and grinding with no relevant defects noted. The welder resumed manual welding in the 2G (horizontal) position utilizing a Shielded Metal Arc Welding (SMAW) with 3.2mm diameter E7018H4R electrode and implementing Caltrans approved Welding Procedure Specification (WPS) ABF-WPS-D15-1072. The plates were preheated to more than 200 degree Fahrenheit using Miller Proheat 35 Induction Heating System with the heater blanket put in place the back of the SK plate being welded. During welding, ABF Quality Control (QC) Julian Razo was noted monitoring the welding parameters of the welder with measured working current of 125 amperes. At the end of the shift, fill pass welding was still continuing and should remain tomorrow.

At OBG 13W/14W-LS5N deck stiffener flange inside, QA randomly observed ABF/JV qualified welder Lou Xiao Hua continuing to perform PJP groove welding root pass to fill pass on the deck stiffener flange T-joint. The welder was observed perform manual welding in the 4G (overhead) position utilizing a Shielded Metal Arc Welding (SMAW) with 3.2mm diameter E9018H4R electrode and implementing Caltrans approved Welding Procedure Specification (WPS) ABF-WPS-D15-1162-4. The stiffener flange plate has a bevel groove being welded PJP T-joint to the longitudinal stiffener. The plates were preheated to more than 200 degree Fahrenheit using Miller Proheat 35 Induction Heating System. During welding, ABF Quality Control (QC) Julian Razo was noted monitoring the welding parameters of the welder with measured working current of 125 amperes. During the shift, cover pass welding was completed and the welder held the same preheat of >200 degree Fahrenheit for three hours after welding as required.

At OBG location 13W-PP122.5-W3 longitudinal diaphragm WT12 stiffener inside, this QA randomly observed ABF welder Lin E. Yun perform fillet welding on the above mentioned stiffener. The welder was noted welding in 3F (horizontal) position using Shielded Metal Arc Welding (SMAW) with 3.2mm diameter E7018 H4R electrode
