**DEPARTMENT OF TRANSPORTATION**

Contract #: 04-0120F4Cty: SF/ALA Rte: 80 PM: 13.2/13.9File #: 1.28**WELDING INSPECTION REPORT****Resident Engineer:** Casey, William**Address:** 333 Burma Road**City:** Oakland, CA 94607**Report No:** WIR-028356**Date Inspected:** 08-Sep-2012**Project Name:** SAS Superstructure**OSM Arrival Time:** 700**Prime Contractor:** American Bridge/Fluor Enterprises, a JV**OSM Departure Time:** 2030**Contractor:** American Bridge/Fluor Enterprises, a JV**Location:** Job Site**CWI Name:** Barry Drake and Pat Swain**CWI Present:** Yes No**Inspected CWI report:** Yes No N/A**Rod Oven in Use:** Yes No N/A**Electrode to specification:** Yes No N/A**Weld Procedures Followed:** Yes No N/A**Qualified Welders:** Yes No N/A**Verified Joint Fit-up:** Yes No N/A**Approved Drawings:** Yes No N/A**Approved WPS:** Yes No N/A**Delayed / Cancelled:** Yes No N/A**Bridge No:** 34-0006**Component:** SAS OBG**Summary of Items Observed:**

Caltrans Office of Structural Material (OSM) Quality Assurance Inspector (QAI) Joselito Lizardo was present at the Self Anchored Suspension (SAS) job site as requested to perform observations on the welding of components for the San Francisco O

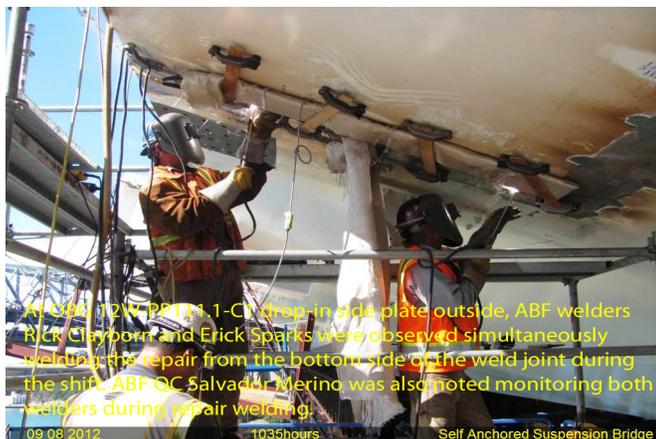
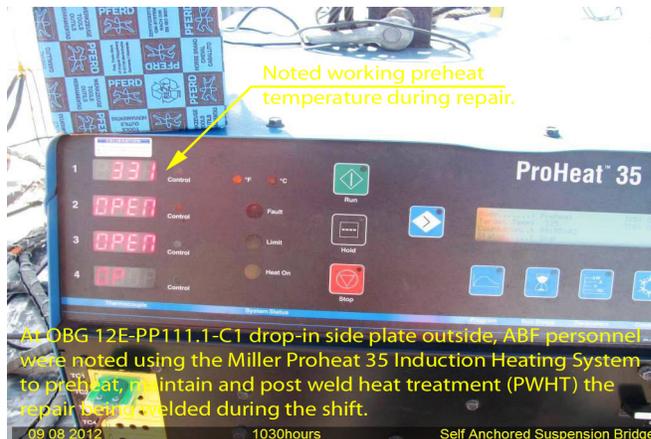
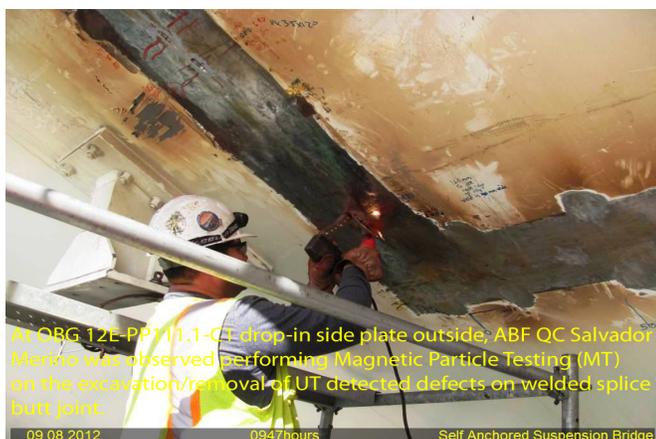
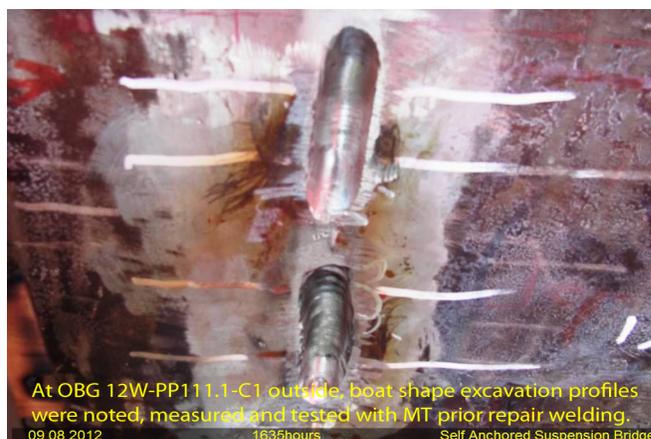
At OBG 12E-PP111.1-C1 drop-in side plate outside, QA randomly observed ABF/JV qualified welder Rick Clayborn and Erick Sparks continuing to perform CJP groove welding repair on a Seismic Performance Critical Member (SPCM) due to Ultrasonic Testing (UT) detected defects on welded splice butt joint. The welder was noted setting up the Miller Proheat 35 Induction Heating System with the heater blanket put in place from the outside to preheat the repair areas to 225°F prior and during excavation using carbon air arc gouging. The welder was given approval to excavate four (4) repair at various locations per Caltrans approved Request for Weld Repair (RWR) #201209-052 to #201209-055. The welders ground smooth the groove of the excavation and after its completion, ABF QC Salvador Merino performed Magnetic Particle Testing (MT) on the removal of the defects with no relevant defect noted during the test. This QA performed the MT verification and noted same result.

The welder pumped up the Miller Proheat 35 Induction Heating System preheats to 325°F and as soon as the required temperature was attained both welders started performing the welding repair. Welders Rick Clayborn and Erick Sparks were observed manually welding in 4G (overhead) position utilizing Shielded Metal Arc Welding (SMAW) with 3.2mm diameter E7018H4R electrode implementing Caltrans approved welding procedure ABF-WPS-D15-1004 Repair. Erick Sparks noted welding repair at Y=1995mm having boat shape excavation profile of 120mm x 15mm wide x 10mm deep while welder Rick Clayborn was noted welding repair at combined excavation of Y=590mm and Y=615mm with combined boat shape excavation profile of 95mm long x 15mm

At OBG 12W-PP111.1-C1 drop-in side plate inside and outside, the same two ABF welders mentioned above were observed welding repair from inside and outside of the OBG. ABF welder Rick Clayborn was noted inside the OBG performed the excavation and welding repair while ABF welder Erick Sparks was noted outside the OBG. The same steps from preheating to >225°F prior excavation, repair welding at 325°F and post weld heat treatment (PWHT) to 450°F were noted followed during the course of the repairs at this side plate location. Welder Rick Clayborn has completed from inside the repairs listed below;
