Quality Assurance and Source Inspection

Contract #: 04-0120F4Cty: SF/ALA Rte: 80 PM: 13.2/13.9File #: 1.28**WELDING INSPECTION REPORT****Resident Engineer:** Casey, William**Address:** 333 Burma Road**City:** Oakland, CA 94607**Report No:** WIR-028540**Date Inspected:** 08-Oct-2012**Project Name:** SAS Superstructure**OSM Arrival Time:** 700**Prime Contractor:** American Bridge/Fluor Enterprises, a JV**OSM Departure Time:** 1730**Contractor:** American Bridge/Fluor Enterprises, a JV**Location:** Job site**CWI Name:** Chris Concha**CWI Present:** Yes No**Inspected CWI report:** Yes No N/A**Rod Oven in Use:** Yes No N/A**Electrode to specification:** Yes No N/A**Weld Procedures Followed:** Yes No N/A**Qualified Welders:** Yes No N/A**Verified Joint Fit-up:** Yes No N/A**Approved Drawings:** Yes No N/A**Approved WPS:** Yes No N/A**Delayed / Cancelled:** Yes No N/A**Bridge No:** 34-0006**Component:** OBG/Tower**Summary of Items Observed:**

Quality Assurance Inspector (QAI) Rodney Patterson was at the American Bridge/Fluor (ABF) job site at Yerba Buena Island in California between the times noted above in order to monitor Quality Control functions and the in process work being perform

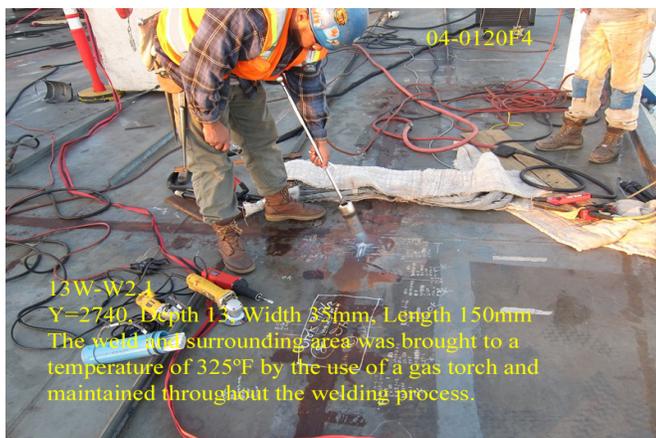
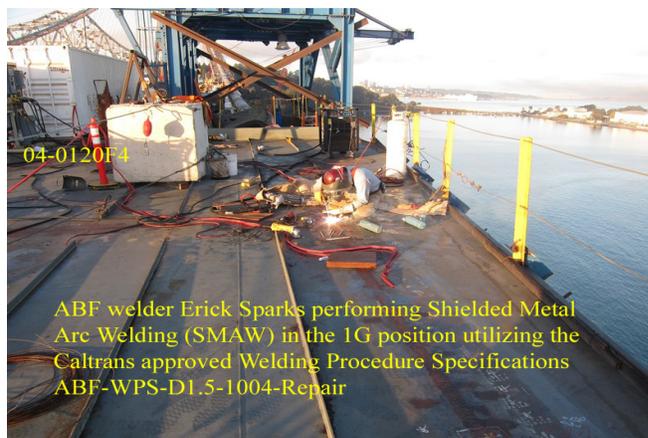
The QAI noted and periodically observed ABF welder Erick Sparks performing Shielded Metal Arc Welding (SMAW) in the 1G position utilizing the Caltrans approved Welding Procedure Specifications ABF-WPS-D1. 5-1004-Repair. The weld was excavated and magnetic particle testing performed on a previous shift. The repairs are located on the deck drop-in longitudinal splice designated as 13W-W2.1 at the following location;

13W-W2.1

Y=2740, Depth 13, Width 35mm, Length 150mm

The weld and surrounding area was brought to a temperature of 325°F by the use of a gas torch and maintained throughout the welding process. The repairs were then observed to be post heated at 450°F for one hour. The repair excavations were performed in accordance with approval for repair documents 201209-106.
