**DEPARTMENT OF TRANSPORTATION**

Contract #: 04-0120F4Cty: SF/ALA Rte: 80 PM: 13.2/13.9File #: 1.28**WELDING INSPECTION REPORT****Resident Engineer:** Casey, William**Address:** 333 Burma Road**City:** Oakland, CA 94607**Report No:** WIR-028544**Date Inspected:** 08-Oct-2012**Project Name:** SAS Superstructure**OSM Arrival Time:** 700**Prime Contractor:** American Bridge/Fluor Enterprises, a JV**OSM Departure Time:** 1730**Contractor:** American Bridge/Fluor Enterprises, a JV**Location:** Job Site

<b>CWI Name:</b>	William Sherwood and Barry Drake			<b>CWI Present:</b>	Yes	No	
<b>Inspected CWI report:</b>	Yes	No	N/A	<b>Rod Oven in Use:</b>	Yes	No	N/A
<b>Electrode to specification:</b>	Yes	No	N/A	<b>Weld Procedures Followed:</b>	Yes	No	N/A
<b>Qualified Welders:</b>	Yes	No	N/A	<b>Verified Joint Fit-up:</b>	Yes	No	N/A
<b>Approved Drawings:</b>	Yes	No	N/A	<b>Approved WPS:</b>	Yes	No	N/A
				<b>Delayed / Cancelled:</b>	Yes	No	N/A
<b>Bridge No:</b>	34-0006			<b>Component:</b>	SAS OBG

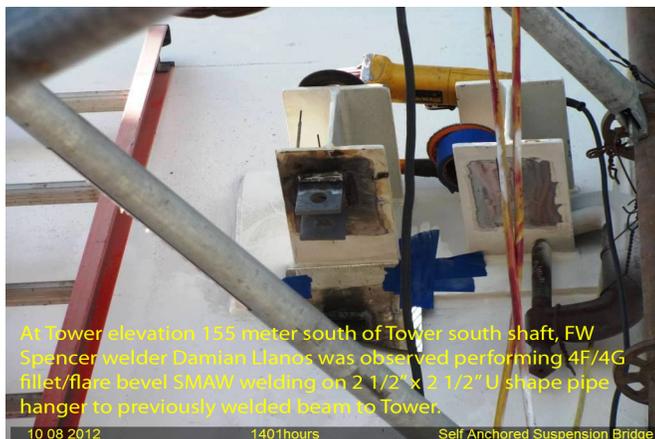
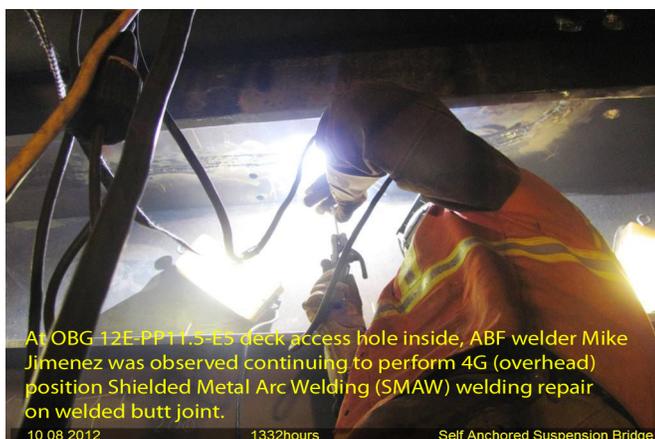
At OBG 12E-PP116.5-E5 deck access hole inside, QA randomly observed ABF/JV qualified welder Mike Jimenez continuing to perform CJP groove welding repair on a Seismic Performance Critical Member (SPCM) due to Ultrasonic Testing (UT) detected defect on welded butt joint. The welder was using Miller Proheat 35 Induction Heating System with the heater blanket put on top of the plate to preheat the repair area and its vicinity to 325°F and as soon as the required temperature was attained the welder started performing the welding repair. Welder Mike Jimenez was observed manually welding in 4G (overhead) position utilizing Shielded Metal Arc Welding (SMAW) with 3.2mm and 4.0mm diameter E7018H4R electrode implementing Caltrans approved welding procedure ABF-WPS-D15-1004 Repair. During welding, ABF QC William Sherwood was noted monitoring the welder's welding parameter with measured working current of 132 amperes on the 3.2mm diameter E7018H4R electrodes. During the shift, the repair welding at the location mentioned above was still continuing and the welder performed the post weld heat treatment (PWHT) of 450°F on the ongoing repair using the Miller Proheat 35 Induction Heating System and held it for one hour as required.

At OBG 12E-E2.1-@31000mm corner drop-in top deck plate inside, QA randomly observed ABF/JV qualified welder Wai Kit Lai continuing to perform CJP groove welding first time repair on a non-Seismic Performance Critical Member (SPCM) due to Ultrasonic Testing (UT) detected defect on welded splice butt joint. The welder preheated the repair area and its vicinity to >150°F using propylene gas torch prior excavation and then ground smooth the groove of the excavation. After its completion, ABF QC William Salvador Merino performed Magnetic Particle Testing (MT) on the removal of the defects with no relevant defect noted during the test.

The welder was noted using propylene gas torch to preheat the repair area and its vicinity to >150°F and as soon as the required temperature was attained the welder started performing the welding repair. Welder Wai Kit Lai was observed manually welding in 4G (overhead) position utilizing Shielded Metal Arc Welding (SMAW) with 3.2mm diameter E7018H4R electrode implementing Caltrans approved welding procedure ABF-WPS-D15-1000 Repair Rev. 2. During welding, ABF QC William Sherwood was noted monitoring the welder's welding parameter with measured working current of 126 amperes on the 3.2mm diameter E7018H4R electrodes. During the shift, repair welding at the location listed below were noted;

At Tower location elevation 145 and 155 meters, this QA randomly observed FW Spencer qualified welder Damian Llanos continuing to perform Complete Joint Penetration (CJP) 6G (all position) Shielded Metal Arc Welding (SMAW) welding fill pass to cover pass on the 1" weldolet for the 2 1/2" domestic water line. The welder was noted welding the fill and cover pass with 3/32" diameter E7018H4R electrode implementing Caltrans approved procedure FW Spencer WPS 1-12-1. The welder was noted preheating and removing the moisture of the joint using a portable propane gas torch prior welding. During welding, ABF QC Barry Drake was noted monitoring the parameters of the welder. After the welding completion of the 1" diameter weldolet, the welder moved to the 155 meter elevation on the south side of the Tower south shaft and fillet/flare welded one 2 1/2" x 2 1/2" U shape hanger to the previously welded beam attached to the Tower. At the end of FW Spencer shift, both welding works mentioned above were completed.
