**DEPARTMENT OF TRANSPORTATION**

Contract #: 04-0120F4Cty: SF/ALA Rte: 80 PM: 13.2/13.9File #: 1.28**WELDING INSPECTION REPORT****Resident Engineer:** Casey, William**Address:** 333 Burma Road**City:** Oakland, CA 94607**Report No:** WIR-028940**Date Inspected:** 02-Jan-2013**Project Name:** SAS Superstructure**OSM Arrival Time:** 700**Prime Contractor:** American Bridge/Fluor Enterprises, a JV**OSM Departure Time:** 1730**Contractor:** American Bridge/Fluor Enterprises, a JV**Location:** Job Site**CWI Name:** See below.**CWI Present:** Yes No**Inspected CWI report:** Yes No N/A**Rod Oven in Use:** Yes No N/A**Electrode to specification:** Yes No N/A**Weld Procedures Followed:** Yes No N/A**Qualified Welders:** Yes No N/A**Verified Joint Fit-up:** Yes No N/A**Approved Drawings:** Yes No N/A**Approved WPS:** Yes No N/A**Delayed / Cancelled:** Yes No N/A**Bridge No:** 34-0006**Component:** OBG**Summary of Items Observed:**

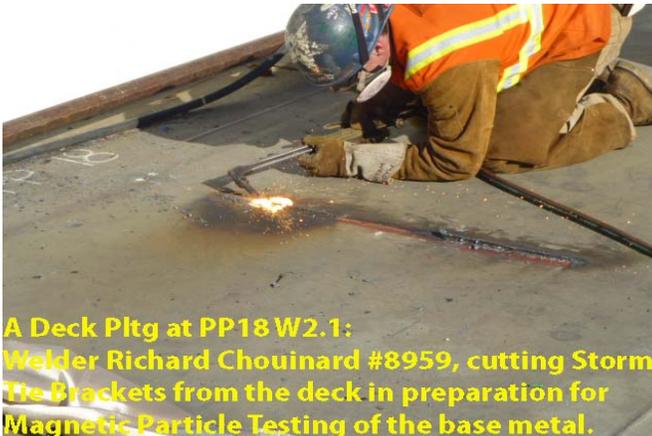
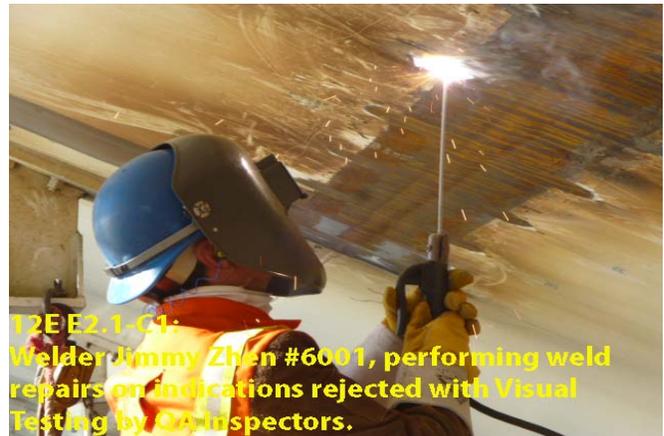
Welder was observed cutting temporary Storm Tie Brackets from the A deck at following locations:

- 5W PP30 W2.1
- 5W PP30 W5.0
- 2W PP19 W5.0
- 2W PP18 W2.1
- 2W PP18 W5.0

Welder was observed cutting using Oxygen/Acetylene and preparing the base metal welded area by grinding for Magnetic Particle Testing (MPT).
