Contract #: 04-0120F4Cty: SF/ALA Rte: 80 PM: 13.2/13.9File #: 1.28**WELDING INSPECTION REPORT**

Report No: WIR-028945
Date Inspected: 04-Jan-2013

Project Name: SAS Superstructure **OSM Arrival Time:** 700
Prime Contractor: American Bridge/Fluor Enterprises, a JV **OSM Departure Time:** 1730
Contractor: American Bridge/Fluor Enterprises, a JV **Location:** Job Site

CWI Name:	William Sherwood Fred Michels			CWI Present:	Yes	No	
Inspected CWI report:	Yes	No	N/A	Rod Oven in Use:	Yes	No	N/A
Electrode to specification:	Yes	No	N/A	Weld Procedures Followed:	Yes	No	N/A
Qualified Welders:	Yes	No	N/A	Verified Joint Fit-up:	Yes	No	N/A
Approved Drawings:	Yes	No	N/A	Approved WPS:	Yes	No	N/A
				Delayed / Cancelled:	Yes	No	N/A
Bridge No:	34-0006			Component:	SAS Tower and OBG

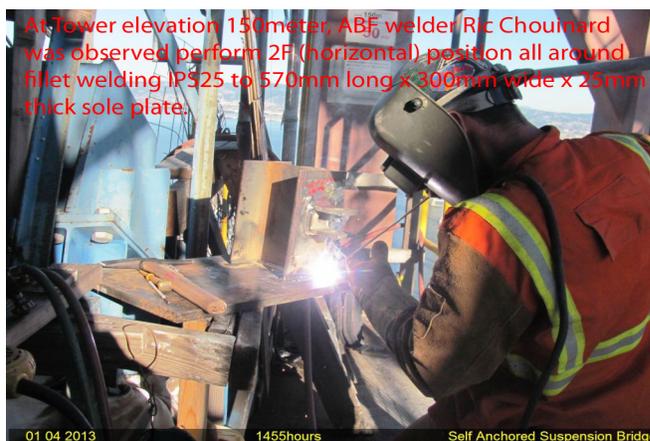
shaft skin plate 'D'. The welder was noted using Shielded Metal Arc Welding (SMAW) with 3.2mm E7018H4R electrode implementing ABF-WPS-D1.5-F1200A. The brackets being welded are pipe supports for the domestic water and compressed air lines and per CCO 203. After the completion of the fillet welding on the 3" x 3" x 6 1/4" long angular shape brackets to the tower head, the welder also started all around fillet welding IPS25 to 570mm long x 300mm wide x 25mm thick sole plate. The welder was noted using the same process at 2F position. At the end of the shift, two (2) IPS25 was welded to the sole plate per Request for Information RFI#3056.

At Tower North shaft elevation 145mm to 89meters inside, this QA together with fellow QA Charlie Stewart performed punch items inspection inside the tower shaft. Various punch items noted include missing chain on every tower diaphragm level, rusty bolt heads and ends, rusty spots on skin plates and many others. The punch items inspection is being performed on a daily basis for two hours per day.
