DEPARTMENT OF TRANSPORTATION

Quality Assurance and Source Inspection

Contract #: 04-0120F4Cty: SF/ALA Rte: 80 PM: 13.2/13.9File #: 1.28**WELDING INSPECTION REPORT****Resident Engineer:** Casey, William**Address:** 333 Burma Road**City:** Oakland, CA 94607**Report No:** WIR-029021**Date Inspected:** 18-Jan-2013**Project Name:** SAS Superstructure**OSM Arrival Time:** 700**Prime Contractor:** American Bridge/Fluor Enterprises, a JV**OSM Departure Time:** 1730**Contractor:** American Bridge/Fluor Enterprises, a JV**Location:** Job Site**CWI Name:** William Sherwood**CWI Present:** Yes No**Inspected CWI report:** Yes No N/A**Rod Oven in Use:** Yes No N/A**Electrode to specification:** Yes No N/A**Weld Procedures Followed:** Yes No N/A**Qualified Welders:** Yes No N/A**Verified Joint Fit-up:** Yes No N/A**Approved Drawings:** Yes No N/A**Approved WPS:** Yes No N/A**Delayed / Cancelled:** Yes No N/A**Bridge No:** 34-0006**Component:** SAS Tower**Summary of Items Observed:**

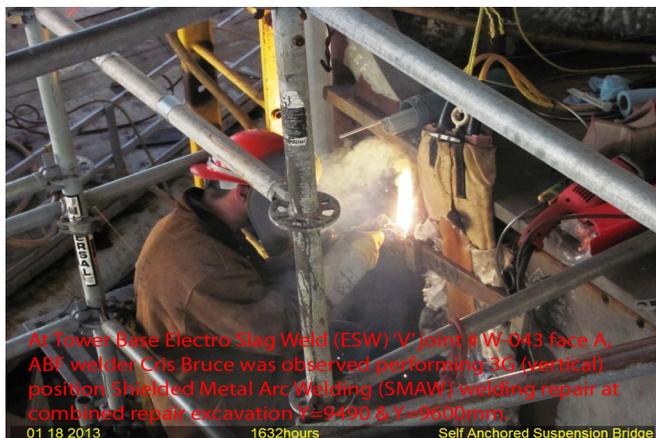
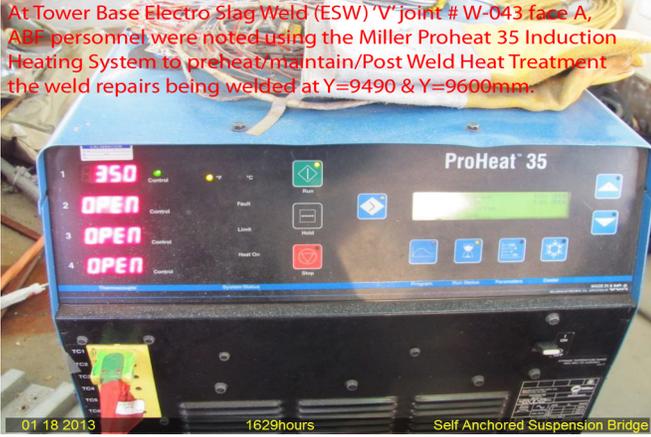
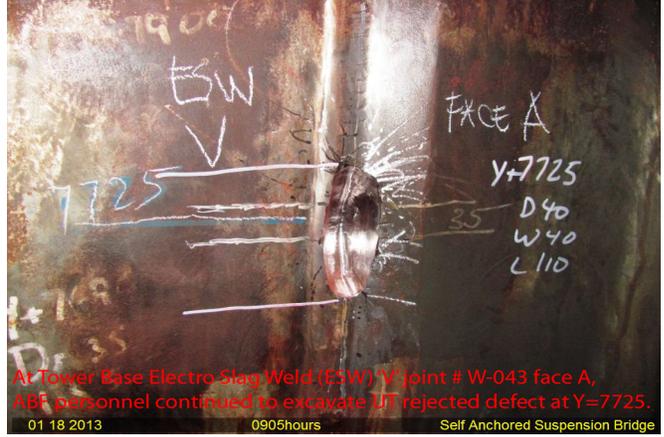
At the Tower Base, Electro Slag Weld (ESW) "V" weld joint #W-043 face B, ABF welder Chris Bruce was observed performing repair welding of the weld cover pass of the previously welded ESW located at Y=7610mm where the welder had left off yesterday, Thursday January 17, 21013. The welder was noted utilizing Shielded Metal Arc Welding (SMAW) with 4mm diameter E7018H4R electrode as per the WPS ABF-WPS-D15-1000 Repair Rev. 3. The welding parameters were measured and noted during the welding was 187 amperes. This weld repair is being performed per Request for Weld Repair (RWR) #201301-027. During the shift, ABF QC William Sherwood was noted monitoring the welding parameters and workmanship of the repair being welded. The repair welding at this location was completed and the welder performed the Post Weld Heat Treatment (PWHT).

At Tower Base Electro Slag Weld (ESW) 'V' weld joint #W-043 face A, ABF welder Erick Sparks was observed perform excavation on previously welded ESW from Y=7775mm to Y=7795mm due to UT reject. Prior to the

excavation, the welder was noted preheating the repair area to more than 350°F using Miller Proheat 35 Induction Heating System with the heater blanket placed on the outside. After the excavation, ABF QC William Sherwood performed the Magnetic Particle Testing (MT) where the excavation that has dimensions of 110mm long x 40mm wide x 40mm deep with no relevant indications noted. This QA also performed the same test (MT) and found same result. This repair excavation has an approved RWR# 201301-028. The excavation was completed and tested but left it for welding repair later.

At Tower Base Electro Slag Weld (ESW) 'F' weld joint #E-045 face A, ABF personnel was observed continuing to perform exploratory excavation on welded ESW at location Y=9620mm due to UT detected defects. The ABF personnel have started the exploratory excavation from the surface but to go 3mm increments up to 18mm then 1mm after that till they reach the detected defects. This new exploratory procedure is per ABF Engineer Daryll Peterson instruction to ABF personnel including QC. The personnel were noted using only the disc grinder in every 3mm increments of excavation. ABF QC Steve Jensen was observed performing Magnetic Particle Testing (MT) on the following various depths with indications stated below. This QA also performed the same test and noted same result. During the shift, the ABF personnel was only managed to excavate up to 3mm deep. The shift was completed up to this depth of excavation.
