DEPARTMENT OF TRANSPORTATION

Contract #: 04-0120F4Cty: SF/ALA Rte: 80 PM: 13.2/13.9File #: 1.28**WELDING INSPECTION REPORT****Resident Engineer:** Casey, William**Address:** 333 Burma Road**City:** Oakland, CA 94607**Report No:** WIR-029325**Date Inspected:** 19-Mar-2013**Project Name:** SAS Superstructure**OSM Arrival Time:** 700**Prime Contractor:** American Bridge/Fluor Enterprises, a JV**OSM Departure Time:** 1730**Contractor:** American Bridge/Fluor Enterprises, a JV**Location:** Job Site**CWI Name:** Andrew Keech**CWI Present:** Yes No**Inspected CWI report:** Yes No N/A**Rod Oven in Use:** Yes No N/A**Electrode to specification:** Yes No N/A**Weld Procedures Followed:** Yes No N/A**Qualified Welders:** Yes No N/A**Verified Joint Fit-up:** Yes No N/A**Approved Drawings:** Yes No N/A**Approved WPS:** Yes No N/A**Delayed / Cancelled:** Yes No N/A**Bridge No:** 34-0006**Component:** SAS Tower**Summary of Items Observed:**

Caltrans Office of Structural Material (OSM) Quality Assurance Inspector (QAI) Joselito Lizardo was present at the Self Anchored Suspension (SAS) job site as requested to perform observations on the welding of components for the San Francisco Oakland Bay Brid

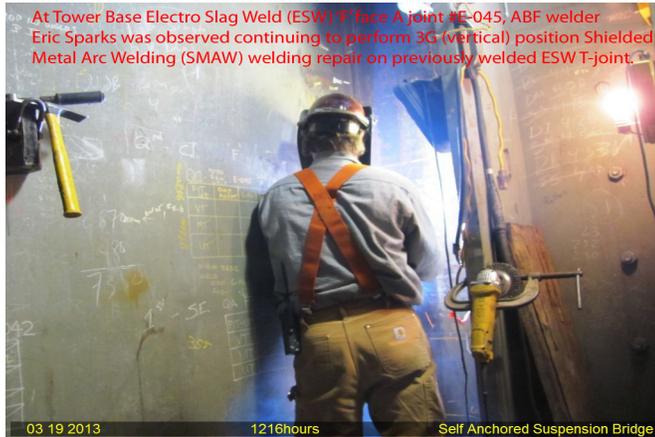
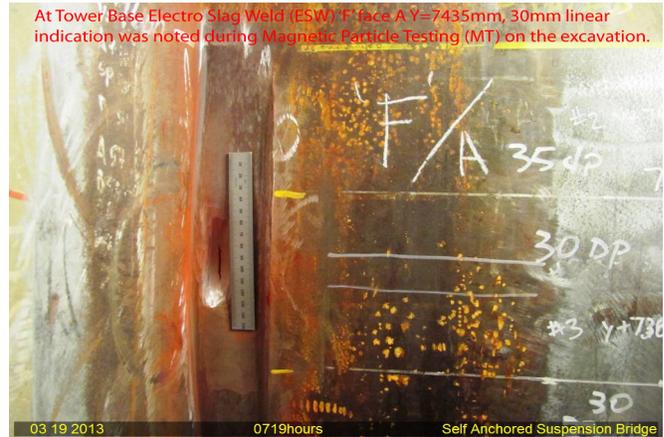
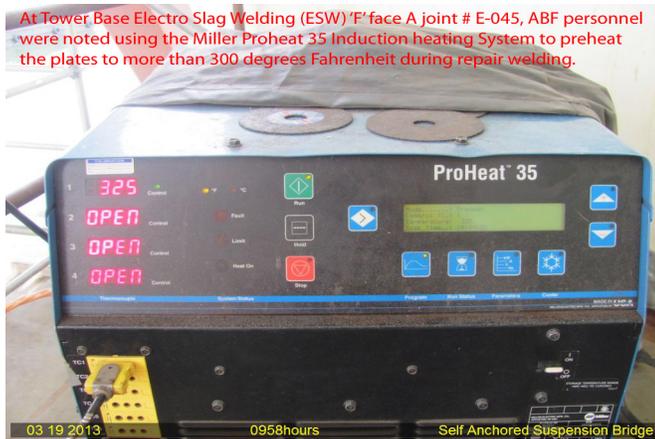
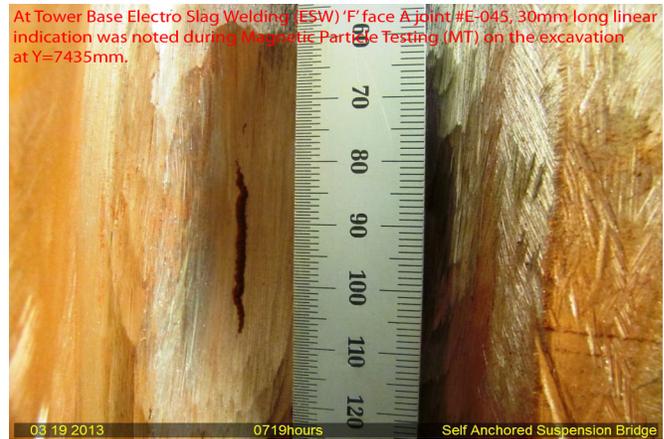
At Tower Base Electroslag Welding (ESW) T-joint #E-045 location 'F' (face A), this QAI randomly observed the ABF welder Eric Sparks perform repair welding due exploratory excavation that was noted with linear indications. The previously excavated repair was having dimensions of 145mm long x 40mm width x 45mm deep. Prior to welding, a 30mm linear indication was noted during Magnetic Particle Testing (MT) and at this time the welder stated carbon arc gouging to remove the linear indication that was noted at 21mm depth. After the completion of the removal of the linear indication and grinding of the excavation to a bright metal, Mr. Keech performed the MPT of the excavation and no significant indications were noted. This QA also performed a verification test at the request of Mr. Keech. At the conclusion of the test this QAI concurs with QC inspector's assessment. At the completion of the test, the welder was observed performing the repair welding utilizing the Shielded Metal Arc Welding (SMAW) using the 5/32" diameter E7018H4R electrodes as per the welding procedure ABF-WPS-D15-1000-Repair Rev. 2. The repair excavation and the adjacent base metal were preheated to approximately 300°F using Miller Proheat 35 Induction Heating System with the heater blanket placed at the opposite side of the shear plate. During the welding, Mr. Keech was noted monitoring the welding and the welding parameters which were noted and recorded as 175 amperes. The repair welding of the ESW located at the Y dimensions 7260mm to 7620mm was not completed on this date and will be continued on the next scheduled shift. The ABF welding personnel performed the Post Weld Heat Treatment (PWHT) to 350 degrees Fahrenheit as required.
