**VISUAL IMPACT ASSESSMENT**  
**of**  
**PROPOSED PASSING LANES AND CURVE CORRECTION**

**On Route 88 in Amador County**

**KP 67.6/75.6 EA 10-432120**

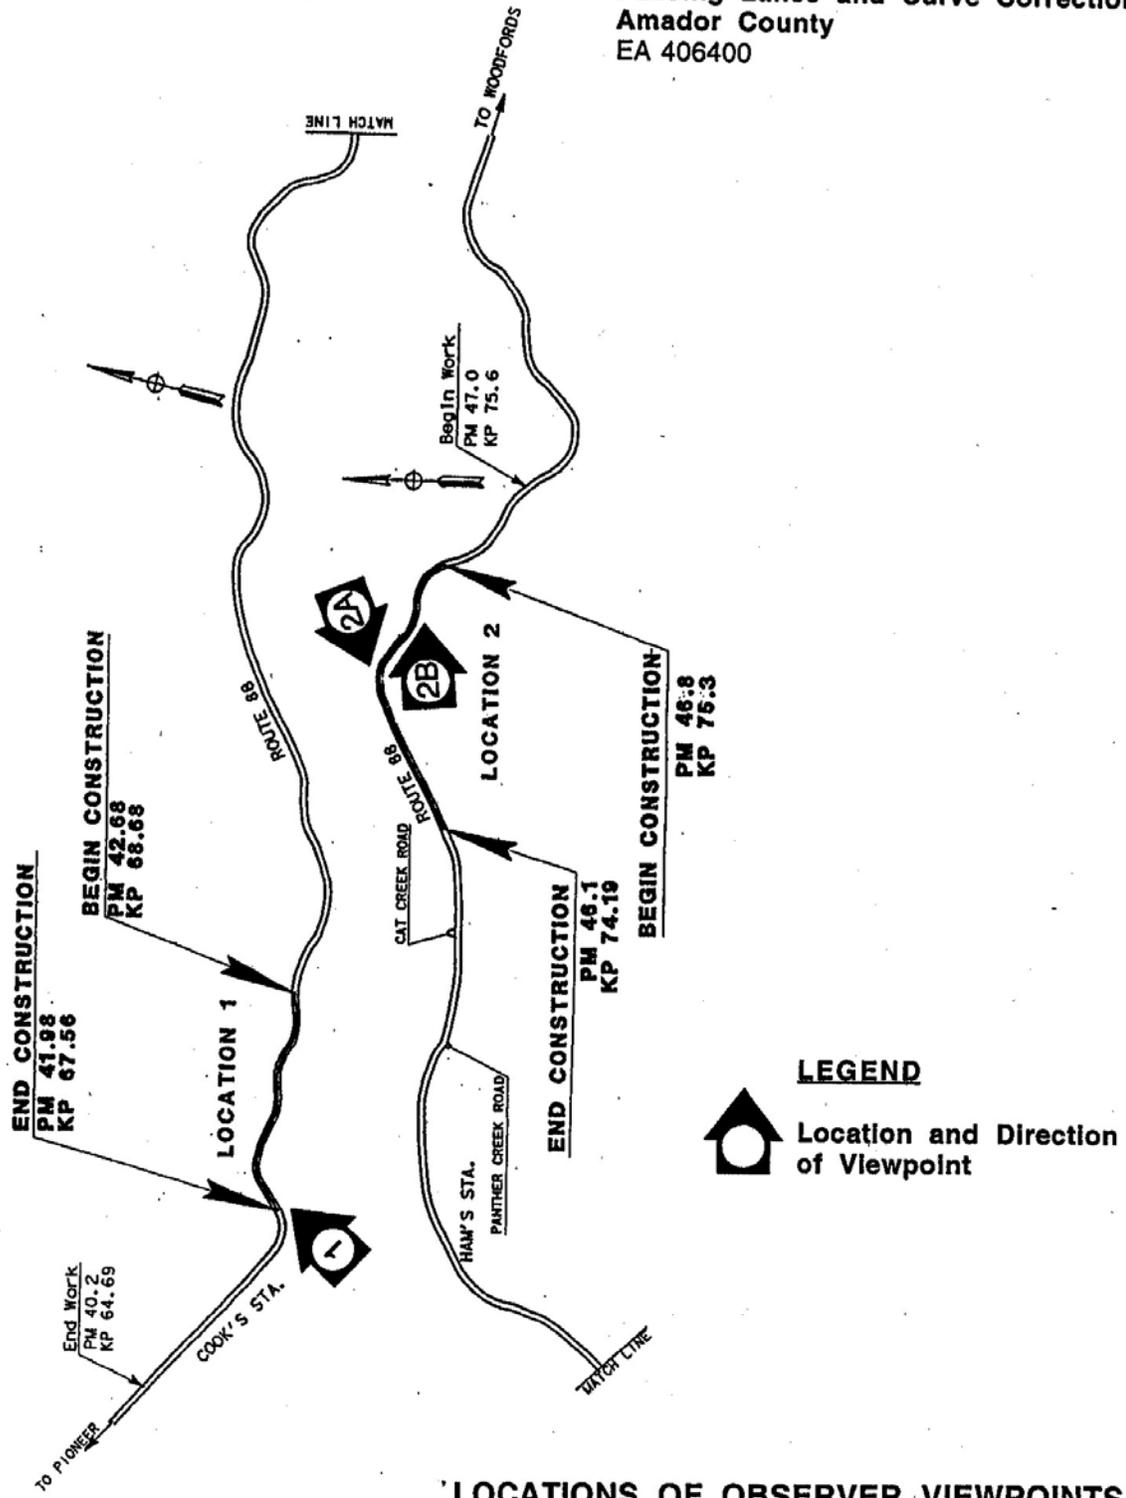
Attachment A

**LOCATIONS OF OBSERVER VIEWPOINTS**

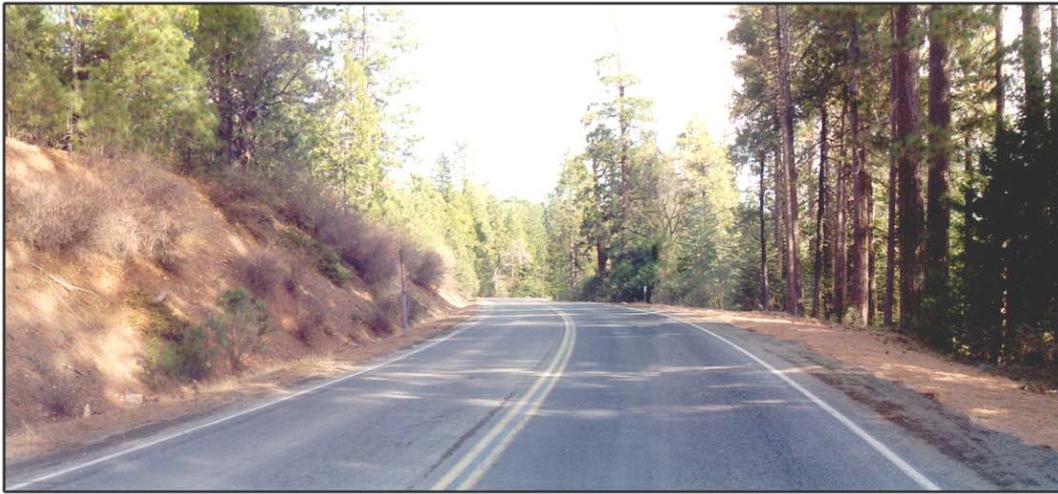
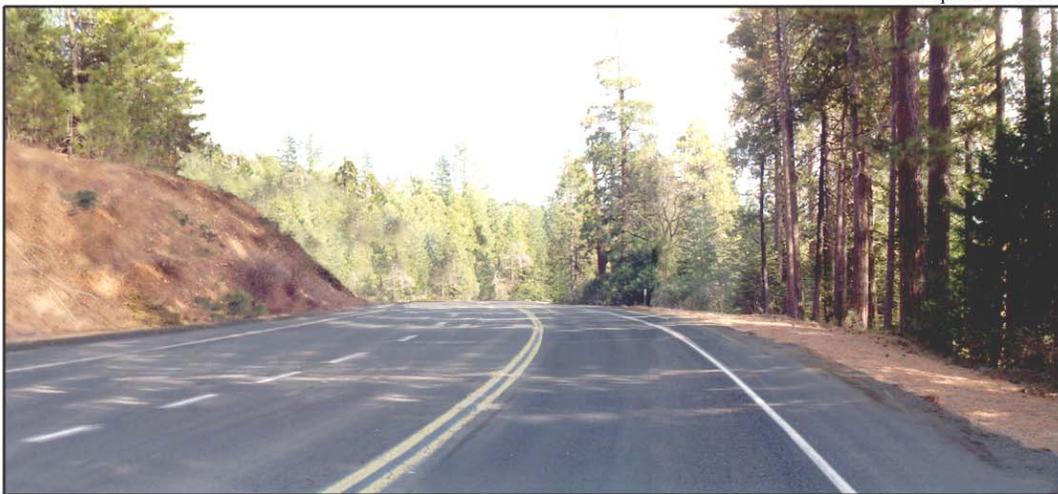
Exhibit 1

Existing view

Proposed view

**OBSERVER VIEWPOINT 1**

Within the area of Location 1, near kilopost 68.0 looking eastbound.

The three photosimulations shown in Exhibits 1, 2A and 2B illustrate the visual character of each previously described Observer Viewpoint, as well as an overview of Route 88 through the project area. In each case, the simulation at the top of the page is of the existing conditions, and the bottom simulation represents how that location might appear with mitigation in place, after approximately three years after roadwork completion.

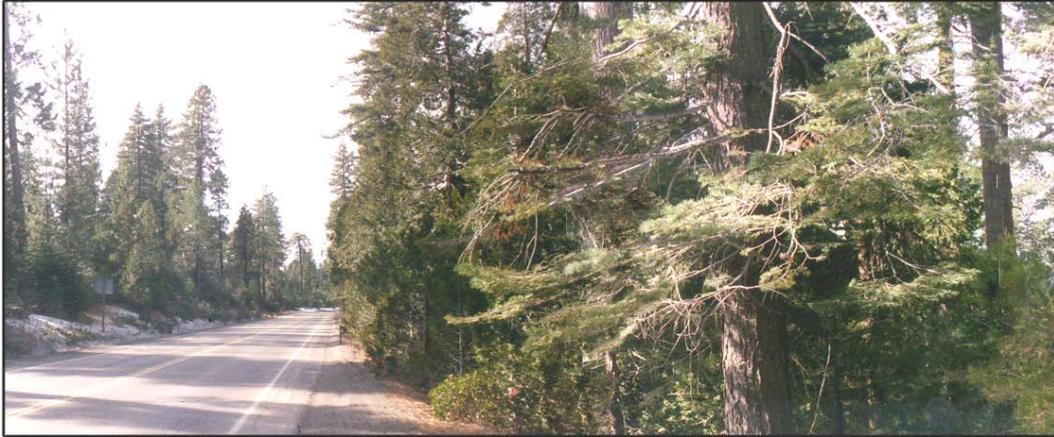
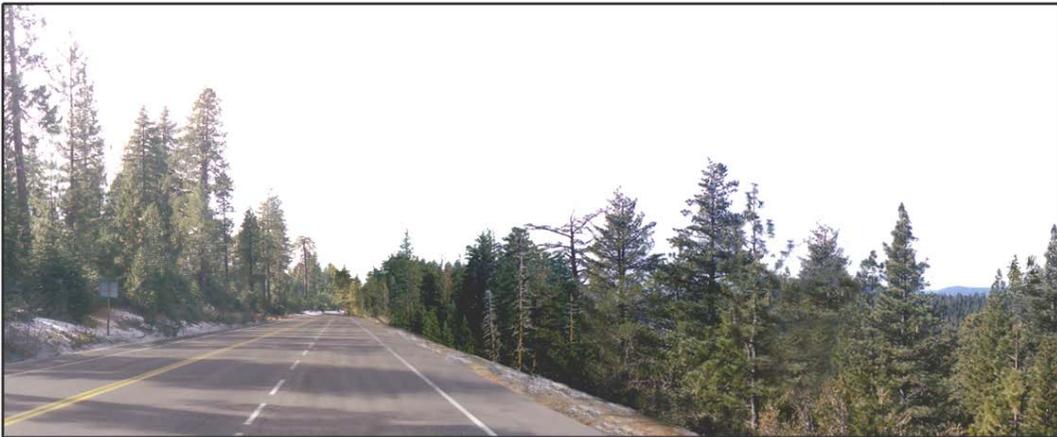
Exhibit 2A

Existing view

Proposed view

OBSERVER VIEWPOINT 2A  
Within the area of Location 2, near kilopost 74.7 looking westbound.

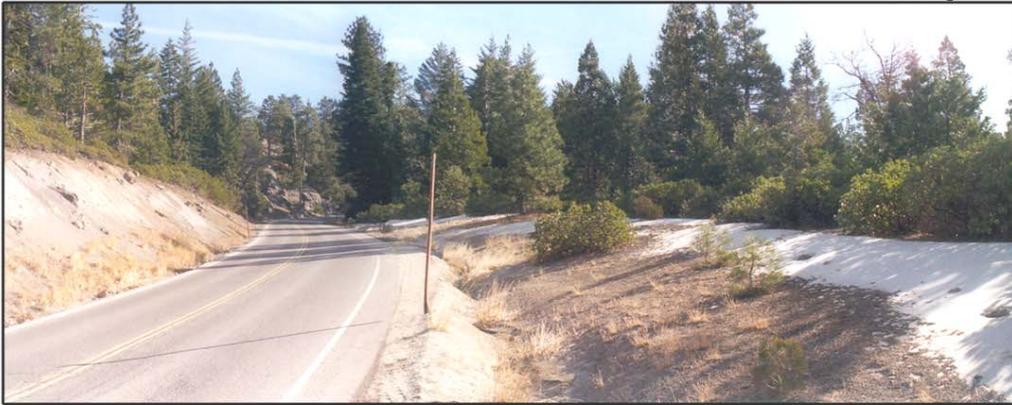
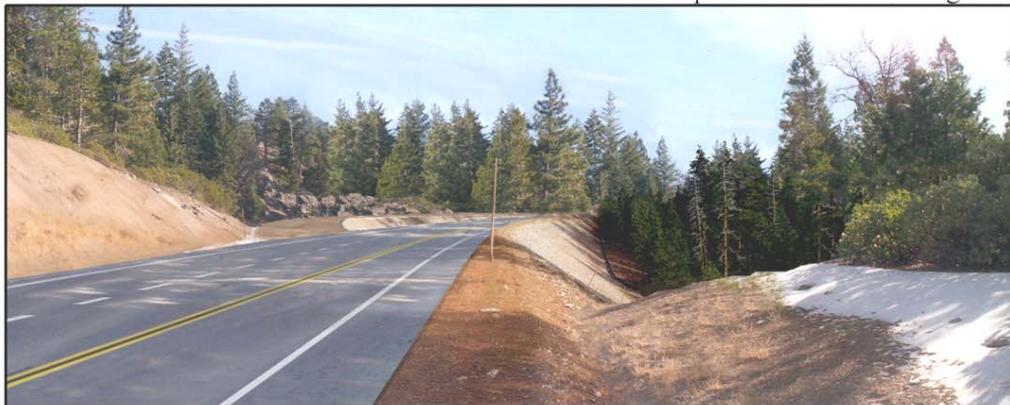
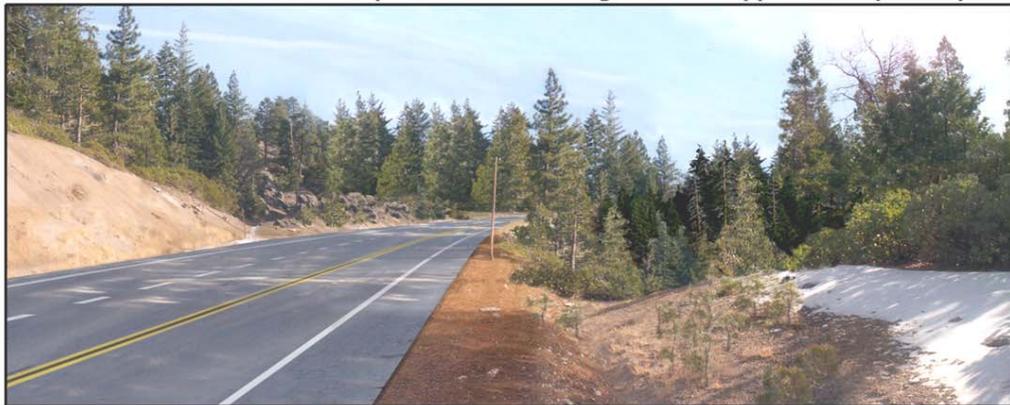
Existing view

Proposed view before mitigation

Proposed view with mitigation after approximately three years

**OBSERVER VIEWPOINT 2B**

Within the curve realignment area of Location 2, near kilopost 75.4 looking eastbound.
