**Federal Highway  
Administration**

Refer to: HSA-10/B-110

In late September, you sent me one copy of a California Department of Transportation test report dated September 2002 entitled "Crash Testing of Various Textured Barriers" and one set of videotapes showing each of the tests you conducted. Based on the results of these tests, you developed general guidelines for the architectural treatment of single-slope barriers and requested formal acceptance of these guidelines.

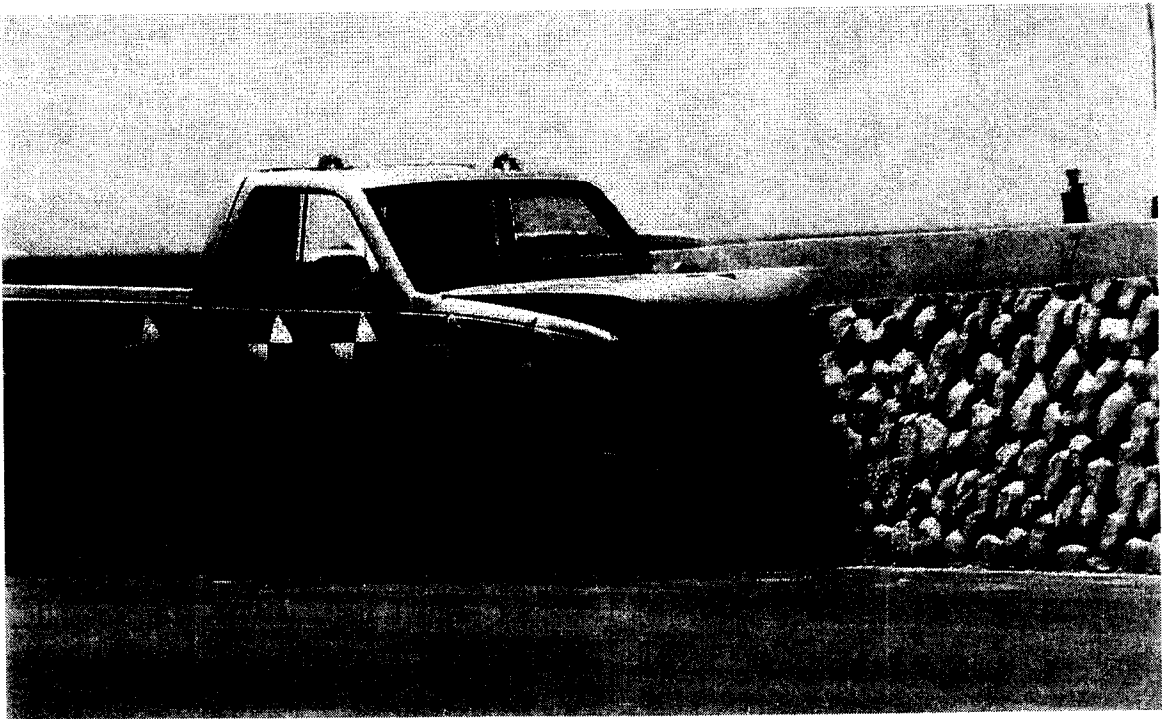
**ENCLOSURE 1**

- Deep Cobblestone design (Enclosure 1) – not acceptable, due to excessive occupant compartment intrusion (2000P vehicle)
- Fluted Rib at 45 degrees (Enclosure 2) – not acceptable, due to rollover (820C vehicle)
- Mission Arch (Enclosure 3) – acceptable performance when tested with 820C vehicle. 2000P test waived
- Deep Cobblestone Reveal (Enclosure 4) – acceptable performance with 2000P vehicle. 820C test waived
- Drystack (Enclosure 5) – acceptable performance with 2000P vehicle. 820C test waived
- Fractured Granite (Enclosure 6) – acceptable performance with 2000P vehicle. 820C test waived
- Shallow Cobblestone (Enclosure 7) – deemed not acceptable due to 2000P vehicle driveshaft separation in crash. Report 350 evaluation criteria were met, however
