San Francisco – Oakland Bay Bridge
East Span Seismic Safety Project

Pile Installation Demonstration Project

Fisheries Impact Assessment

August 2001

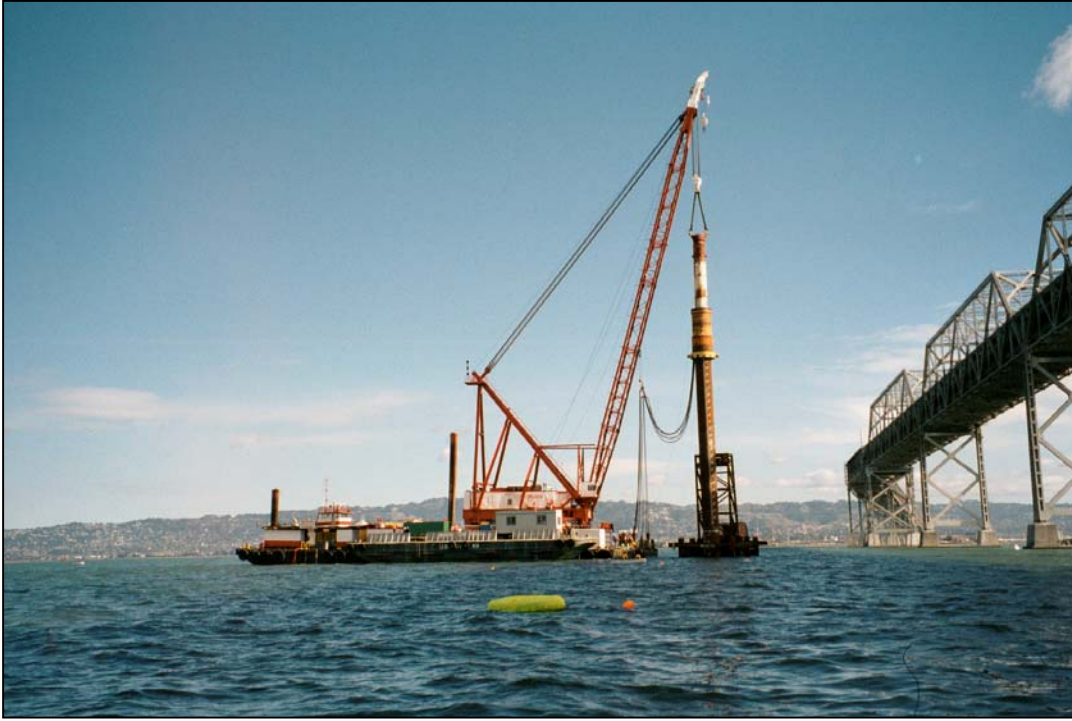
Figure 1-5. PIDP Barge and Large Hammer. (Note: Buoy in the foreground was used to support underwater sound monitoring instruments.)

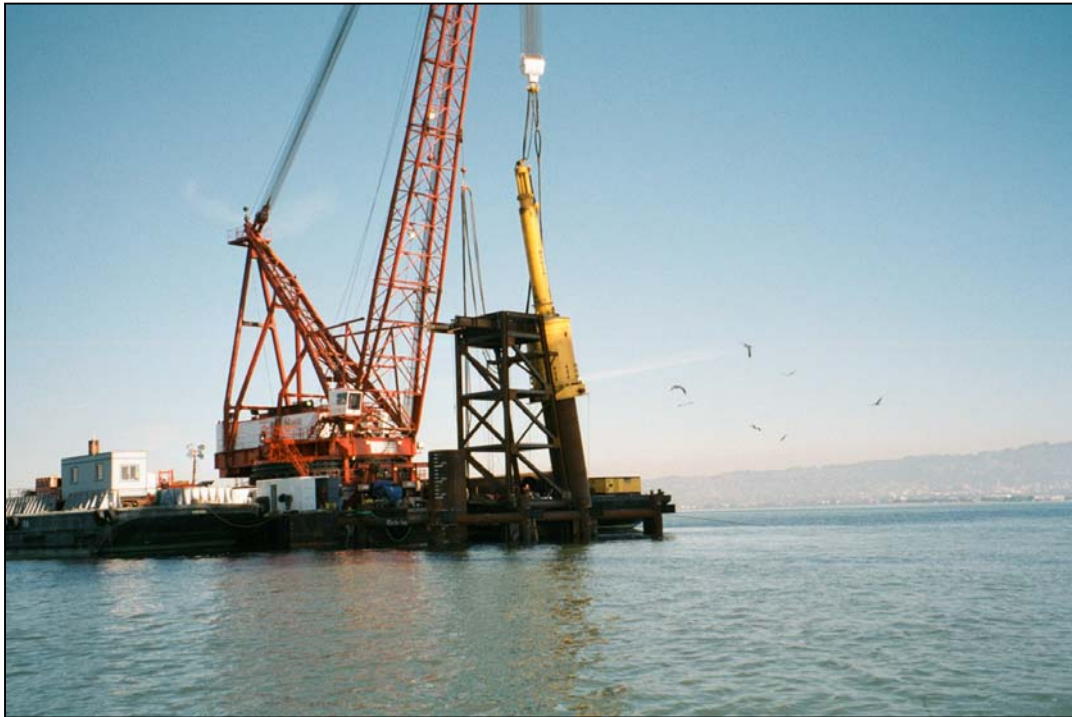
Figure 1-6. PIDP Barge and Small Hammer. (Note: Birds circling the area.)

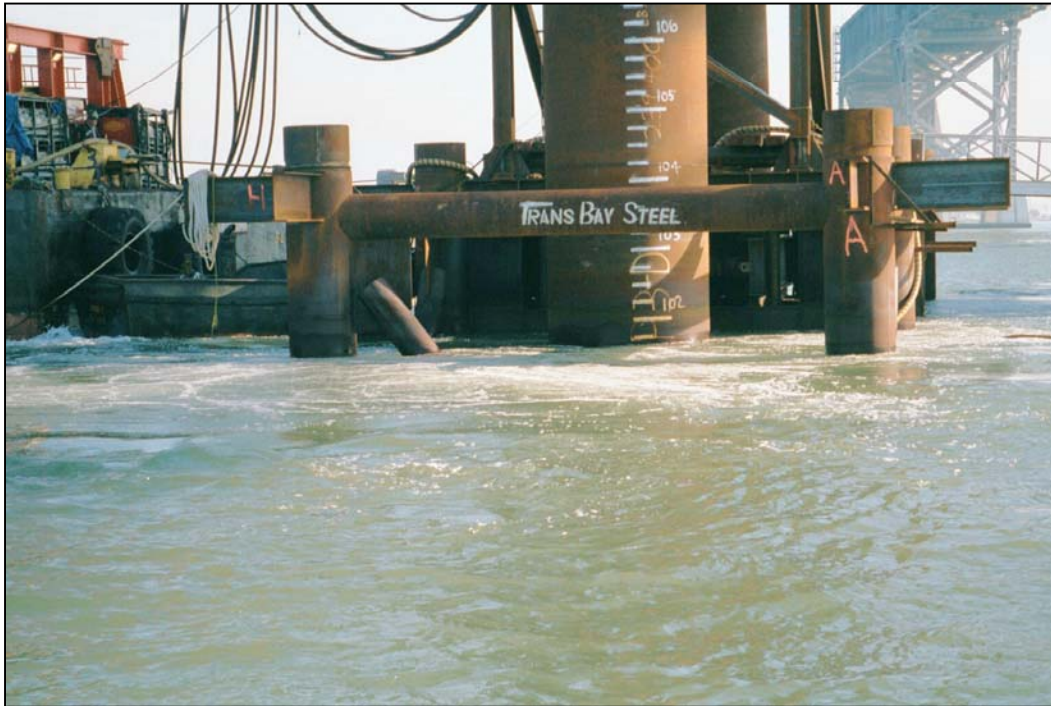
Figure 1-7. Air Bubble Curtain in Operation.

Pile 2 was a battered pile angled 1h:6v to the east and used an air bubble curtain. The air bubble curtain provides a curtain of air around the pile to attenuate noise from driving activities. Bubbles emerged from a submerged piping system that surrounded the pile template (used to hold the hammer/pile in place). The piping system was comprised of three 10.2-centimeter (4-inch) diameter perforated polyvinyl chloride (PVC) pipes attached to a steel frame, forming a 30.5-meter (100-foot) diameter octagonal ring. Two rows of 0.1-centimeter (0.04-inch) diameter holes were drilled into the PVC pipes. The bubble curtain system was fabricated and assembled off-site, then transported to the pile-driving site using a barge-mounted crane. The piping system ring was then submerged to the bay floor to encircle the pile template. Air was supplied from a 1600 cubic feet-per-minute (cfm) compressor located on the PIDP barge. Though Pile 2 was driven at an angle, the bubbles streamed straight up to the water surface, potentially providing less attenuation near the surface than at greater depths. A similar system was used by Würsig et al. (2000) for attenuating noise received by dolphins during pile driving activities for an airport expansion.

The piles were installed at two locations adjacent to the existing SFOBB East Span (Figure 1-3). Piles 1 and 2 were installed north of East Span pier E6, where the water is approximately 9 meters (30 feet) deep. Pile 3 was installed north of East Span pier E8, where the water depths range between approximately 7 meters (25 feet) to the west of the pile and 5 meters (17 feet) deep to the east of the pile. The barge from which pile driving equipment was operated was held in place next to the test pile by a system of anchors and pilings that could be adjusted as needed. A schematic of the PIDP study area is shown in Figure 1-4. Photos of the PIDP barge and the large and small hammers are shown in Figures 1-5 and 1-6. Photos of the air bubble curtain in operation and the fabric barrier system are shown in Figures 1-7 and 1-8.

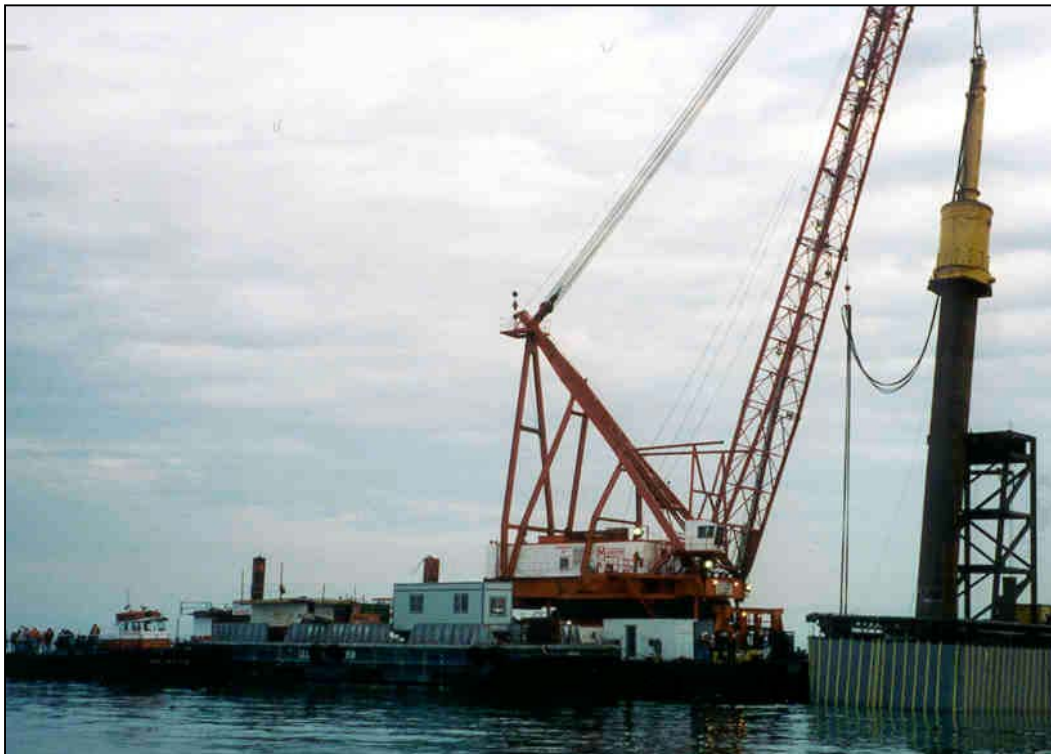
Figure 1-8. Fabric Barrier System with Aerating Mechanism (lower right corner of figure).

Pile 3 was a battered pile angled 1h:6v to the west and was surrounded by a proprietary method of sound attenuation referred to as a fabric barrier system with aerating mechanism. The fabric barrier system consisted of an in-water, double-layer fabric curtain with a single 7.6-centimeter (3-inch) diameter pipe between the two fabric sheets and three 7.6-centimeter (3-inch) diameter pipes between the inner fabric layer and the pile. The fabric curtain was made of water-permeable material which enclosed the pile template. The top of the curtain attached to the pile template at a level a few meters above the surface of the water. The bottom was attached with beams to the bottom of the template.

The fabric barrier system with aerating mechanism had a 10.7-meter by 22.9-meter (35-foot by 75-foot) rectangular footprint. This proprietary fabric barrier system with aerating mechanism was assembled and attached to the template off-site. The template/air bubble and fabric barrier was transported by barge to the Pile 3 location. Air was supplied from the same 1600 cfm compressor that was used on Pile 2; however, air was supplied to four pipes which were arranged in a smaller footprint than for the air bubble curtain, thereby providing a higher density of air bubbles around the pile.

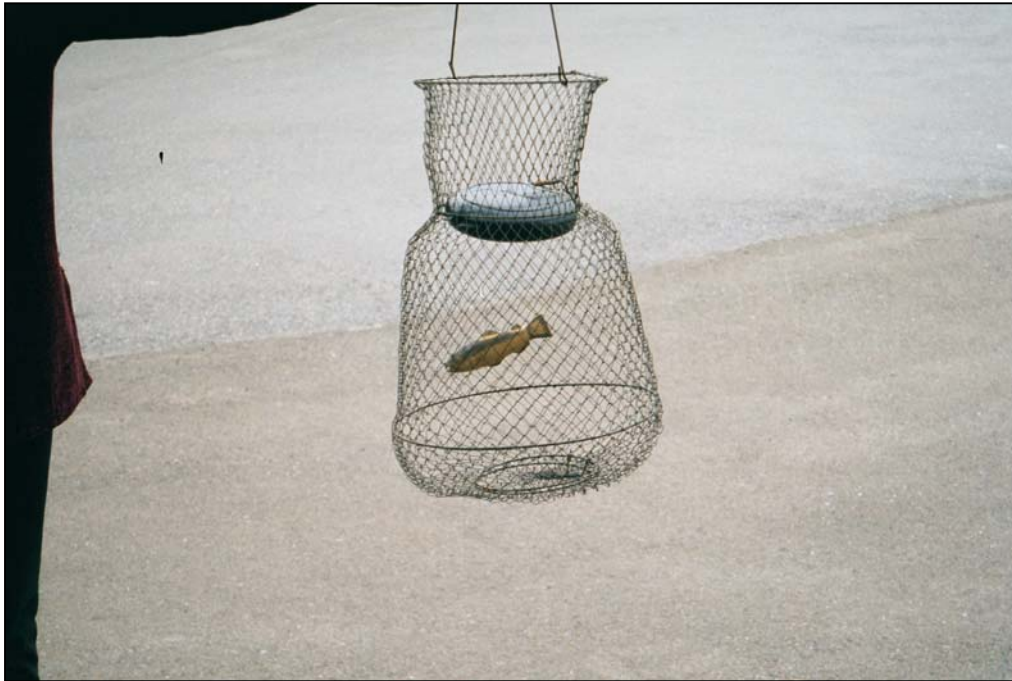
Figure 2-1. Experimental Fish Cage With Model Fish to Illustrate the Relative Size of the Fish and Cage.

Each cage was weighted by two spherical 900-gram (2-pound) weights attached to the bottom of the cage to help hold the cage approximately vertical in the water column in the strong tidal currents. A 1-centimeter (0.4-inch) diameter nylon rope tied to the top of the cage was used to suspend it from a floating buoy or cleat on the PIDP barge.

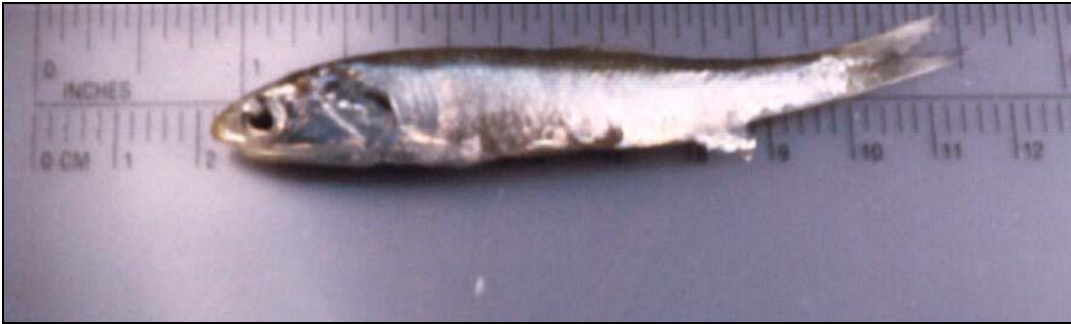
Figure 4-2. Anchovy Collected November 19, 2000 Showing Ruptures Behind the Gill Plate and at the Vent.

A number of fish were photographed to illustrate the varying degrees of damage observed. See Figures 4-2 through 4-7.

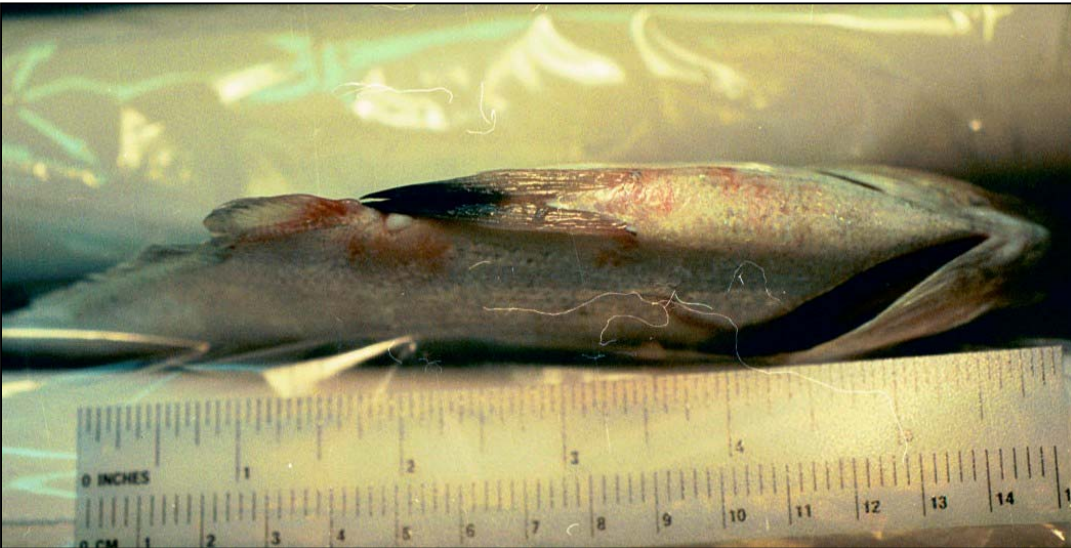
Figure 4-3. Ventral Surface of a Surferperch Showing Areas of Redness Where Blood Vessels Were Ruptured.
