Devil's Slide/Hwy 1 Storm Repair

Daily Updates from Bijan Sartipi

Daily Update
June 13

Devil's Slide (post mile 39.14)

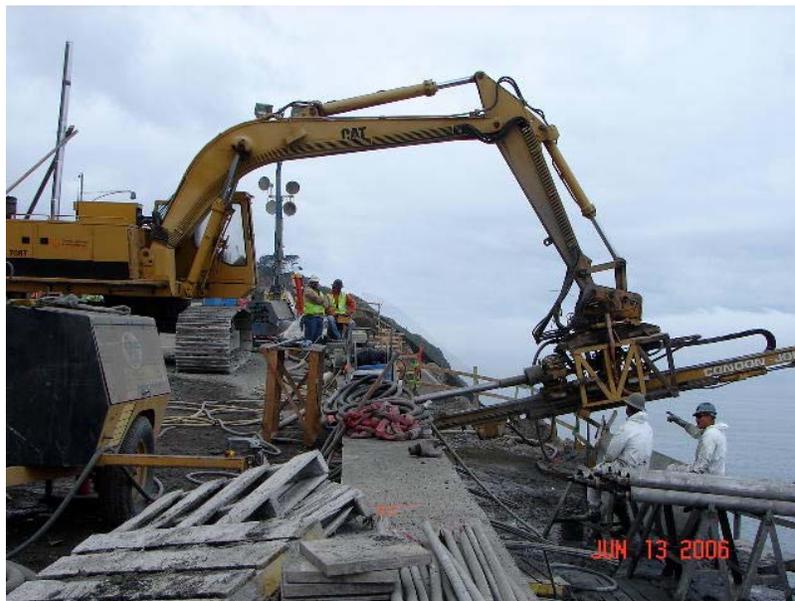
Condon & Johnson's reach over drill rig at work on wall 'A'

- Whaler (bracing) wall construction:
 - Whaler wall 'A' (upper level ocean side) – complete.
 - Whaler wall 'B' (lower level ocean side) – foundation work expected to start 6/14/06.
 - Whaler wall 'C' (lower level cliff side) – complete.
 - Whaler wall 'D' (upper level cliff side) – approximately 50% complete.
- Drilling and tie back installation:
 - Two drill rigs continued with tie back work to-day. The new 'reach over' drill rig is working on wall 'A'. Tie back stressing work also continued on wall 'A'.

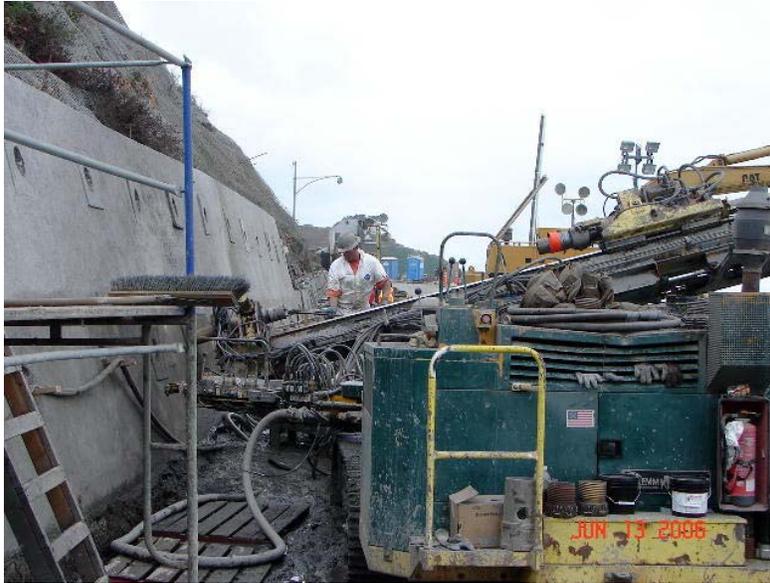
Drill Tech drilling at lower level wall 'C'. Note part of the completed upper level wall 'D' in this photograph.

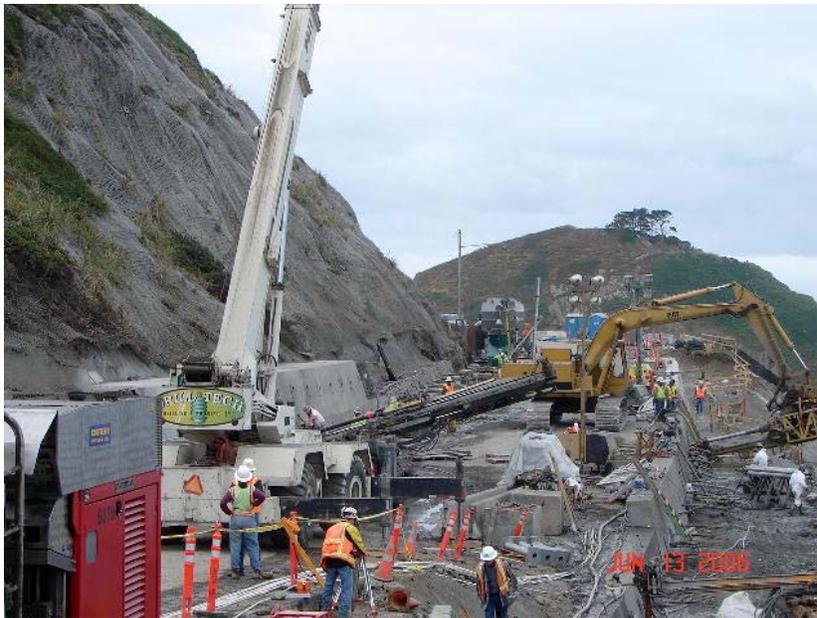
This is how the site looked to-day with two drill rigs operating at the same time.
