Weekly Update

Aug 7 - 13

Repair Work

Devil's Slide (post mile 39.14)

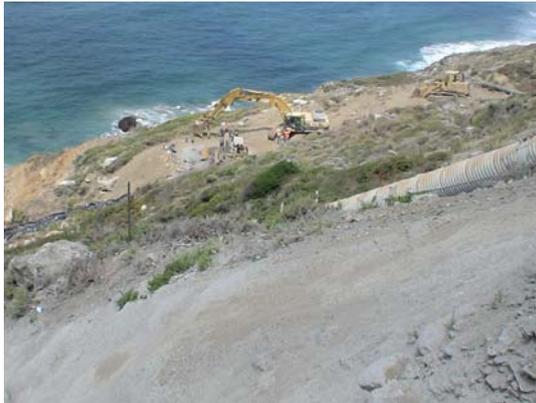
View of drill site below the road

- Jensen Drilling continued drilling horizontal drains on a 7 day per week, 12 hours/day schedule. They hit water on August 7 with the first horizontal drain. A plastic lined ditch was placed on the ground for erosion and sediment control.

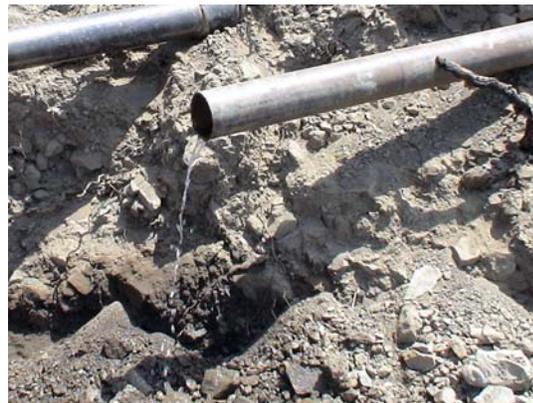
Flow of water from the first drain

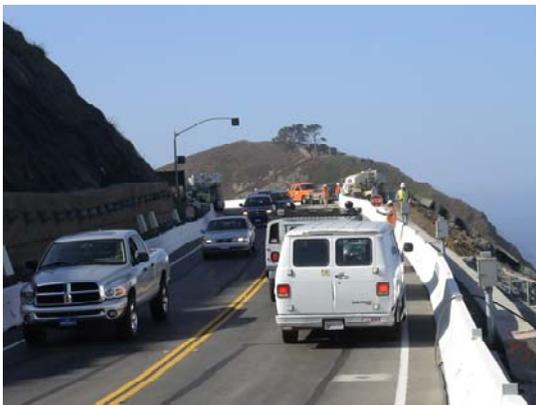
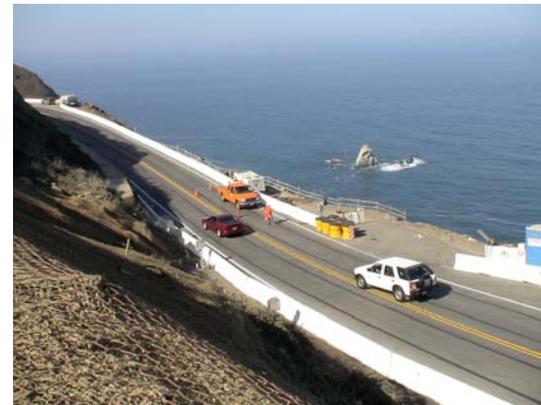
One way traffic control during installation of part of the slide sensor system.

- St. Francis Electric continued installation of the slide sensor system. They set a service cabinet along the north bound lane on August 9th. Intermittent one-way traffic control was in effect from 9:30 AM to 2:30 PM.

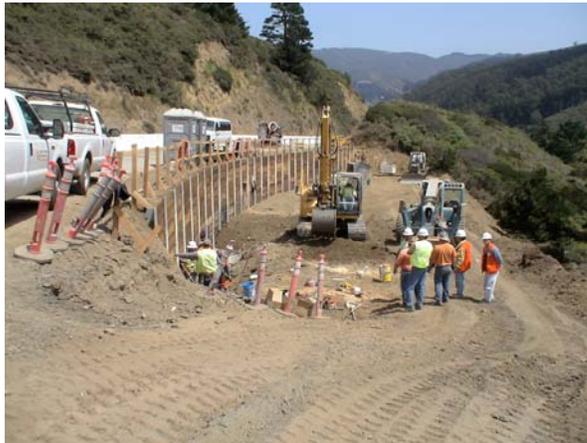
Timber lagging for the retaining wall

- Condon Johnson completed installing the timber lagging approximately 11 ft below grade. They started drilling tiebacks on Friday, August 11th, and have completed 13 of 29 tiebacks over the weekend. Tieback installation is expected to be completed by Wednesday, August 16th, and then waler construction will start.
