August, 2000

ESC, Division of Materials
Engineering and Testing Services
Roadside Safety Technology
Branch (916) 227-7257

Roadside Safety News

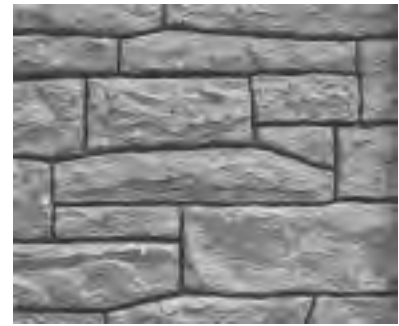
“Dry Stack” Pattern

The team identified eight candidate textures and patterns for testing, plus two alternates. Examples include horizontal reveals (grooves), a “mission arch” pattern, vertical and angled flutes, a “dry stack” pattern and cobbles. The team concluded that these candidates include sufficient variability in surface relief, angles and shapes that test results could be applied to most textures and patterns likely to be used by Caltrans on barriers in the future.

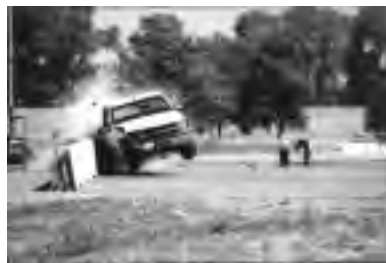
Crash testing involving a 2000-kg pickup truck and an 820-kg sedan was recently completed. Maximum lateral barrier deflection was 760 mm with the truck and approximately 100 mm for the small sedan. No snagging occurred during these tests and the test vehicles were smoothly redirected. Except for some easily replaced bent pins, damage to the barrier was limited to mostly cosmetic scuffing and spalling.

Crash Test of Type 60K Barrier

To resolve this problem, RSTB staff redesigned the barrier. Individual segments were lengthened to 3.7 m to increase their mass. In addition, each segment was fitted with two sets of tight fitting pin and loop connections at each end to minimize independent movement between segments. This new design has been informally named the "Type 60K."
