The effect of two design parameters on the bent cap torsional behavior and moment capacity was investigated in a series of four component tests, with the most promising detail to be validated in a final system test. The two parameters investigated were (1) bent cap reinforcement (post-tensioned versus conventionally reinforced), and (2) girder web configuration inside the bent cap (with or without bearing stiffeners). The specimens with post-tensioned bent caps exhibited less crack dilation during the initial loading stages than the specimens with conventionally reinforced bent caps. The specimens with girder web bearing stiffeners reached maximum capacities approximately 25% higher than the specimens without girder web stiffeners.

The component test results lead to the recommended design for the system test of stiffened steel girders integrated with a post-tensioned bent cap. The system test demonstrated that the bent cap could be designed to perform essentially elastically while the column developed an inelastic mechanism.

Based on the experimental findings and force transfer models, design guidelines for an integral bridge were developed. The procedure for determining the bent

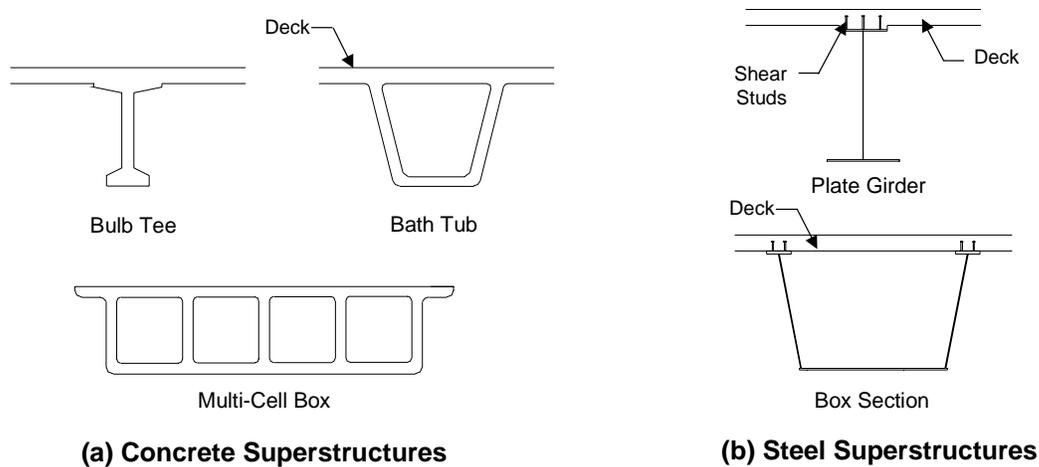
Figure 1-2 Bridge Superstructure Configurations

Steel plate girders or box sections (Figure 1-2b) can also function as longitudinal girders of the superstructure and can be made composite with a concrete deck with shear studs. The high strength-to-weight ratio of steel reduces the superstructure weight and increases the distance that can be spanned. Because steel girder fabrication is done at a mill, the girders are delivered to the site already constructed and ready to be set in place, eliminating the need for formwork and associated construction hazards that may necessitate road closures or traffic interruptions.

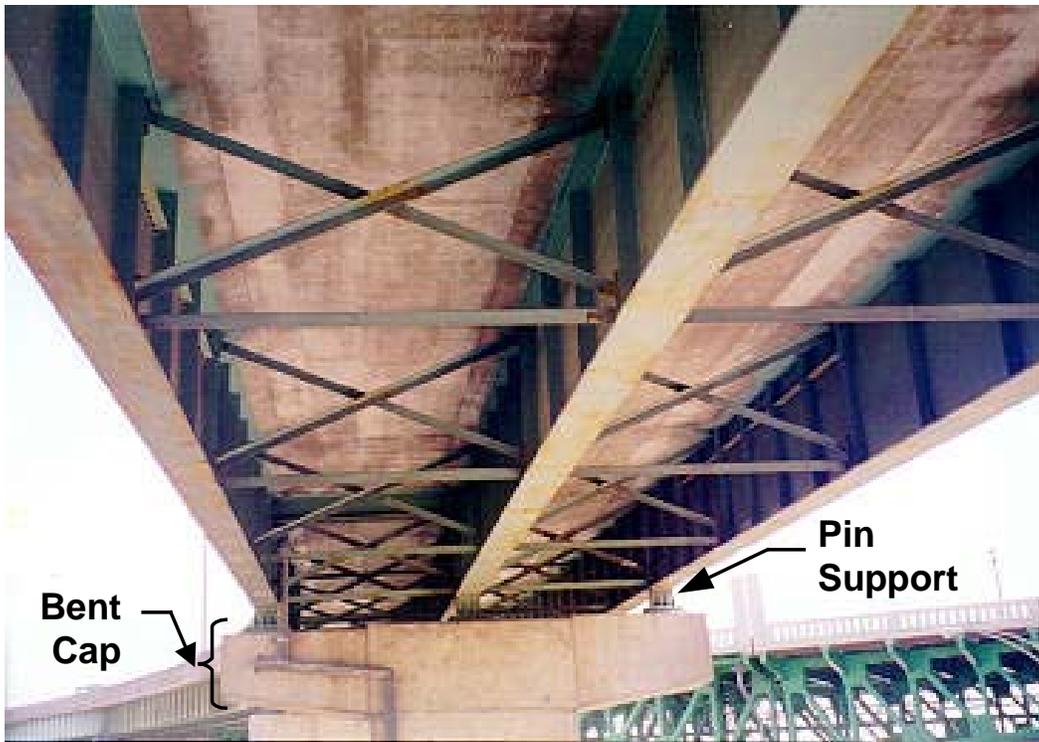
Figure 1-6 Steel Superstructure on Concrete Hammerhead Bent Cap (4)

When a steel superstructure bridge with a concrete substructure is constructed in California (Figure 1-1 and Figure 1-6), the superstructure is typically connected to the substructure by a pin or rocker bearing, a connection which requires high maintenance to protect the pin component against rust. Unlike the monolithic concrete super-to-substructure connections, this steel superstructure to concrete substructure pin connection detail allows relative rotation between the superstructure and substructure.

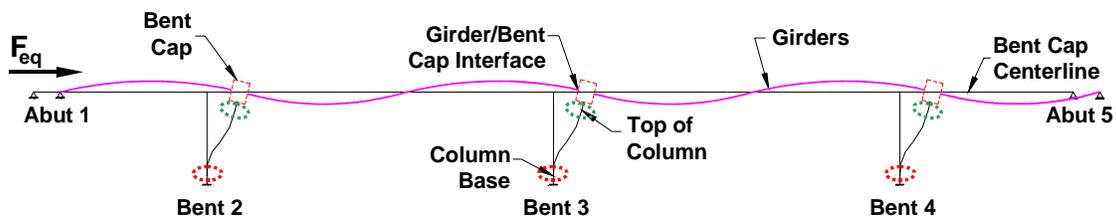
Figure 1-9 Potential Hinge Locations

To ensure that the inelastic mechanism occurs in the desired location (the column), adjacent members, where inelastic actions are not desired, must be designed to ensure elastic response. All locations susceptible to inelastic action are identified in Figure 1-9, on the deformed shape of a bridge model subjected to a longitudinal seismic motion. The desired failure mechanism locations are highlighted by dashed ovals at the top and bottom of each column. At these locations, the column is detailed to ensure flexural ductility. At each pier, the bent cap, the girders, and the interface between the bent cap and girders must perform elastically. These members are considered capacity protected components and need to be designed using the full column overstrength moment based on capacity design principles.

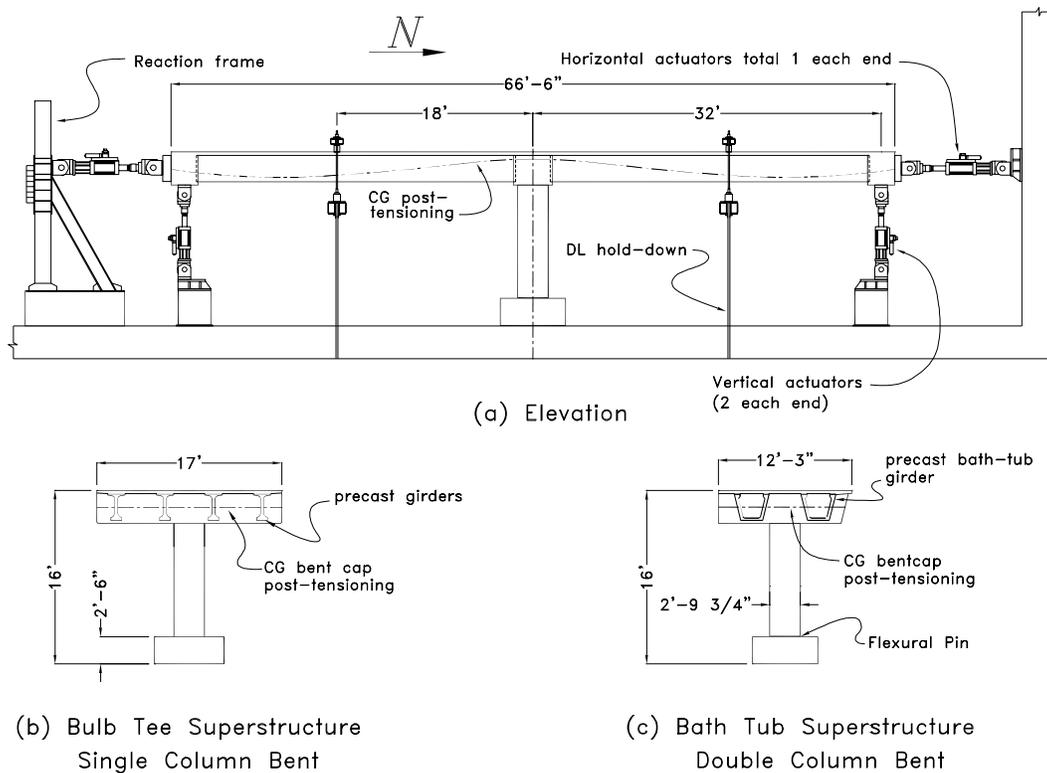
Figure 1-10 Precast Superstructure Configurations (9)

the viability of such connections under a longitudinal seismic event. A similar issue arises with precast girder/concrete composite superstructures integral with concrete substructures. Holombo, et al. (9, 10) investigated the use of precast concrete girders integrally connected to a CIP concrete substructure through a research program that included two large-scale tests (Figure 1-10a). The girders of the first test were precast bulb tee girders that ran continuously through the bent cap, integrating the cap into the superstructure (Figure 1-10b). The second test had precast bathtub girders, which terminated a distance inside the bent cap (Figure 1-10c). In both tests, the girders were supported while the bent cap was cast around them.

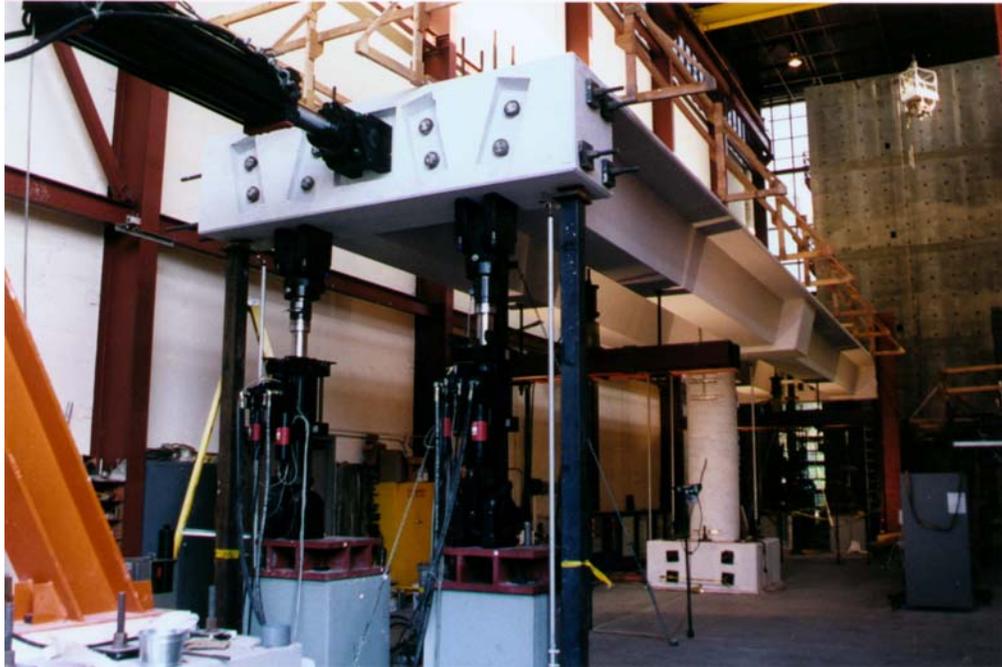
Figure 1-11 Precast Bathtub Girder Test (9)

The two tests, constructed at 40% scale were subjected to a simulated longitudinal seismic event (Figure 1-11). Both tests performed well and demonstrated that a reliable connection could be developed between precast superstructure girders and the cast-in-place concrete bent cap, forcing hinging into the column with minimal superstructure damage.

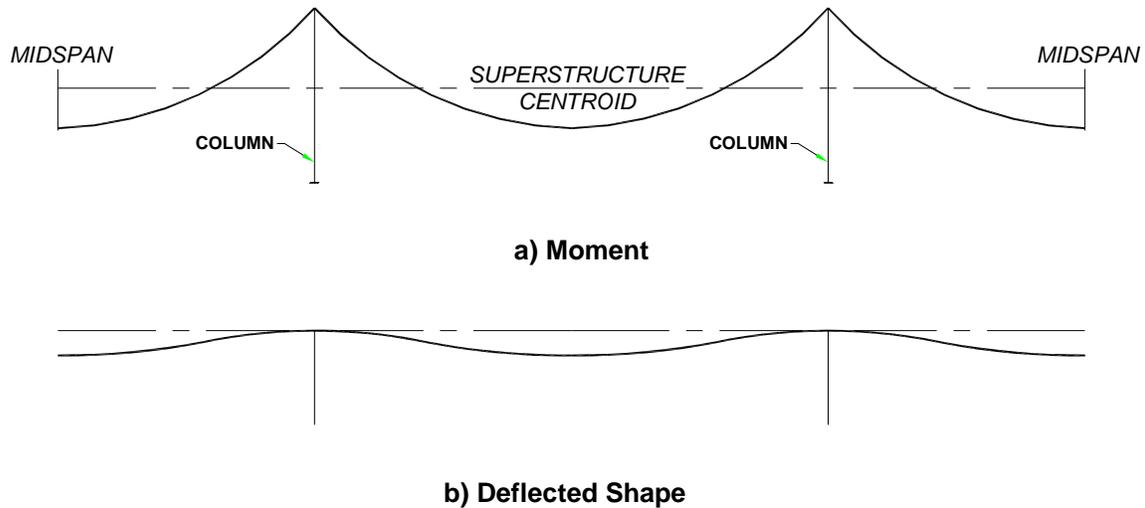
Figure 2-5 Prototype Superstructure Moment and Deflected Shape Due to Self-Weight

Since the superstructure was continuous, it was in positive bending at midspan and negative bending over the piers (Figure 2-5). Therefore, the section over the supports where the concrete deck can be assumed cracked was designed considering only the girders and the deck reinforcing steel contributed to the flexural capacity while flexural capacity of the midspan section included the contribution from the deck concrete. Using influence lines, the maximum live load demands on the girder were determined and the section was designed for the load cases specified in Caltrans Bridge Design Specifications (BDS) (14).

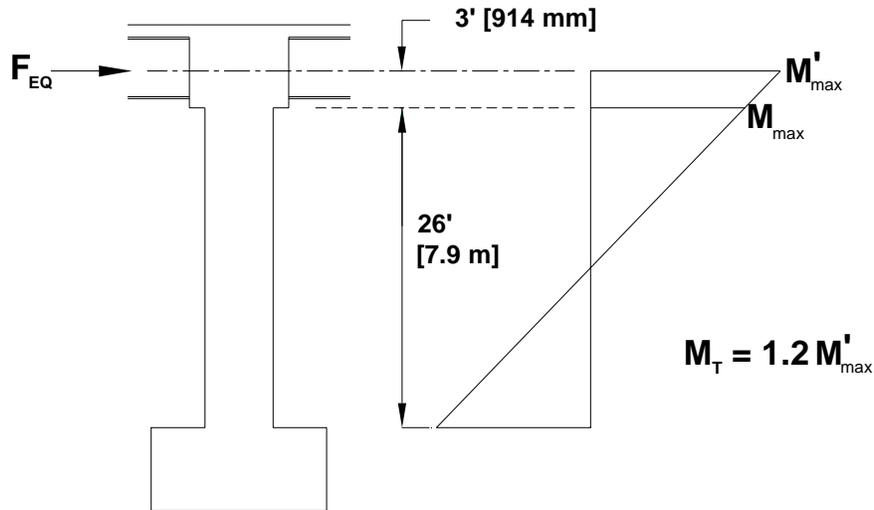
Figure 2-6 Substructure Seismic Moment

The moment at the top of the column due to full material overstrengths, M_{max} , (Figure 2-2) was extrapolated to the center of the girder section (Figure 2-6). This extrapolated moment, M'_{max} , is the moment expected to be transferred through the bent cap to the girders via equilibrium torsion. To ensure the superstructure elastically transfers the moment M'_{max} , it is multiplied by an overstrength factor of 1.2, a component overstrength factor designated in the Caltrans Seismic Design Criteria (20). This results in a column overstrength moment at bent cap centerline M_T .

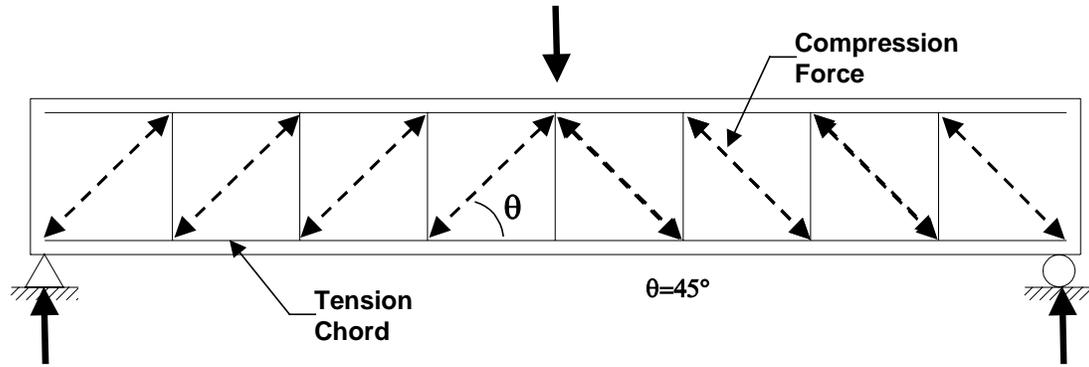
Figure 2-16 Beam Shear Represented as a Plane Truss

Around the same time, Ritter, in 1899 (30) introduced the concept of using a truss model to explain load paths in cracked reinforced concrete members (Figure 2-16). He explained the transfer of shear in a beam as a series of diagonal compression forces balanced by horizontal and vertical tension forces. In his model, the concrete compression stresses were assumed to act at 45° angles while the stirrups and flexural reinforcement made up the vertical and horizontal members of the truss. The inclination of compression members corresponds to the inclination of crack patterns. Morsch (31) in 1902 expanded on Ritter's truss analogy by suggesting the compression force was more akin to a continuous compression field rather than discrete struts. In both Ritter and Morsch's models, the contribution of tensile stress in the concrete is neglected as is the dowel action of reinforcement.

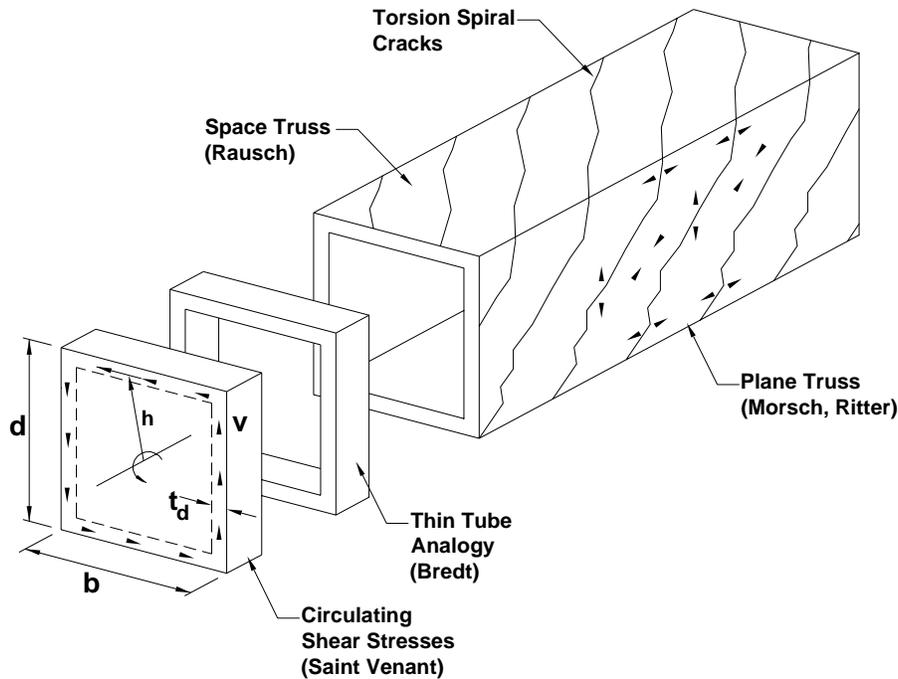
Figure 2-17 Development of Space Truss Analogy (adapted from (27))

All the previously described scientific developments before 1929 were combined in Rausch’s Ph.D. thesis (34) to develop a space truss model to describe a section in torsion. The space truss uses Saint Venant’s circulating shear stresses and Bredt’s thin tube. Rausch then uses four plane trusses as described by Morsch to make up the walls of the tube. This leads to a three-dimensional explanation of the post-cracking behavior of a section in torsion.

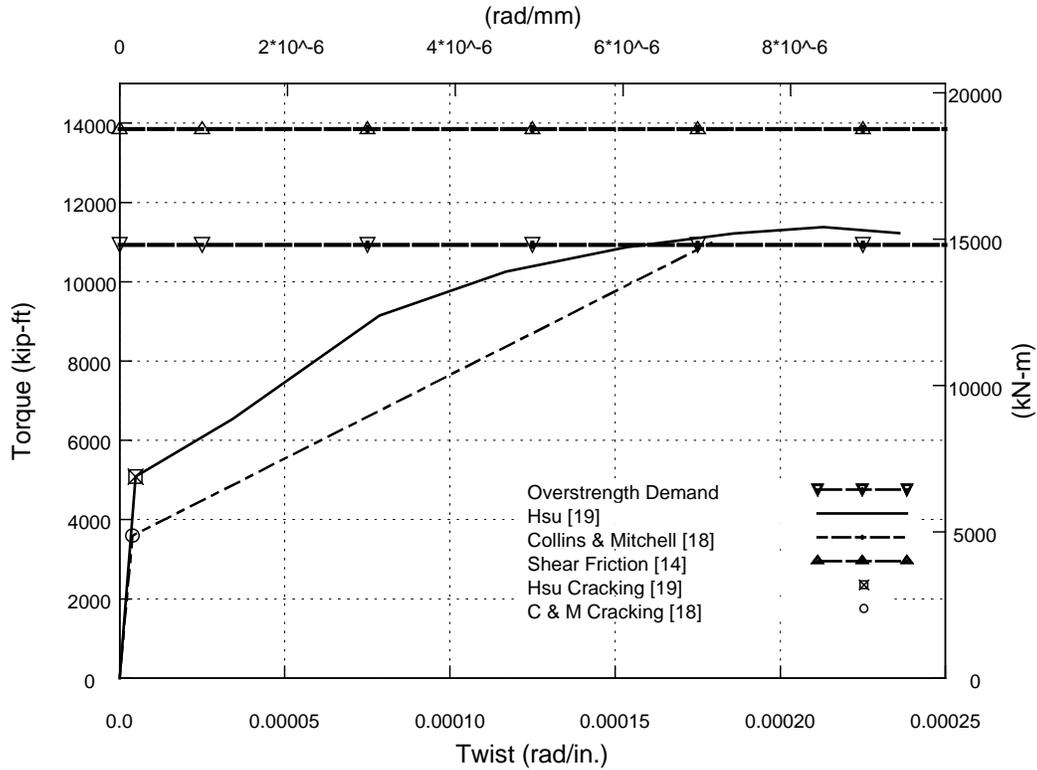
Figure 2-19 Prototype Torque – Twist Prediction

This section presented two procedures for developing torque-twist curves for the prototype bridge. The procedures are based on the assumption that the section is of sufficient length for a full helical failure surface to develop. The torsion shear friction analysis presented in the next section predicts ultimate force capacity for short sections that fail in a vertical shear friction plane.

This cracking torque and twist according to Collins and Mitchell is plotted with a circle in Figure 2-19.

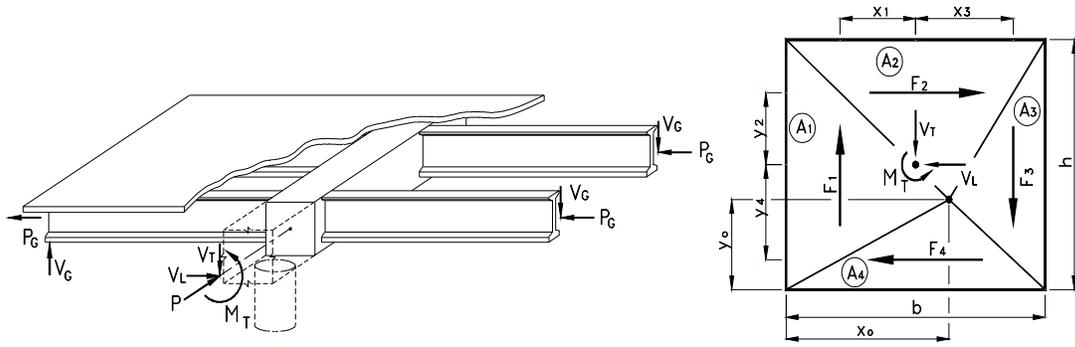
(a) Torsion Shear-Friction in Bent

A torsion shear friction failure mechanism was observed in testing of the San Francisco viaduct bridges (39). In a torsion shear friction mechanism (19), the area of the failure plane can be divided into four unequal quadrants as shown in Figure 2-20. Each quadrant contributes a shear resistance, F_i , proportional to its cross-sectional area, A_i , and the applied axial force, P . Each shear resistance is multiplied by its moment arm, x_i or y_i , from the center of rotation of the section to determine the torsional strength.

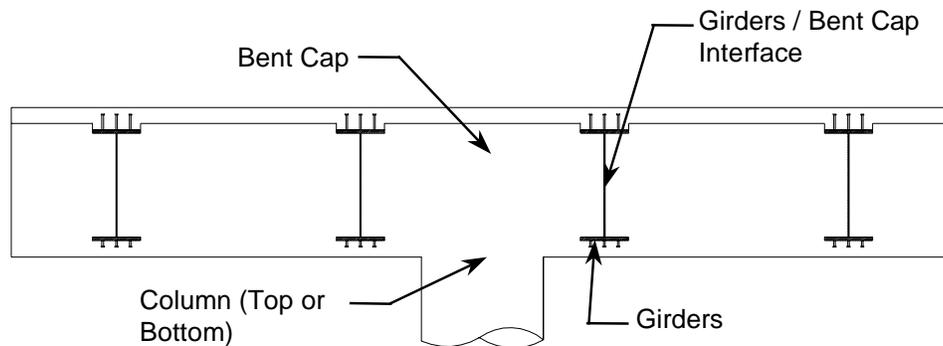
Figure 2-22 Potential Failure Mechanisms Locations

As stated in Section 1.2, all undesirable inelastic actions need to be prevented to ensure the desired failure mechanism occurs in the column. Section 2.6.2 outlined how the bent cap is designed to prevent a torsion failure. The girders are designed to prevent a flexural failure by accounting for the additional moment demand imposed from a seismic event. The final component to be designed using capacity protection principles is the interface of the steel girder and the bent cap (Figure 2-22).

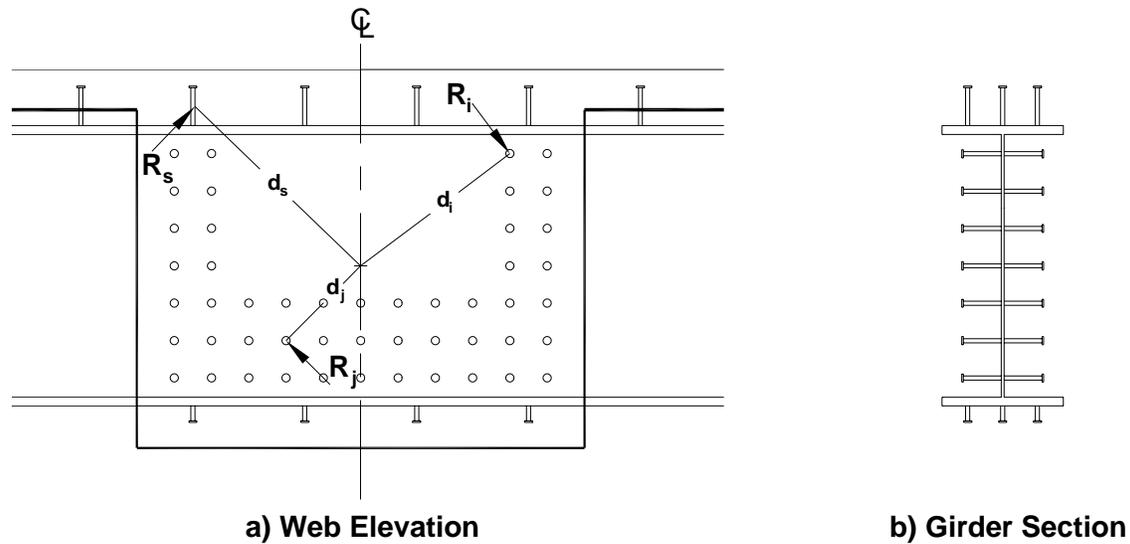
Figure 2-25 Stud Group on Girder Web

the reaction force on each shear stud is determined. A total of 90 studs were distributed on the girder web as shown in Figure 2-25a. Applying the concept of eccentrically loaded connections to this shear stud distribution on the girder web, the stud group was expected to carry 6,000 k-ft [8,130 kN-m] of the 9,000 k-ft [12,195 kN-m] demand.

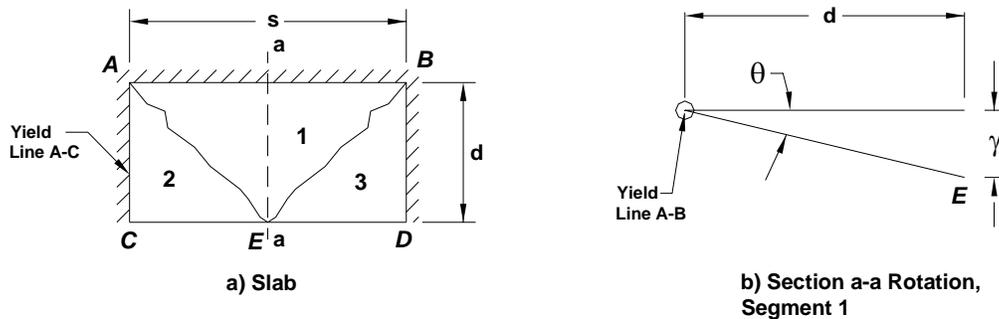
Figure 2-26 Yield Line Theory for Concrete Slabs (adapted from 45)

In Figure 2-26a, yield lines are assumed for a uniformly loaded concrete slab fixed on three edges and free on one edge. The five yield lines (two diagonals across the section and one along each fixed edge) serve as axes of rotation for the three sections they divide the slab into. The ultimate load this slab can carry is determined using the yield lines and the principle of virtual work. The principle of virtual work states that the sum of all work done on a system in equilibrium is zero. Therefore, the work due to the external force to apply the displacement γ is equal to the work due to internal actions along the yield lines that resist it.

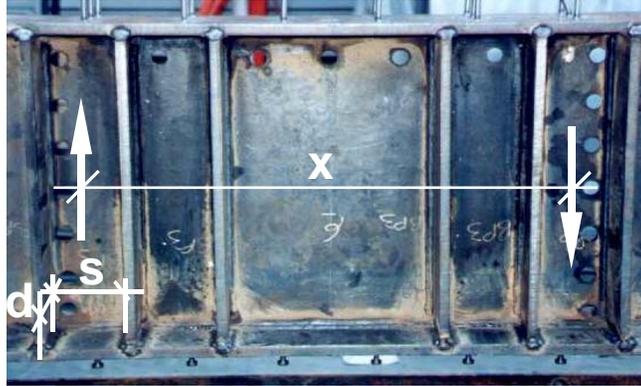
Figure 2-28 Torsional Capacity of Concrete Compression Struts

Once the stiffener spacing is found to maximize the compression strut, the force from the strut is found by multiplying the concrete compressive strength by the area of flange the strut acts over. This gives a resultant force oriented as shown in Figure 2-28, which is multiplied by the moment arm to obtain an approximation for the moment transferred by the concrete struts. With the spacing determined from this analysis, the resultant moment transferred in the two outermost struts is 5,040 k-ft [6,829 kN-m] of the 9,000 k-ft [12,195 kN-m] moment demand.

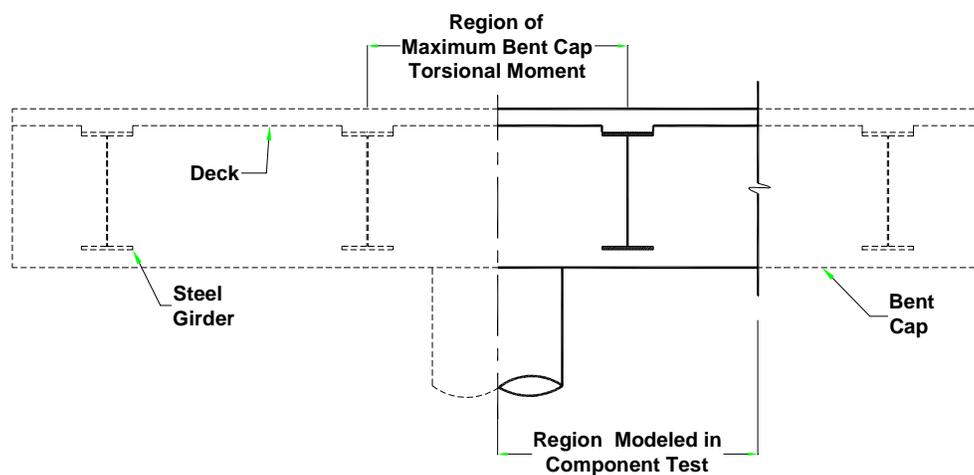
Figure 3-1 Component Test Region of Investigation

Due to symmetry of the prototype structure about Pier 3 (see Figure 2-1), all tests are designed for Pier 3. As shown in Figure 2-8, the maximum bent cap torsional moment occurs at the column centerline and is equally distributed to the superstructure on either side of the column. Hence, the portion of superstructure between the column centerline and the interior girders is the critical location (Figure 3-1). In order to capture the highest torsional moment demand on the bent cap, it is only necessary to model the superstructure between the column centerline and either interior girder.

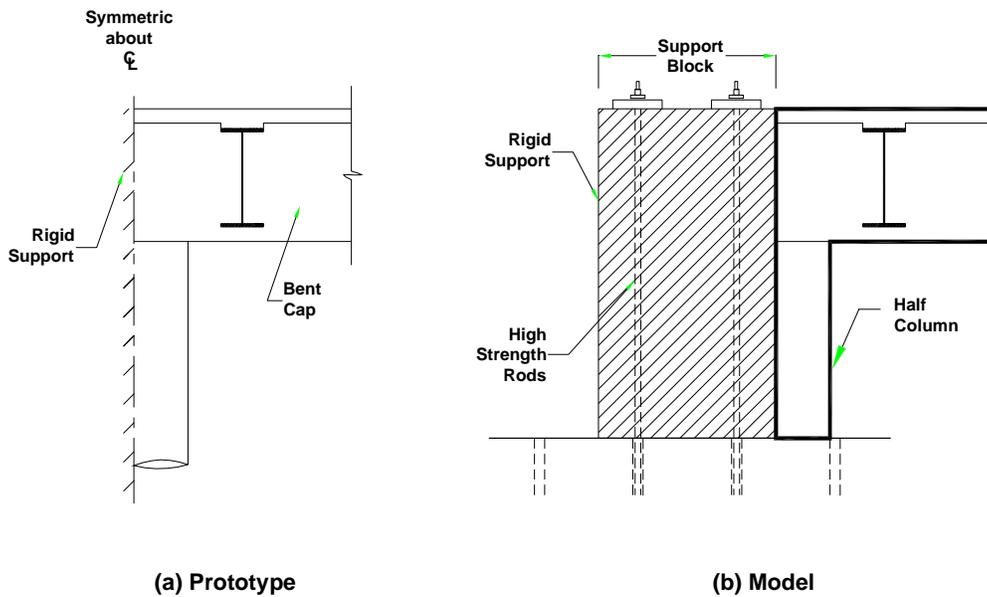
Figure 3-2 Component Test Specimen Prototype and Model

To protect against premature column failure, the bridge section shown in Figure 3-2a is supported by a rigid concrete block (Figure 3-2b). The block is post-tensioned to the laboratory floor with 1- $\frac{3}{8}$ " [35 mm] diameter Grade 150 [1,034 MPa] high strength rods. A partial column with vertical and spiral reinforcement was designed to protrude from the support block.

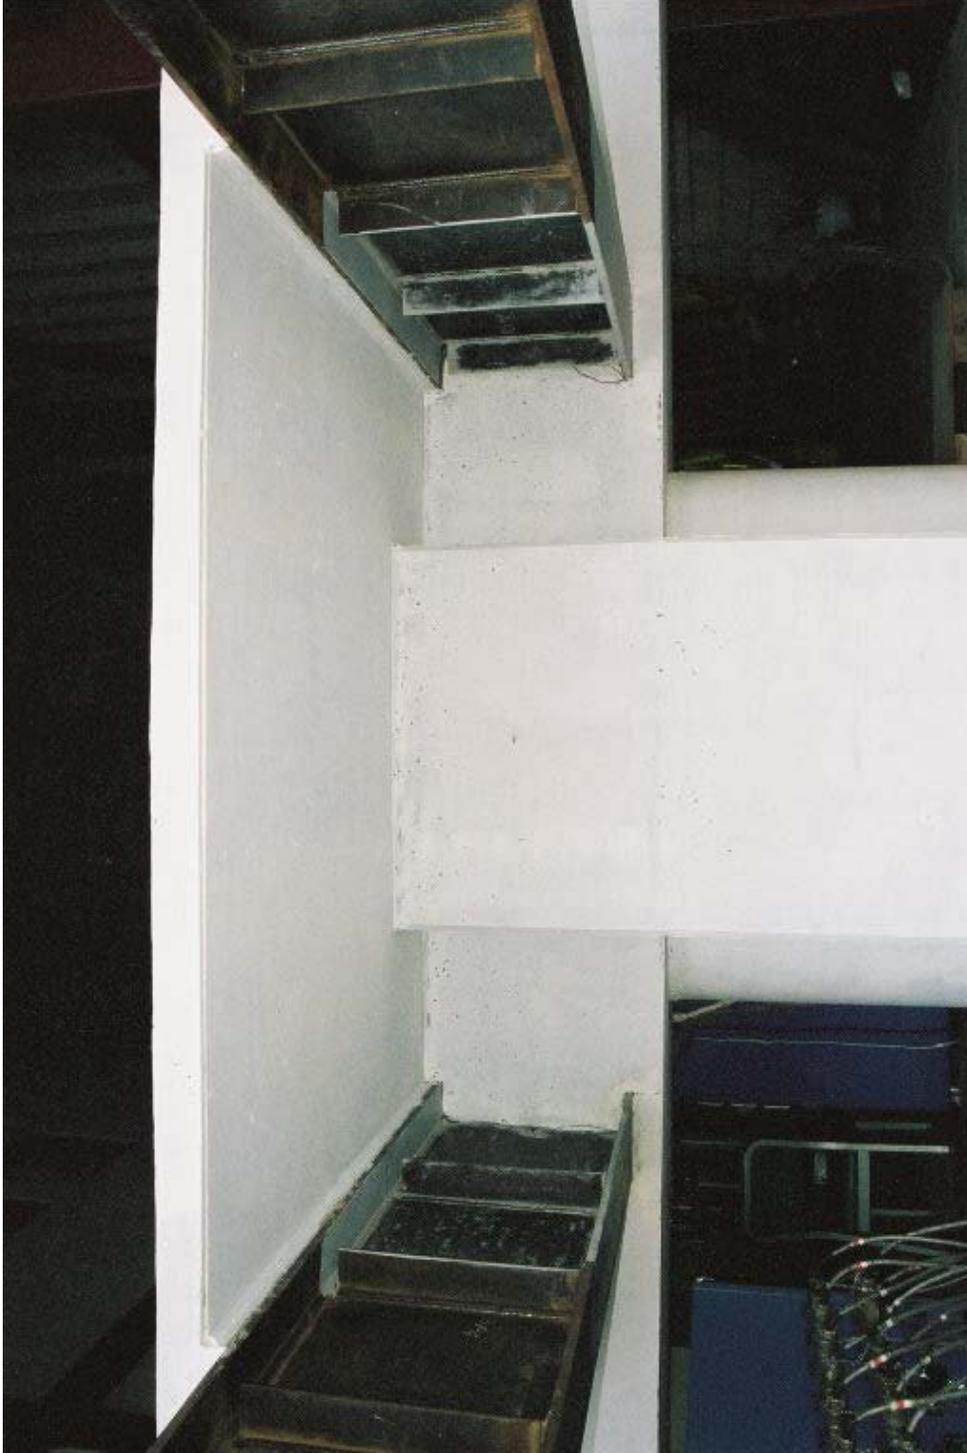
Figure 3-5 Component Test Specimen Before Testing

the correct stresses. A three-dimensional rendering of the setup is presented in Figure 3-4 and the setup as it was prior to instrumentation and testing is shown in Figure 3-5.

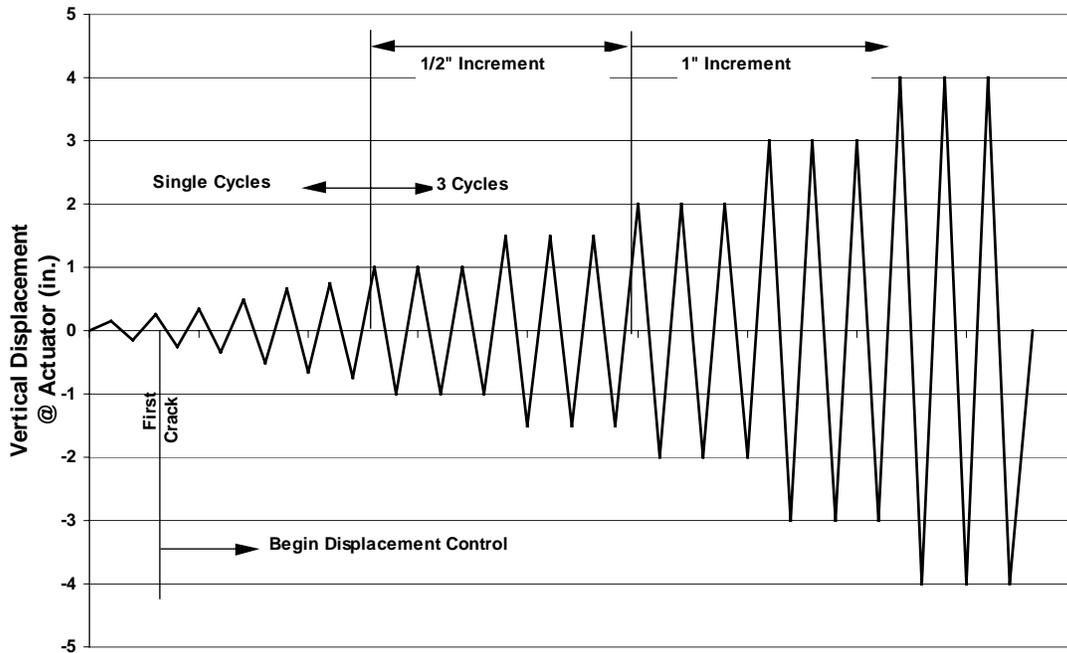
Figure 3-20 Component Test Loading Sequence

applied, the seismic loading protocol began. Seismic loading began in pseudo force control (displacement control while monitoring the force) in single cycles of 5 kip [22 kN] increments to first torsional cracking. After the first crack, the specimen was loaded in single cycle displacement increments of 0.25 in. [6 mm] to 1 in. [25.4 mm]. The specimen was then subjected to three cycles of 0.5 in. [12.7 mm] displacement increments up to 2 in. [51 mm]. After 2 in. [51 mm] displacement was reached, three cycles of 1 in. [25.4 mm] increments were imposed until failure. The loading sequence is detailed in Figure 3-20.

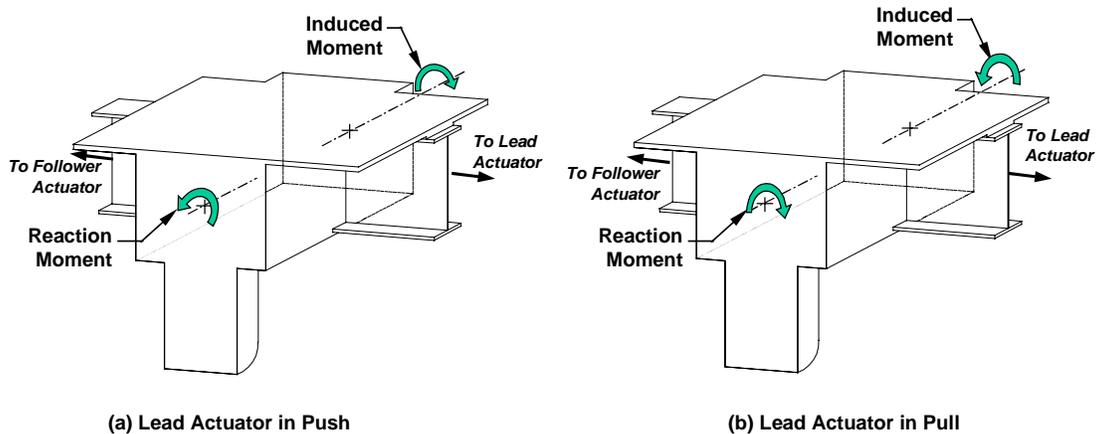
Figure 4-2 Torsional Moment Directions in Component Tests

When the lead actuator is in push, it creates a positive moment about the transverse bridge axis (Figure 4-2a), resulting in the bent cap torsion indicated. This torsional moment in the bent cap is reacted by an opposing moment at the support block. The same equilibrium requirements apply to the lead actuator in pull (Figure 4-2b).

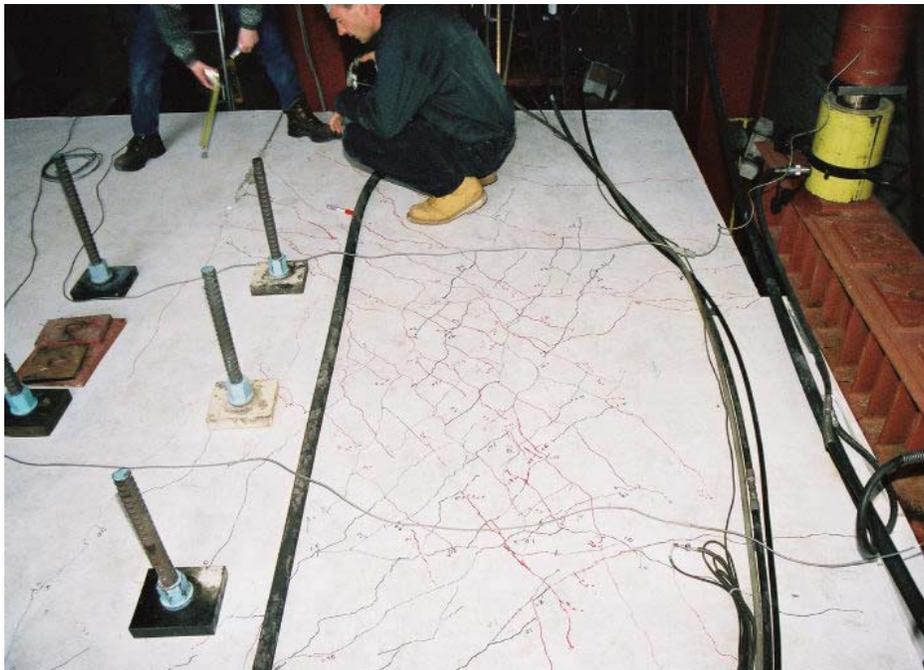
Figure 4-11 Specimen CR-NS: Deck Damage at Maximum Torsional Rotation

At the maximum bent cap torsional rotation of 0.031 radians, the torsional moment was 952 k-ft [1,290 kN-m]. A torsional shear friction plane at the first crack location (Figure 4-9) was the failure mechanism. The underside of the bent cap between the girder and column spalled significantly, exposing bent cap flexural reinforcement and transverse reinforcement near the column face (Figure 4-10). Under the girder, the bent cap concrete had spalled to expose multiple shear studs as well as portions of all the bottom flexural reinforcement bars. The deck only experienced cracking and exhibited no significant damage (Figure 4-11). The column concrete remained undamaged.

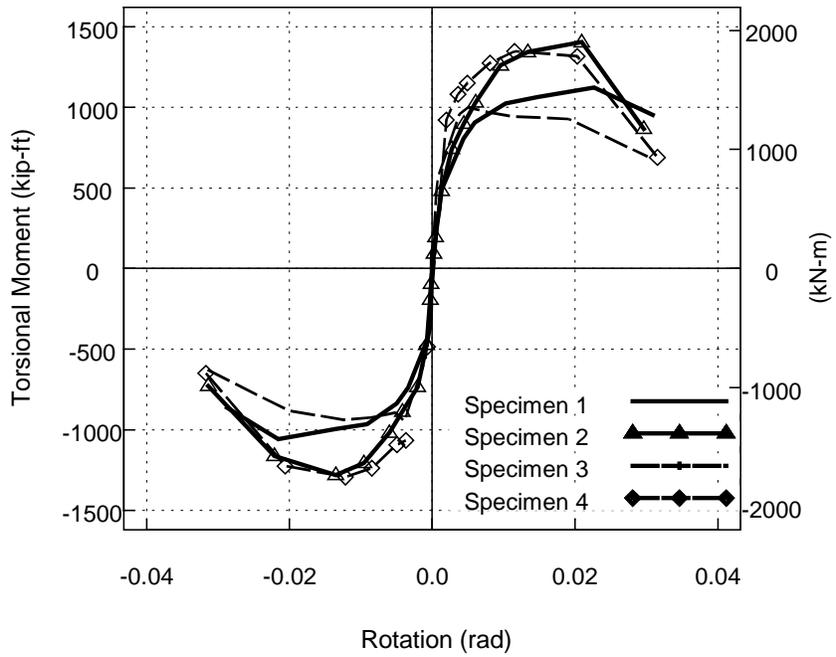
Figure 4-68 Comparison of Torsional Moment-Rotation Envelopes

tensioned bents developed similarly to the conventionally reinforced beam. The remainder of this section presents detailed comparisons between pairs of tests.
