**CALIFORNIA DEPARTMENT OF TRANSPORTATION**

Division of Maintenance - Structure Maintenance and Investigations

# ELEMENT LEVEL INSPECTION MANUAL

October 2008

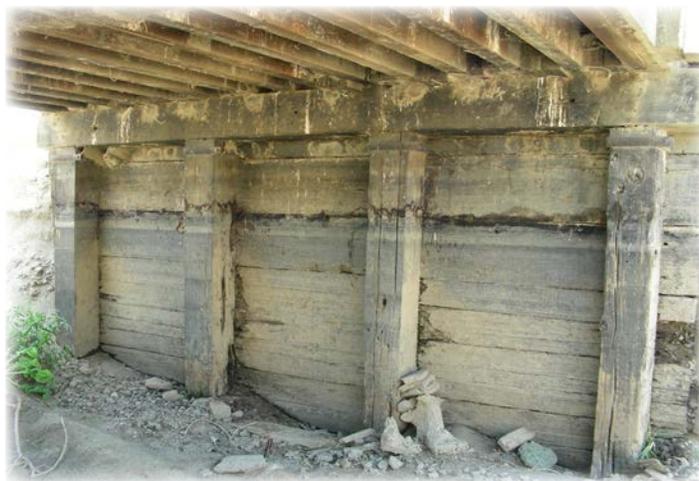
Example: Use Elements 235 (cap), 206 (columns), and 216 (abutment) for the bridge abutment shown above.

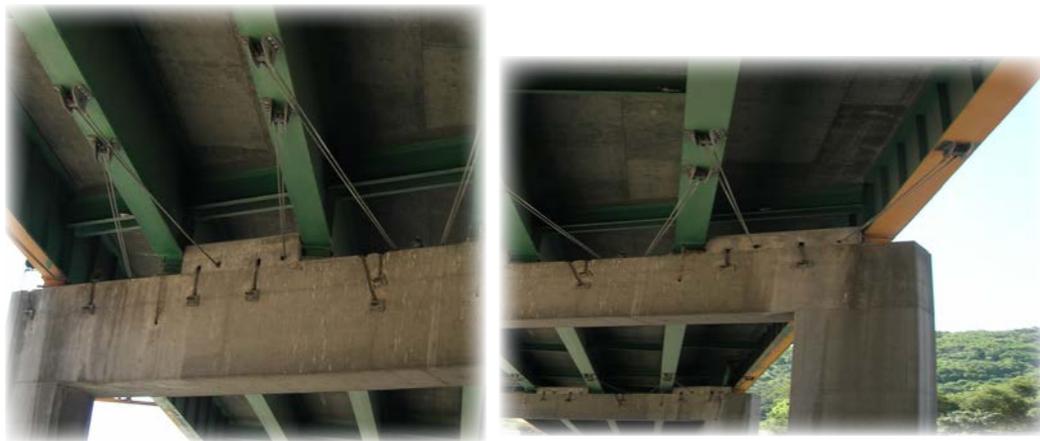
Examples of other Seismic Restrainer Cable System

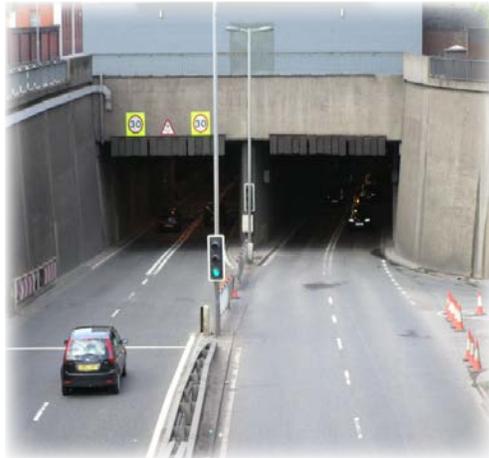
Do not use Tunnel element for cut-and-cover type tunnels

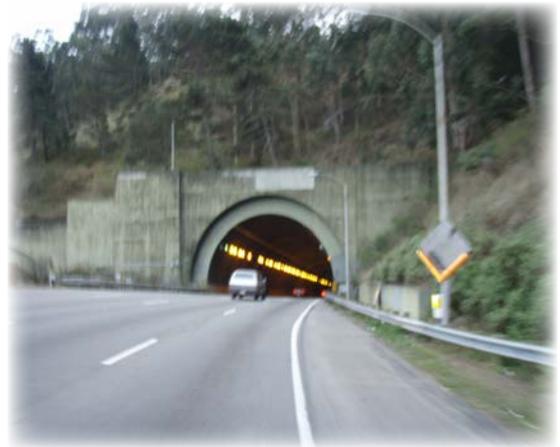
Use this Tunnel element only for bored and lined type tunnels

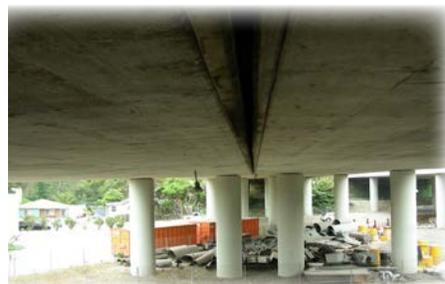
Quantity =  $1/2 \times 4 \text{ faces} = 2 \text{ Box Girders} \times \text{Length}$

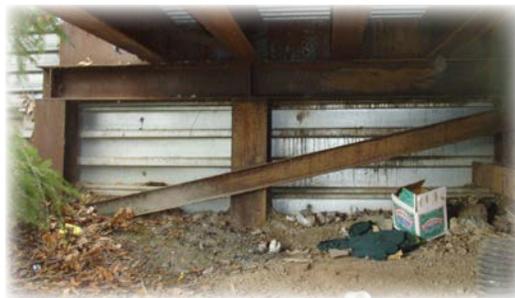
Quantity for Element Type: Piles = 3, Cap = 1 x width, and Other Abutment = 1 x width

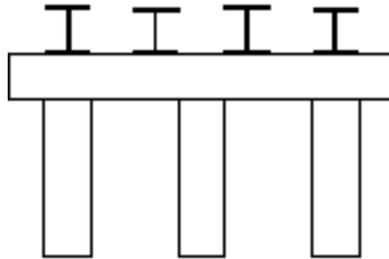
Quantity for Element: Columns = 3 and Cap = 1 x width

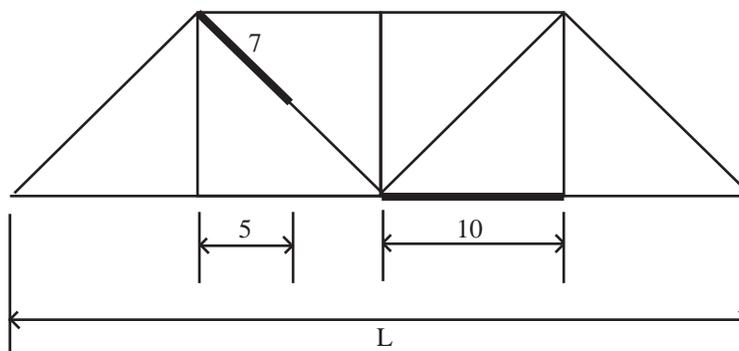
- **Deteriorated Portions of a Truss:** All measurements of the truss components are along the horizontal projection of the element. For deteriorated vertical and portal members record the appropriated horizontally projected width of the member to the nearest meter (typically 1 meter). Deteriorated portions of diagonal members should also be recorded as the horizontally projected quantity to the nearest meter. In the example above, the total deficient length to record is 15 meters.
