California Road Meter Study

March 1972

Howard, D.D. and Neal, B.F.

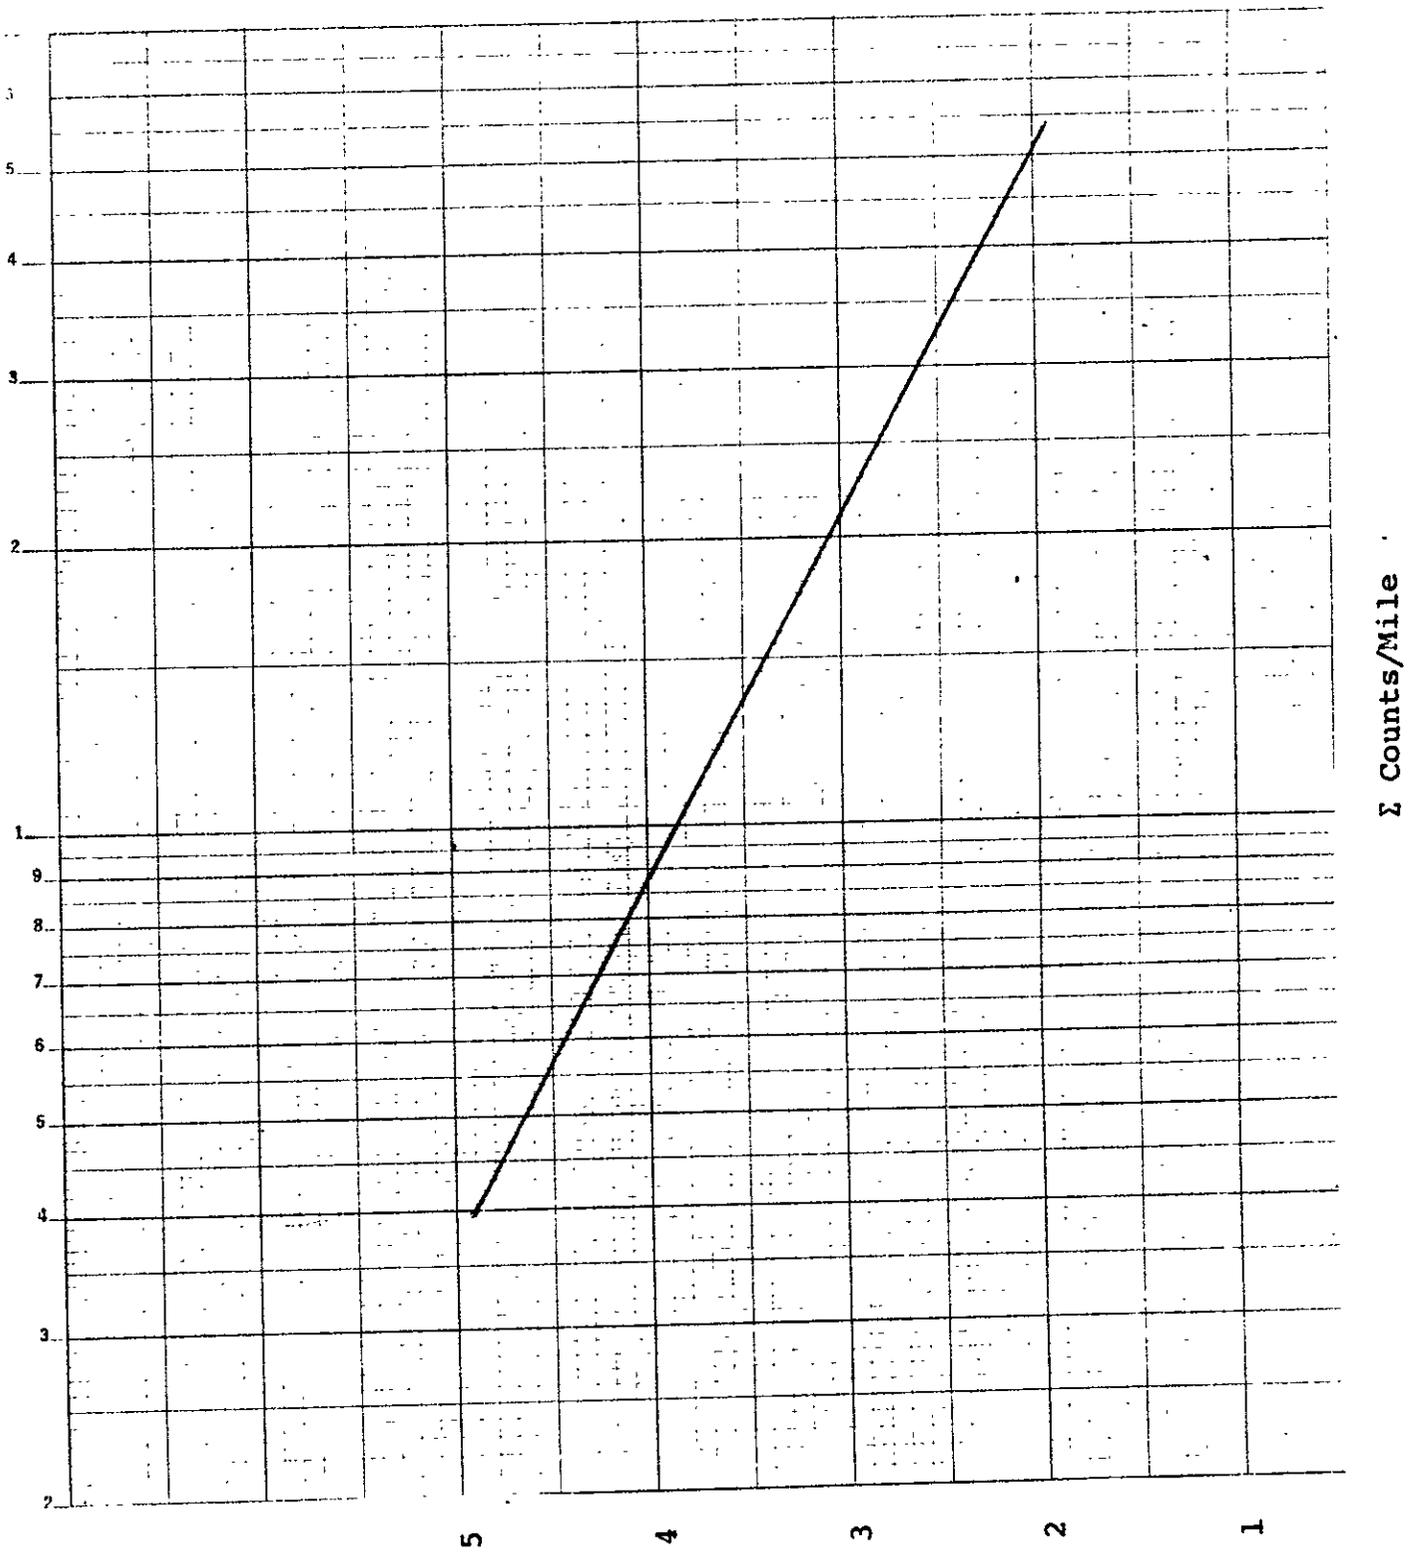
Figure 1

CHLOE PSI - Portion attributable to slope variance

A Road Meter was made available by loan from the Portland Cement Association, and was installed in a laboratory car for testing. A number of runs were made to measure its repeatability and to establish a correlation with the CHLOE Profilometer. The repeatability of the instrument was assured (Table 1) and a reasonable correlation with CHLOE was worked out (Figure 1). Runs were made on sites scattered throughout the State, to gain experience with the unit and to check subjective observations with Road Meter results.

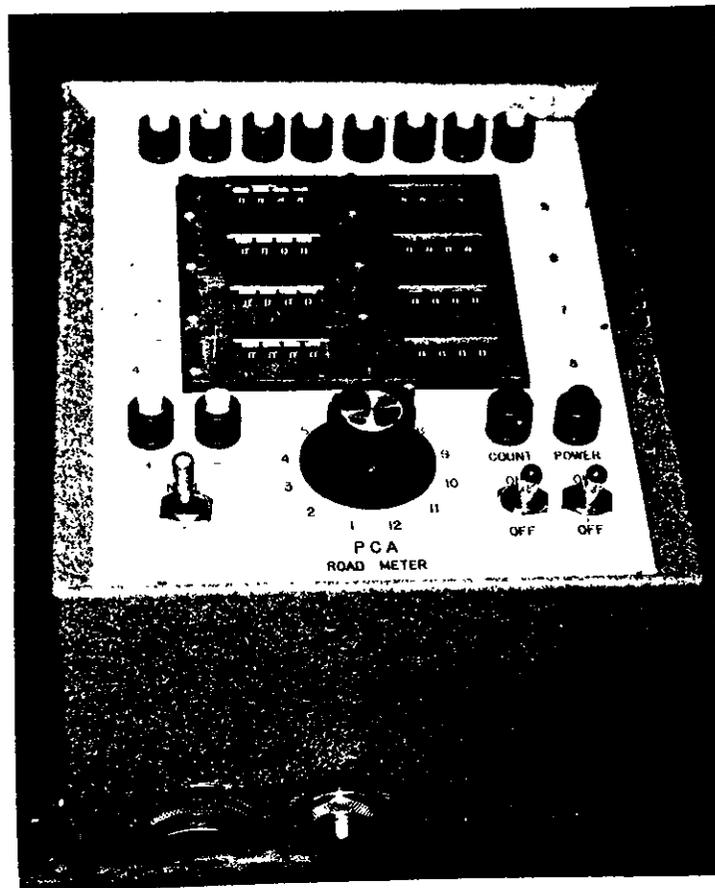
Figure 4

Road Meter Console  
(Cox Type)

translator assembly (switchplate and contact rollers) is mounted in the trunk compartment in a vertical position (Figure 3). All pulleys, cables, and springs were eliminated. The two roller microswitches are connected by a rod directly to the differential housing. When actuated, the rollers impinge on the printed circuitboard (divided into 1/8 inch segments) which in turn transmits signals to the counters mounted in the console in the front compartment of the vehicle (Figure 4).

To operate, the power switch is turned on, activating a vacuum device to bring the rollers in contact with the circuitboard. To set the reference plane, or zero balance, the circuitboard is moved by means of a small DC motor so that the center segment of the circuitboard is in contact with the rollers. Indicator lights on the console show the position of the board at all times. When the null position is established, the switch controlling the counters is turned on and the meter is in operation. The entire operation can be carried on without stopping the car.

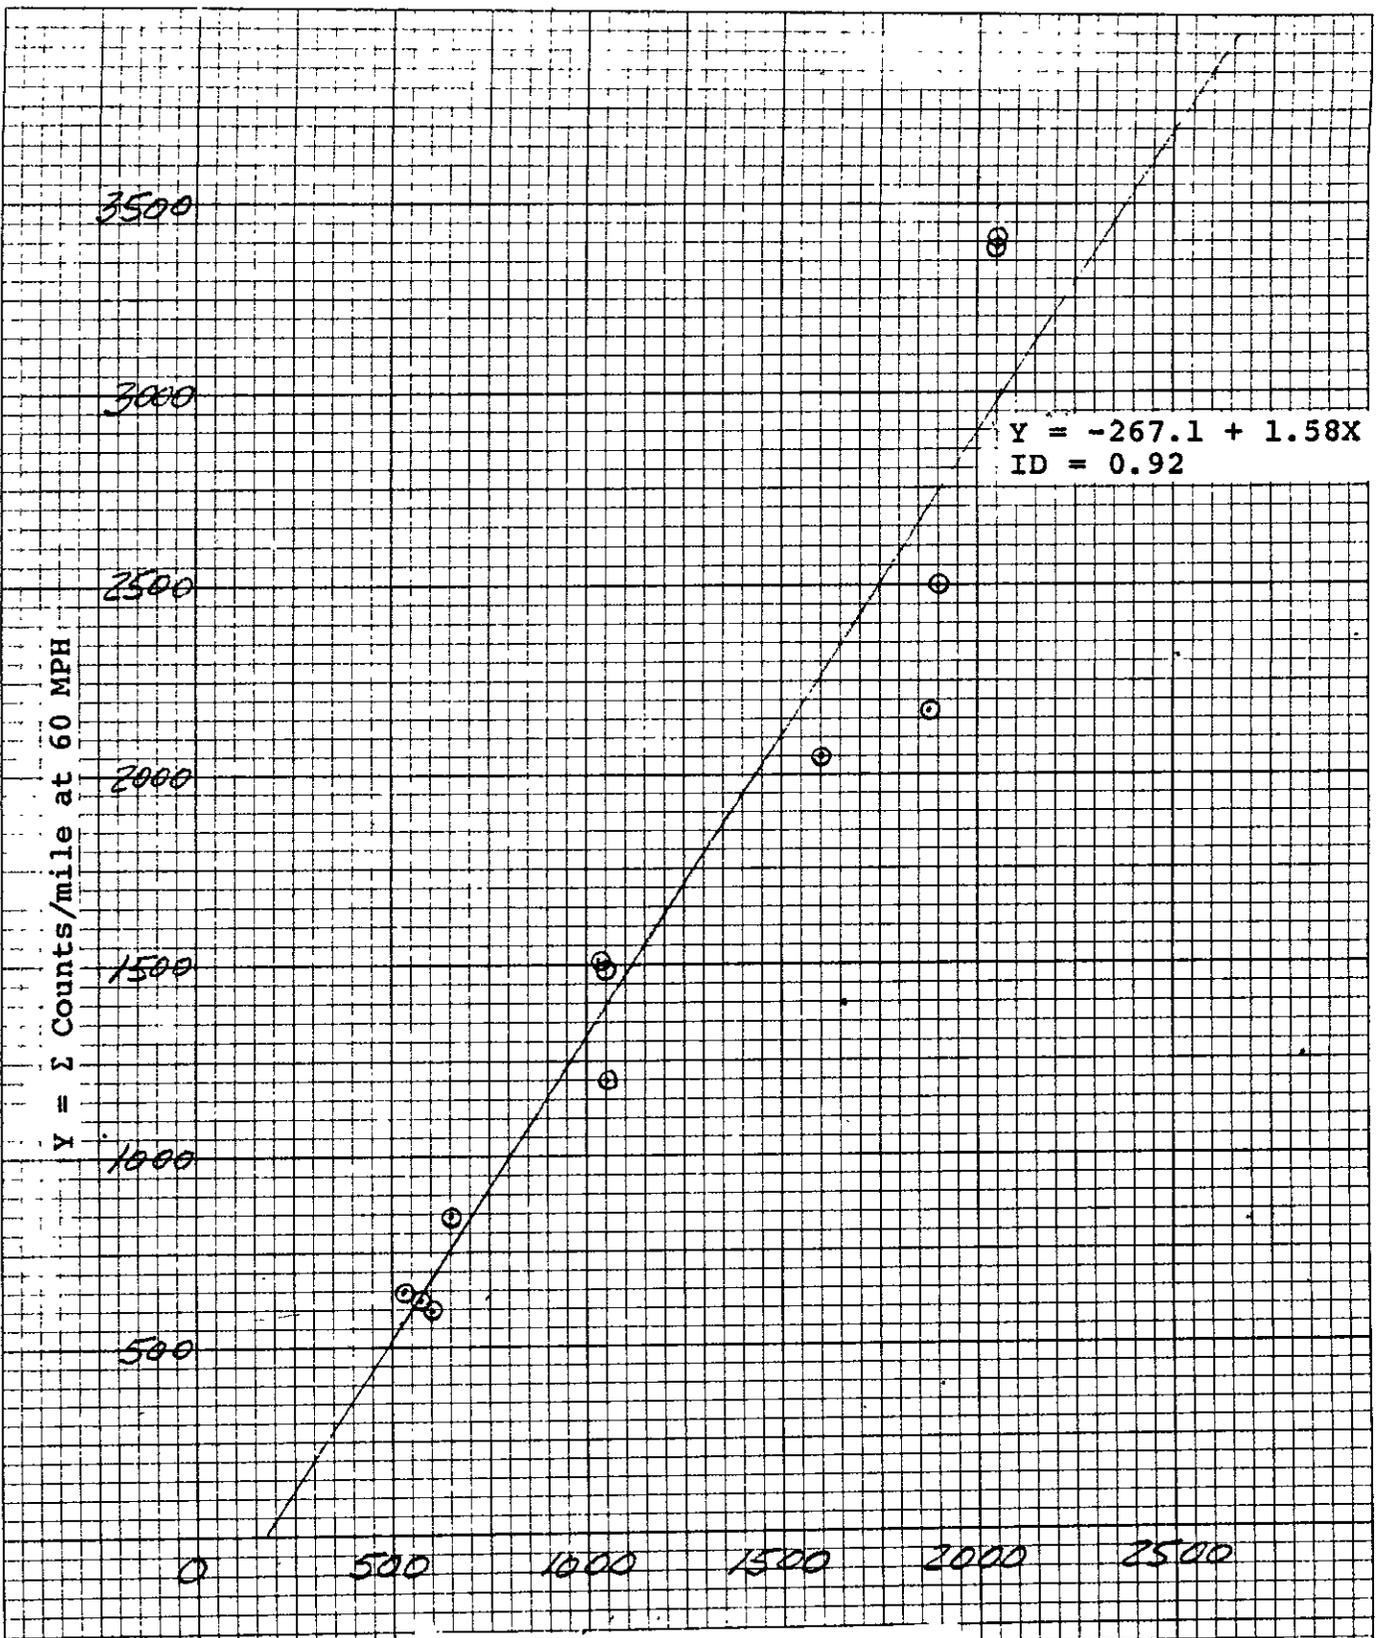
Figure 8

Y = Σ Counts/mile at 60 MPH

A statistical analysis was made of the results obtained (Tables 2 and 3), and it was found that adding weight in the trunk of the car within reasonable limits, varying the amount of gasoline in the tank, using a tire pressure within  $\pm 4$  lbs. of the normal of 26 lbs., and interchanging drivers and operators made no significant changes in the results. However, runs at speeds other than 50 MPH were highly significant. As it is sometimes desirable to make runs at speeds other than 50 MPH because of traffic conditions or geometrics, more tests were made in an attempt to obtain a factor for this use. Runs made at some speeds did show a fair correlation with those made at 50 MPH,

but more tests will have to be made before reliability can be assured (Figures 5, 6, 7, and 8). (Additional information will be supplied on this aspect as it becomes available.)

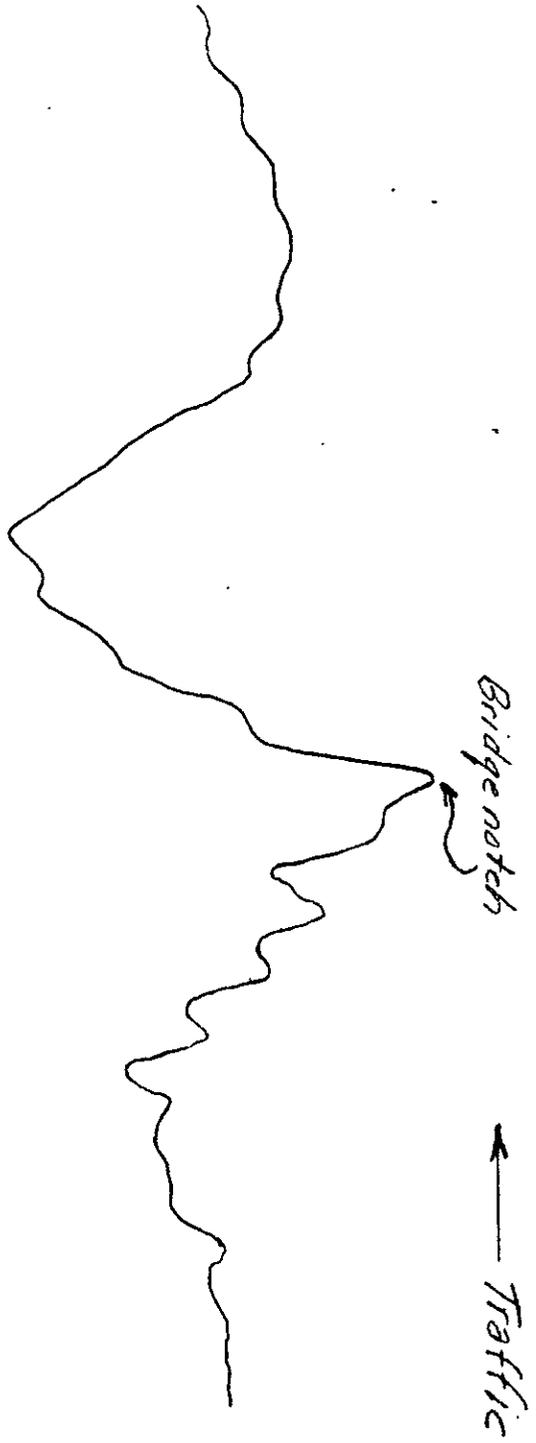
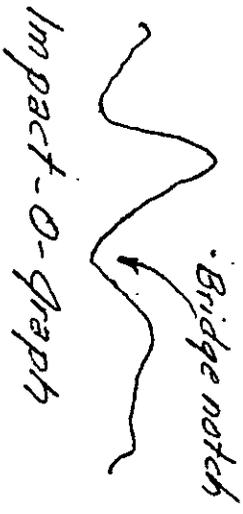
Road Meter Recorder

Comparison Traces - Bridge No. 24-243L

The recorder, which is mounted over the rear seat of the test vehicle, has its pen drive mechanism fastened directly to the translator assembly of the Road Meter and shows graphically the same road-car deviations as depicted digitally on the Road Meter console. The recorder chart drive is driven by servomotors powered by the speedometer drive of the car. The chart speed can be preset by means of a potentiometer in the system. Starting of the chart drive and operations of the pen are controlled from the Road Meter console. Because of the greater magnitude of excursions, the charts are much easier to compare than those made with the Impact-O-Graph. Figure 9 illustrates a typical condition.

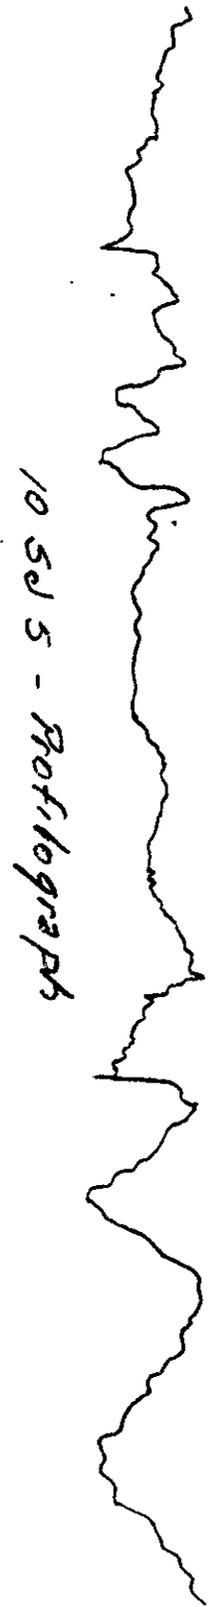
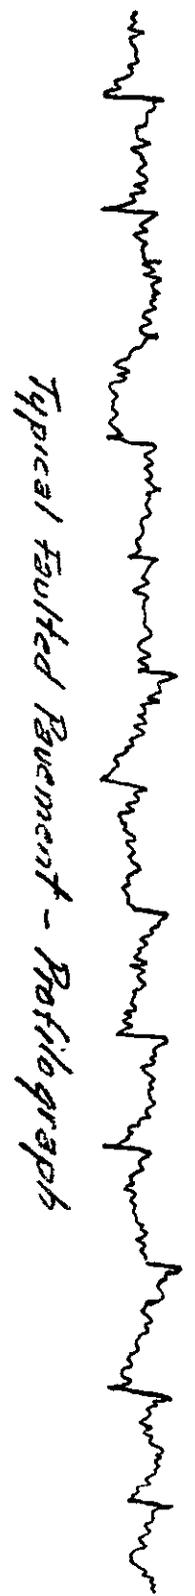
10 SJS - Road Meter Recorder  
@ 50 MPH

Typical Faulted Pavement. Road Meter Recorder  
@ 20 MPH

A few runs were made in an attempt to correlate this equipment with the California Profilograph. The overall graph as drawn by the Road Meter recorder, is similar in appearance to that drawn by the Profilograph, but the magnitude of the bumps is different. At slow speeds (below 20 MPH), the Road Meter recorder clearly shows the faulting at joints, but unlike on profilograms, is not directly measurable (Figure 10).
