EA	04-0120F4
Co-Rte-KP (PM)	SF-080-13.2/13.9 (8.2/8.7)
Structure Rep.	Rick Morrow

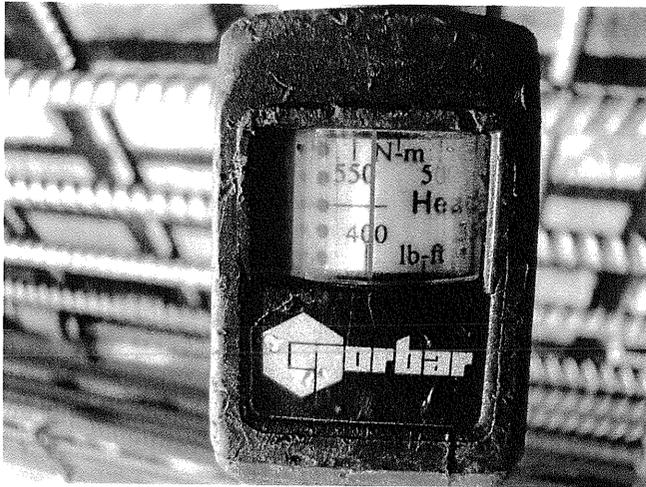
File Name:	DSC00372
Date:	12-13-07

By Int: SH Song
 Description: The torque wrench was set to 400 lb-ft per HRC's recommendation, and submittal 293R1.

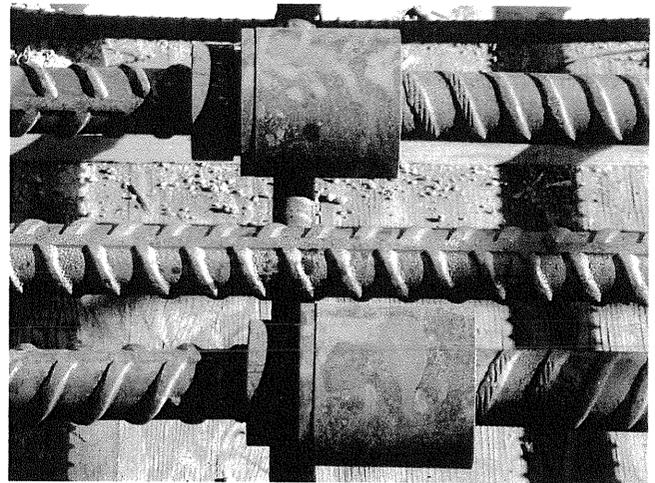
File Name:	DSC00375
Date:	12-13-07

By Int: SH Song
 Description: Mechanical couplers that were torqued to the specified 400 lb-ft were spray painted orange. Approximately 90+ couplers were completed today.

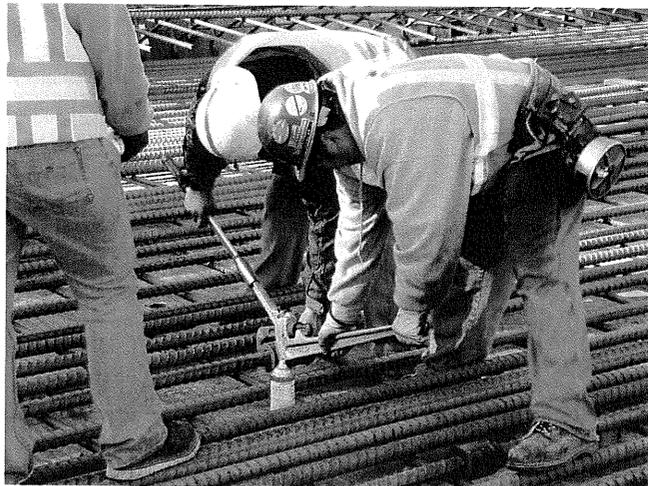
File Name:	DSC00379
Date:	12-13-07

By Int: SH Song
 Description: Pamela and Song watched Tim and Jorge torque each mechanical coupler to 400 lb-ft. A "clicking" noise is heard when the coupler obtain the specified torque.

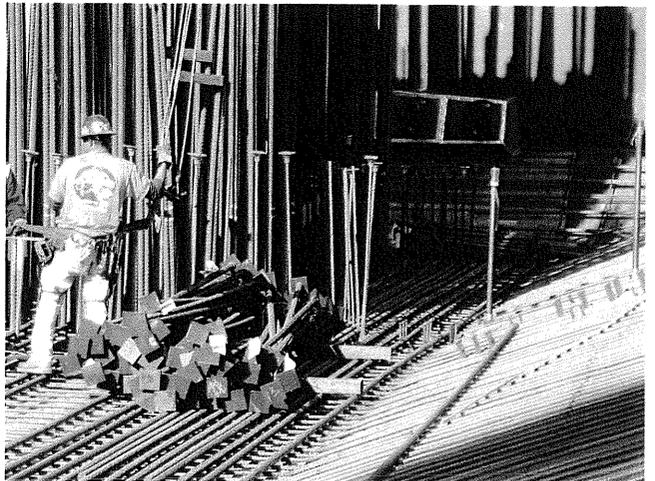
File Name:	DSC00382
Date:	12-13-07

By Int: SH Song
 Description: B4 layer reinforcing 2x2-43HBT04* to be placed in the Northeast corner of W2 cap beam. 2x20-43B4T07* bars are seen in the back corner.
