Job Stamp 04-0120F4 SFOBB SAS
-------------------------------------

ASSISTANT RESIDENT ENGINEER'S **CONTRACTOR – ABFJV, Sub RPS**

**Description of Operations @ W2 Cap Beam:**

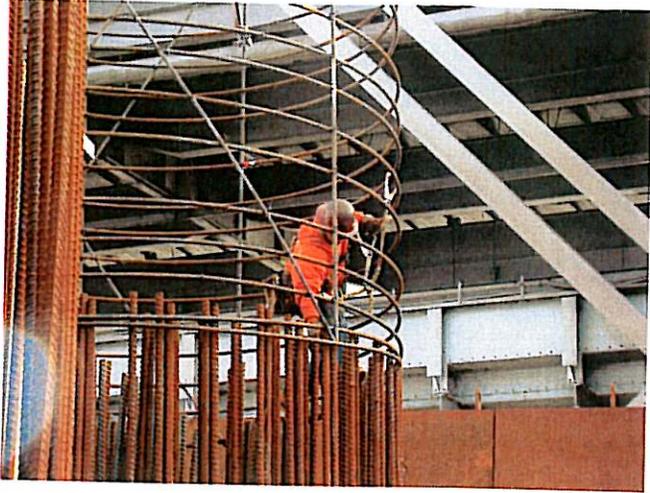
File Name: DSC00586

Description: Installation of #25 outer hoops at W2E-SW cage where ironworker was properly tied off in this photo.

- Positioned #25 outer hoop bars at W2E SE and SW cages. The hoops still need to be placed in the proper position and the stagger distances for the ultimate butt splice are currently acceptable. I informed Alex Coloma of the hoop installation safety concern from yesterday. The ironworkers had fall protection equipment today. However there still were some situations where they didn't comply with acceptable procedures for fall protection.
- Continued to place transverse diaphragm wall rebar, see sheets 497S2 and 497S3.
- Pamela, Song and myself met with TY-Lin designers Alex Sanjines and Derrick Hirschfeld regarding miscellaneous rebar issues/concerns.

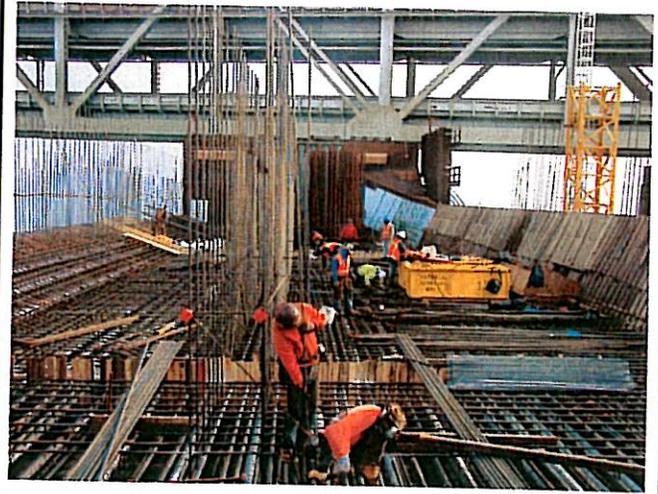
File Name: DSC00591

Description: Continued construction of transverse diaphragm.
