Job Stamp 04-0120F4 SFOBB SAS

Construction Calendar	393
Project working days no.	603
Date	01/10/2008
Inspectors Hours	Start 7:30 Stop 11:00
Shift Hours	Start 6:30 Stop 15:00

Description of Operation:

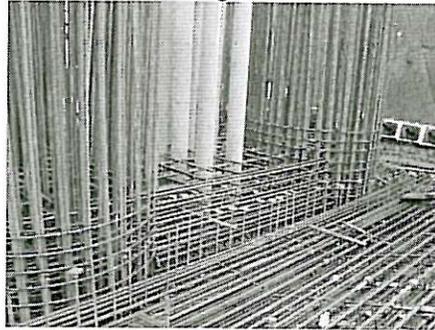
Fig. 1

- See Lalit Mathur's diary for ABF labor, equipment, materials, weather, and comments.
- Daily activity of Regional Steel (R.S.) and ABF
 - R.S. continued to place hoops at north column (WNW).
 - R.S. continued to place L and T-bars at north column (W2W)

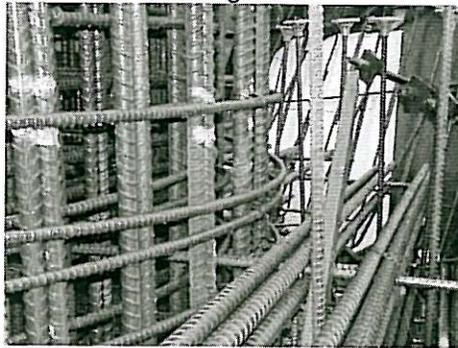
Fig. 2

- Note
 - Informed John regarding hoops which spacing needs to be corrected. He indicated that he would fix it soon.

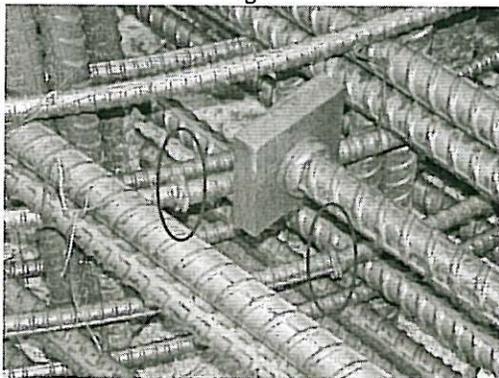
Fig. 3

- Informed John and Daniel regarding hoops (WNW outer hoops, WNE inner hoops) which need to be staggered. They fixed them right away.

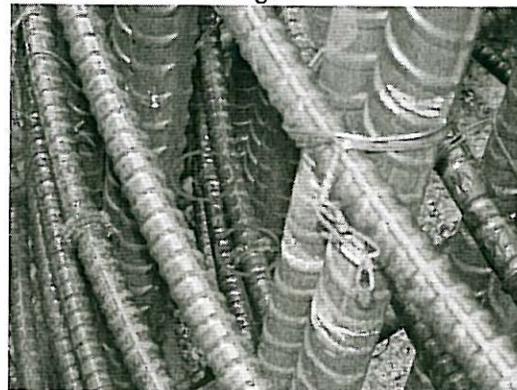
Fig. 4

- Had a meeting with Ron Martin regarding T and L-bars placed in the columns and was informed that the total number of T and L bars needs to be maintained with uniform spacing.
