Job Stamp 04-0120F4 SFOBB SAS

Const. Calendar:	436			
Project Work Day No.:	646			
Date	02/22/2008			
Inspectors	Start	09:50	Stop	11:30
Hours				
Shift Hours		07:00		15:30

Description of Operations @ W2 Cap Beam:

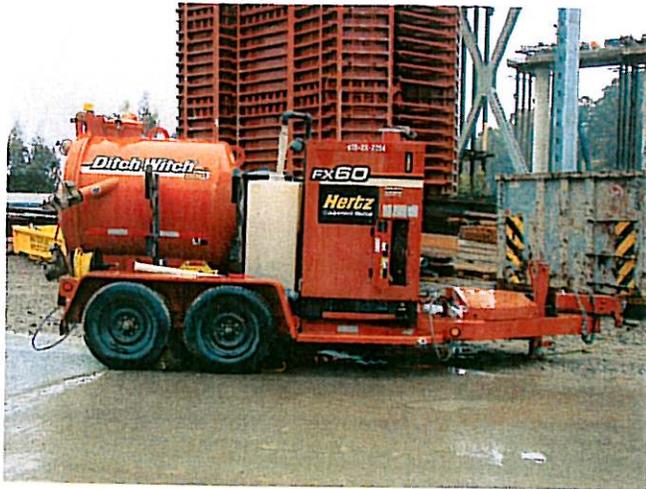
File Name:	DSC00955
Date:	02-22-08
By Int:	M Bruce

Description: Ditch-Witch FX60 was on the ground near the new W3 pier today. ABF engineers were asked to provide the specification sheet on this piece of equipment to verify the weight and/or loading on the falsework.

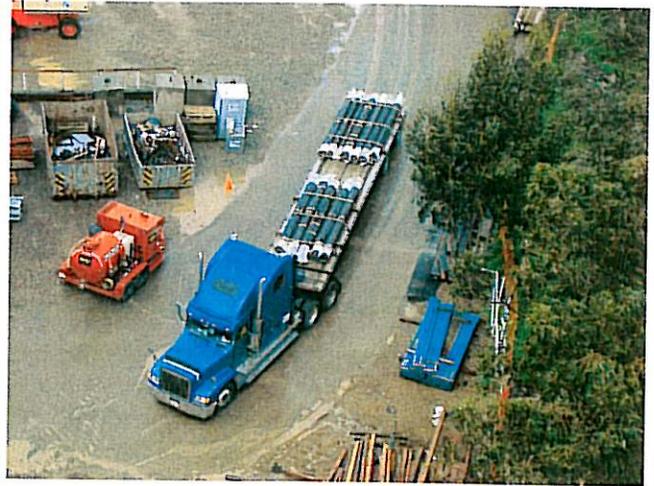
File Name:	DSC00959
Date:	02-22-08
By Int:	M Bruce

Description: Delivery of the Macalloy rods to the jobsite from the pier 7 warehouse.

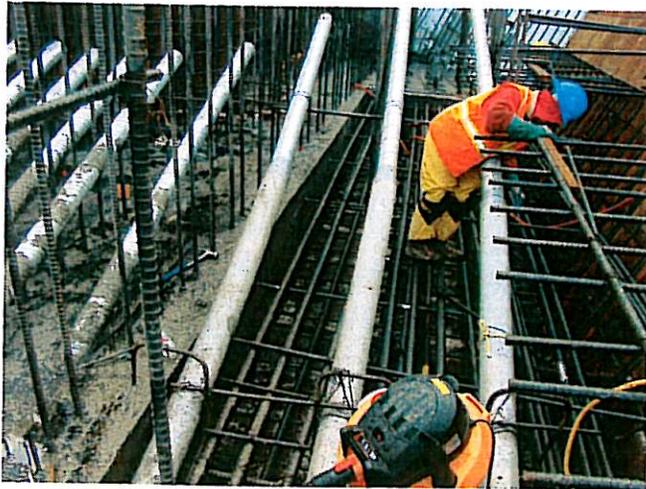
File Name:	DSC00963
Date:	02-22-08
By Int:	M Bruce

Description: Vertical bar blockout forms were removed the previous day on both ends of the W2 cap beam.

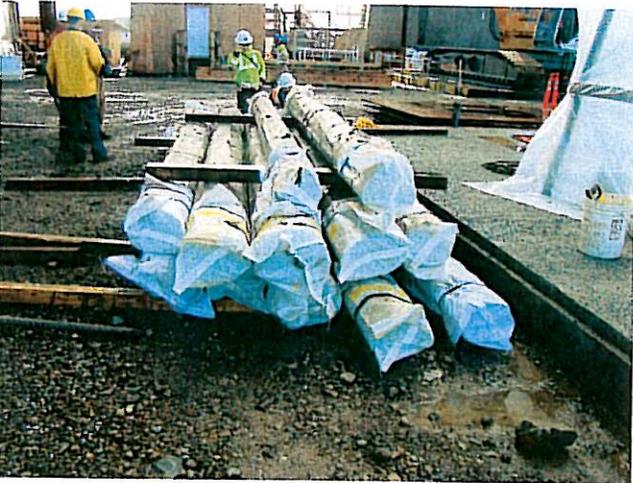
File Name:	DSC00975
Date:	02-22-08
By Int:	M Bruce

Description: Macalloy rods were placed on the east side of the Hinge K working slab. Photo was taken looking south as the rods were covered on this end while high strength rods were being identified.

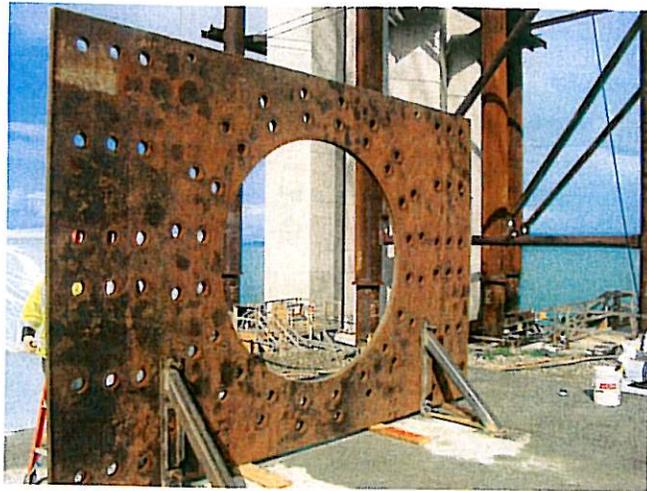
File Name:	DSC00979		
Date:	02-22-08	By Int:	M Bruce
Description: Templates were constructed today on the working slab to set up 60mm anchor plate.

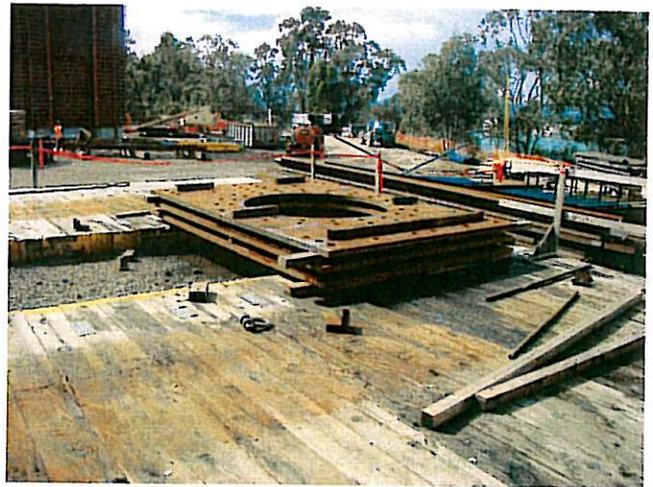
File Name:	DSC00981		
Date:	02-22-08	By Int:	M Bruce
Description: Remaining anchor plates mobilized on the northwest side of the Hinge K working slab.

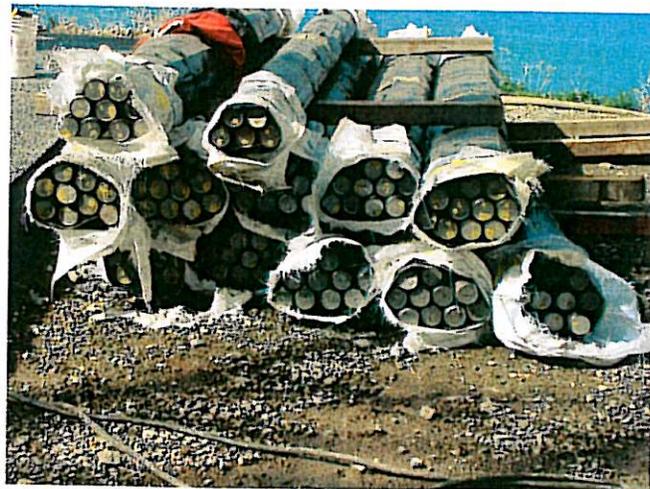
File Name:	DSC00983		
Date:	02-22-08	By Int:	M Bruce
Description: ABF engineers marked with yellow paint and in some cases numbered with the paint the high strength Macalloy rods. ABF engineers and foreman were reminded to cover/protect the exposed ends of the rods before leaving the jobsite today.

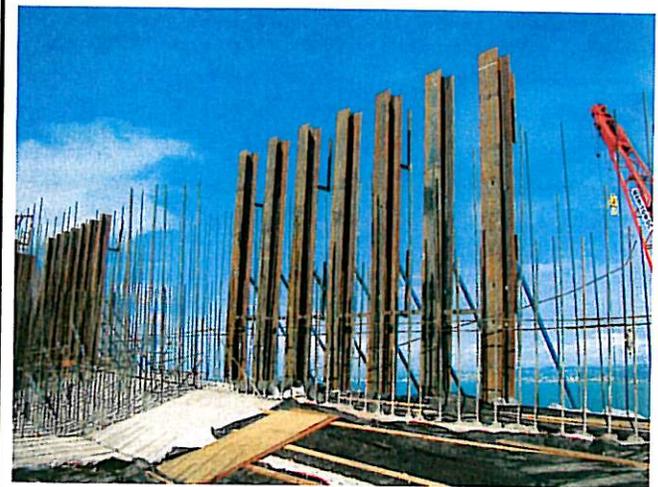
File Name:	DSC00985		
Date:	02-22-08	By Int:	M Bruce
Description: HP vertical strongback erection on the east side of the W2 cap beam.
