Job Stamp:  
04-SF-80-13.2/13.9 04-0120F4  
SFOBB SAS  
San Francisco Co. in San Francisco  
Fm 0.6 km to 1.3 km East of Yerba Buena  
Tunnel East Portal

**ASSISTANT RESIDENT ENGINEER'S DAILY BRIDGE REPORT**

Location: <b>W2 Cap Beam</b>	7-day const. cal.: <b>436</b>	Weather: <b>overcast, int. light rain</b>
Remark: <b>Begin work for Hinge K assembly</b>	Project work day: <b>646</b>	<b>Hi 54F/Lo 44F</b>

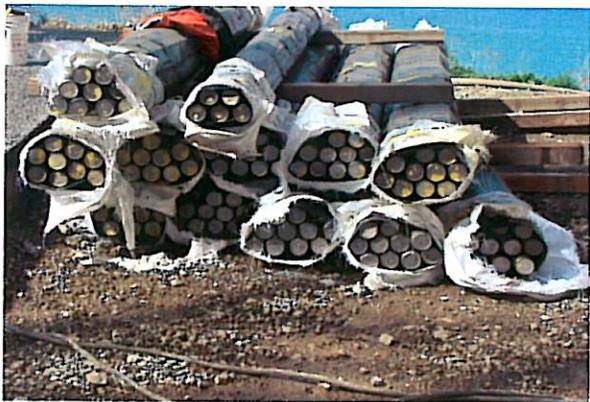
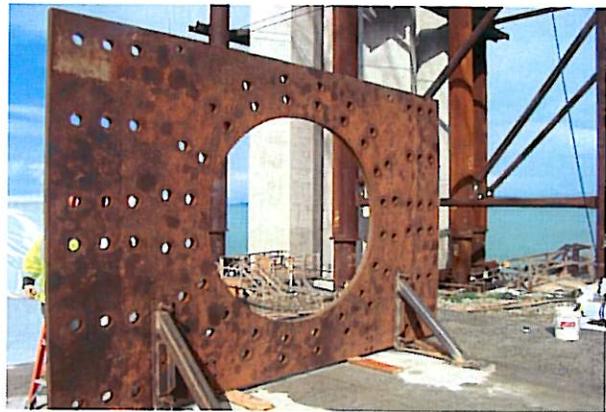
Field visit with Matt Bruce ~ 0930: the first shipment of prestressing rod was delivered to the site. Rods were counted and we noticed eight (8) # "03" bars were missing from the lot --> req'd count = 13  
- a template for the assembly was being fabricated on the concrete slab.

Up above: the ducts in the blockouts did not appear to be damaged where the forms were removed.

Matt talked to several ABF personnel, stating that the ends of the prestressing rods needed to be capped for protection.  
~1300 in elevator: Matt asked Mark (ABF engineer) for load calculations and he acknowledged: he said he would get those to us.
