Job Stamp:
04-SF-80-13.2/13.9 04-0120F4
SFOBB SAS
San Francisco Co. in San Francisco
Fm 0.6 km to 1.3 km East of Yerba Buena
Tunnel East Portal

ASSISTANT RESIDENT ENGINEER'S DAILY BRIDGE REPORT

Location: W2 Cap Beam	7-day const. cal.: 441	Weather: clear skies
Remark: Hinge K assembly	Project work day: 651	Hi 63F/Lo 48F

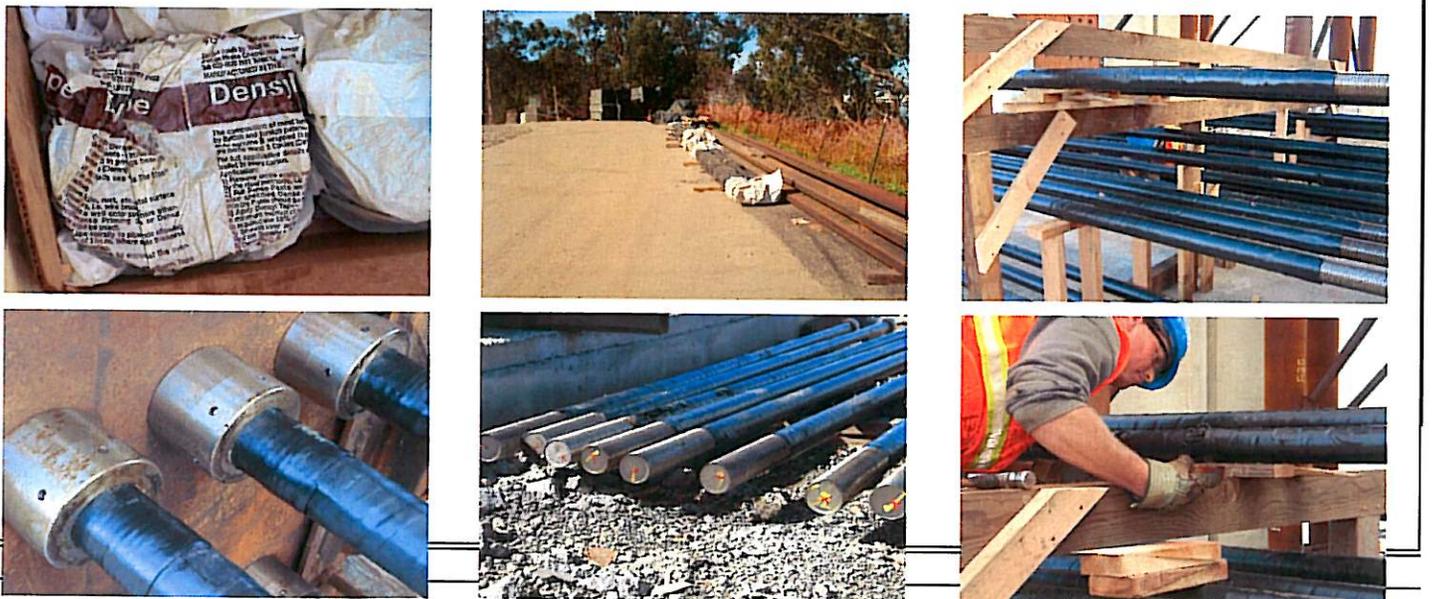
During a routine field inspection, one of the ABF carpenters (Nigel) was placing Densyl tape around holes created during shipping/handling. It was also seen that he applied tape around the threads at the dead end of the rod. The plans designate 50 mm of threads exposed to concrete (DRG No. Y3889). A designer from T.Y.Lin (Derek) happened to visit the site and we asked him if our interpretation was right. He later contacted Matt and said that the tape around the threads was okay and that the purpose of the 50mm was to allow room for the Macalloy nut to be affixed. Concern was brought up to the Foreman (Terry) about the placement of the HS rods - see attached picture
Yellow marks appeared on the ends of a few of the "lower strength" bars (89 bars were fabricated at ~10% higher strength than the rest and were marked with yellow at the ends of the rods). To avoid them being placed in the wrong location, the yellow marks were crossed out with a red 'X'. Carpenters are using shims to align HS rods as close as possible to template holes.
