Job Stamp:  
04-SF-80-13.2/13.9 04-0120F4  
SFOBB SAS  
San Francisco Co. in San Francisco  
Fm 0.6 km to 1.3 km East of Yerba Buena  
Tunnel East Portal

**ASSISTANT RESIDENT ENGINEER'S DAILY BRIDGE REPORT**

Location: <b>W2 Cap Beam</b>	7-day const. cal.: <b>446</b>	Weather: <b>Clear</b>
Remark: <b>Hinge K assembly</b>	Project work day: <b>656</b>	<b>Hi 67F/Lo 43F</b>

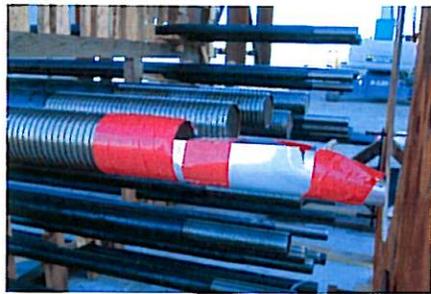
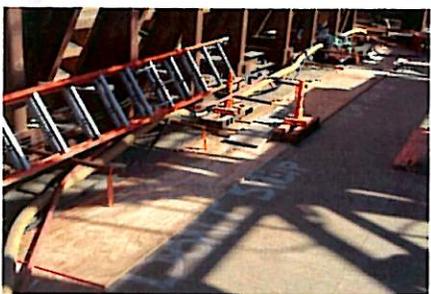
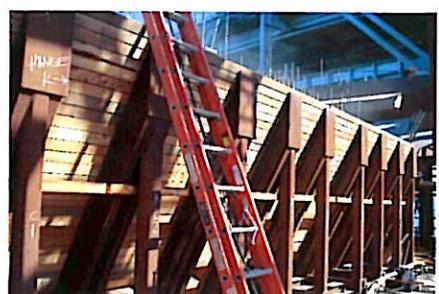
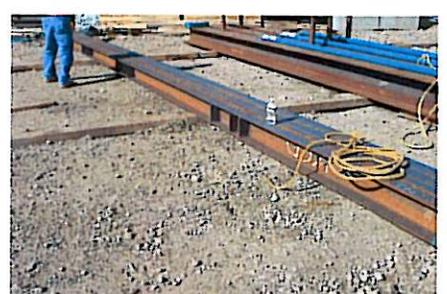
Site visit ~ 1000  
Duke (ABF labor) said no work was being performed on Hinge K today  
Close-up picture shows the way they will attempt to align the HS rods to be inserted into the template - the example shown is red duct tape around sheet metal. The sheet metal would be shapeable enough to align the rods without damage to the threads of the bolts.  
upon leaving site, steel members arrived on a truck lumber rack. Assumed to be support for Hinge K assembly on FW. Hinge K assembly has been located and soffit forms have been cut through.
