STATE OF CALIFORNIA	Job Stamp	7-day Const. Calendar	Day No. 464
DEPARTMENT OF TRANSPORTATION	SFOBB SAS	Project Work Day No.	Day No. 674
Form HC-10A (Rev. 6/80)	04-0120F4	Date	03/21/2008

ASSISTANT RESIDENT ENGINEER'S

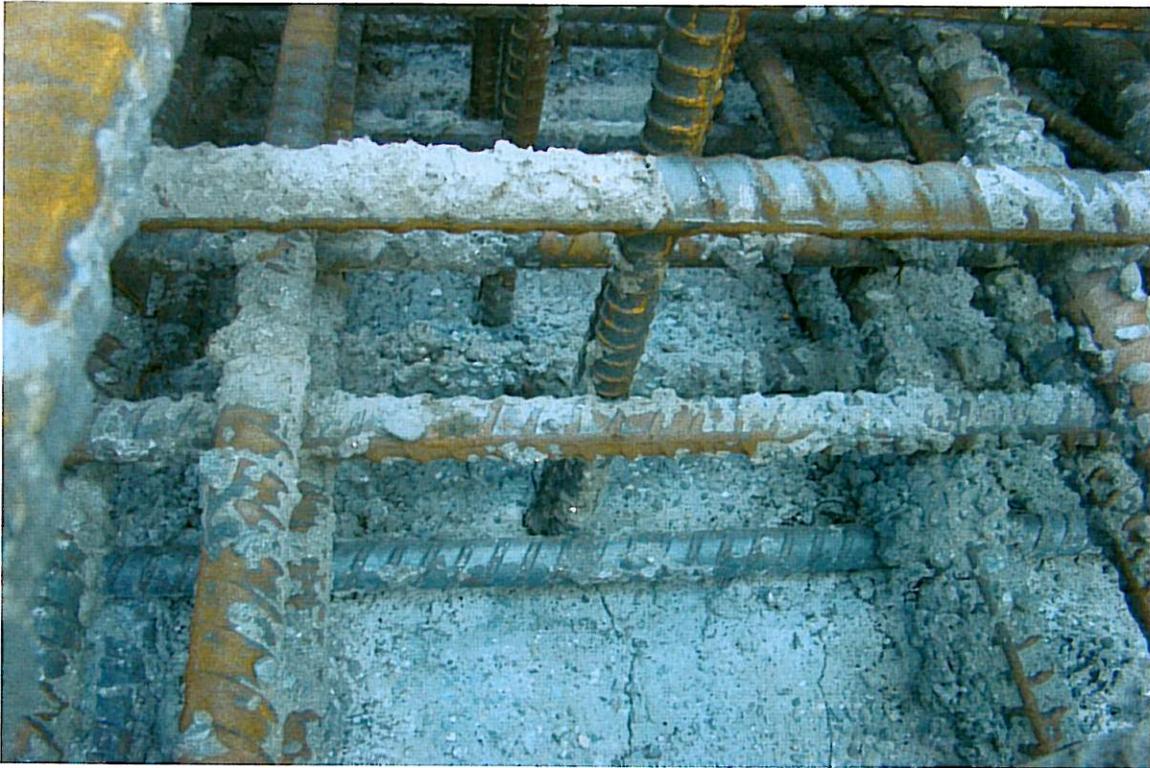
- Inspected L & T bars for concrete remaining on rebar after ABF has attempted to clean using a impact tool. Additional cleaning is required. See photos below.

L & T rebar in south column region. Requires additional concrete removal.
