Job Stamp 04-0120F4 SFOBB SAS

ASSISTANT RESIDENT ENGINEER'S **CONTRACTOR – ABFJV, Sub RPS**

Description of Operations @ W2 Cap Beam:

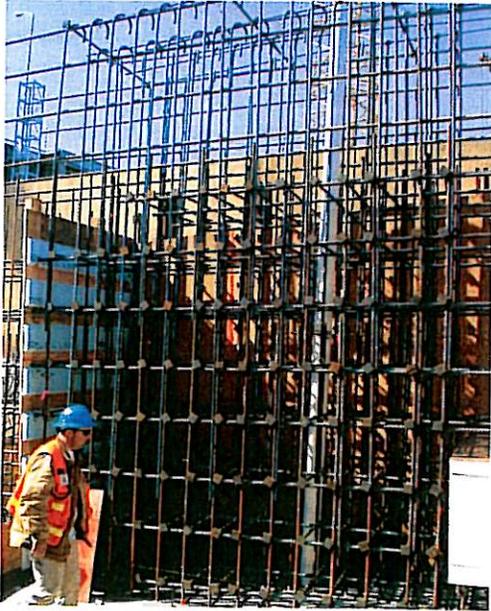
File Name:	DSC01276		
Date:	04-03-08	By Int:	D Chung

Description: Transverse diaphragm construction in the south. The diaphragm blockout with shear keys was out of plumb.

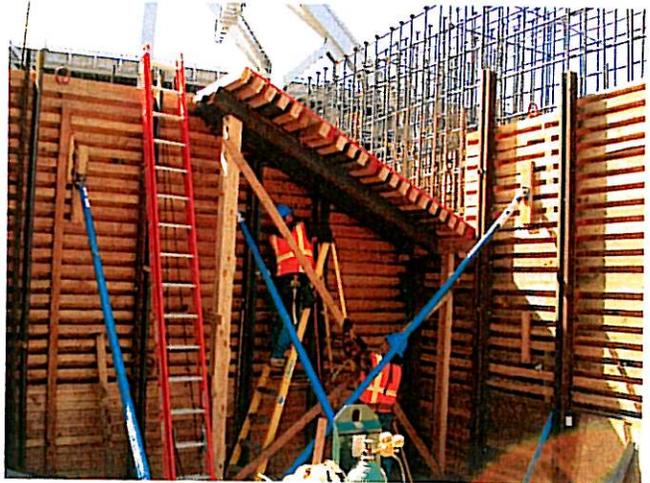
File Name:	DSC01277		
Date:	04-03-08	By Int:	D Chung

Description: Jacking block formwork for the longitudinal diaphragms in the northeast.

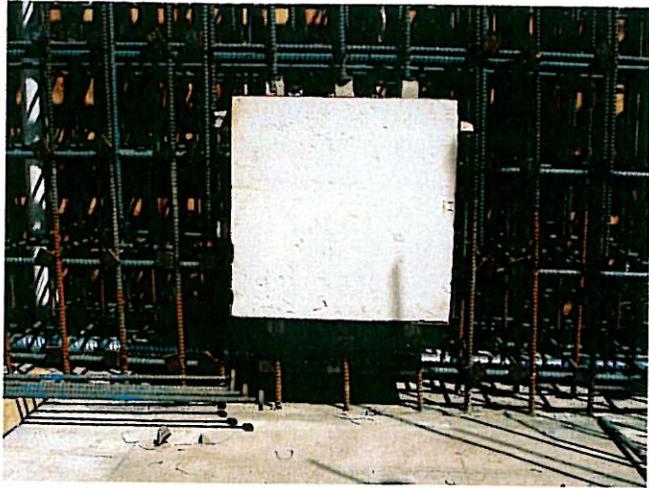
File Name:	DSC01281		
Date:	04-03-08	By Int:	D Chung

Description: Styrofoam blockout for the access opening installed in the transverse diaphragm.
