Job Stamp 04-0120F4 SFOBB SAS

Description of Operations @ W2 Cap Beam:

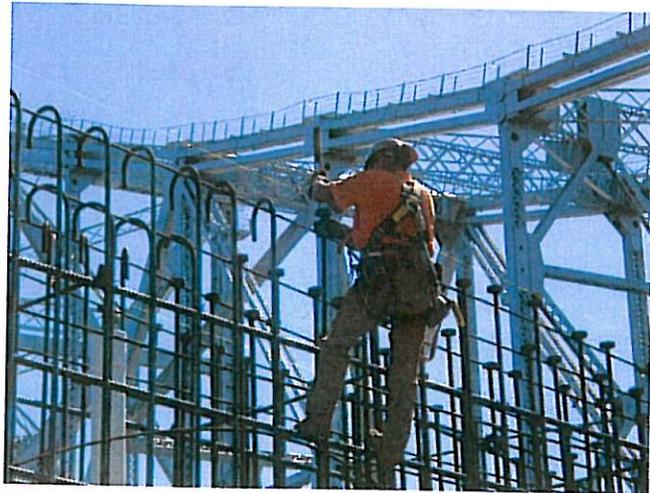
File Name:	DSC01381
Date:	04-10-08
By Int:	D Chung

Description: Ironworker adjusting vertical bars in the transverse diaphragm.

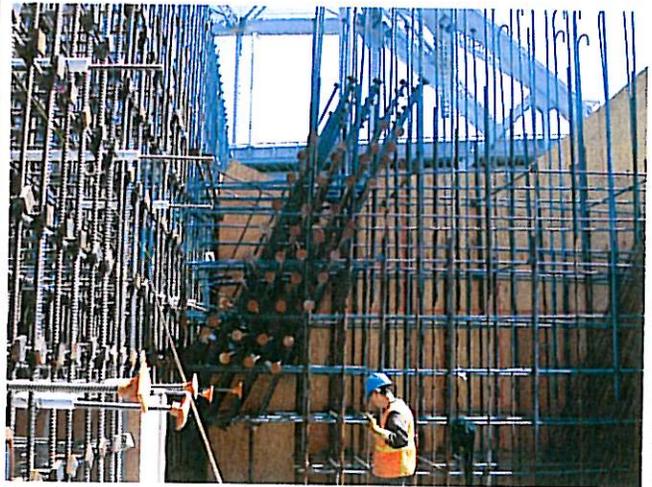
File Name:	DSC01388
Date:	04-10-08
By Int:	M Bruce

Description: Longitudinal diaphragm and jacking support frame block reinforcement.
