Job Stamp:  
04-SF-80-13.2/13.9 04-0120F4  
SFOBB SAS  
San Francisco Co. in San Francisco  
Fm 0.6 km to 1.3 km East of Yerba Buena  
Tunnel East Portal

Report No. **46.B**

**ASSISTANT RESIDENT ENGINEER'S DAILY BRIDGE REPORT**

Location: W2 Cap Beam	7-day const. cal.: 532	Weather: Partly cloudy
Remark: Hinge K/cleanup/sandblast/epoxy	Project work day: 742	Hi 67F/Lo 53F

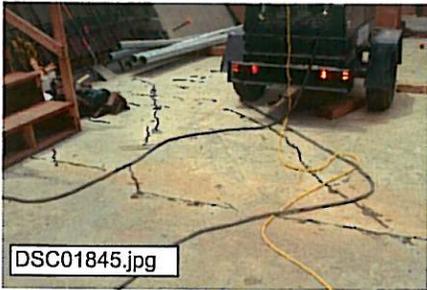
ABF has started to epoxy inject the cracks in the soffit (pour 1) in the void areas (DSC01845). Damage to the densyl tape on the HS Macalloy rods for the second Hinge K assembly is seen in DSC01846. It is unclear how this could have occurred if the wood panels were slid on from the end and not have gotten this far along the rod. I saw Terry (ABF foreman) at the bottom of the elevator shaft and asked if he was going to place some plastic tarps to keep the denso paste from melting and dripping to the mild steel reinforcement - as previously seen under the 1st Hinge K assembly. He said he will soon. Today, the workers were sandblasting the top of the diaphragm walls and cleaning up the area. Shown in DSC01848, panels closing up the intermediate transverse diaphragm and end walls have started. Office work included studying mild steel reinforcement plans for pour 3.
