Job Stamp 04-0120F4 SFOBB SAS

Description of Operations @ W2 Cap Beam:

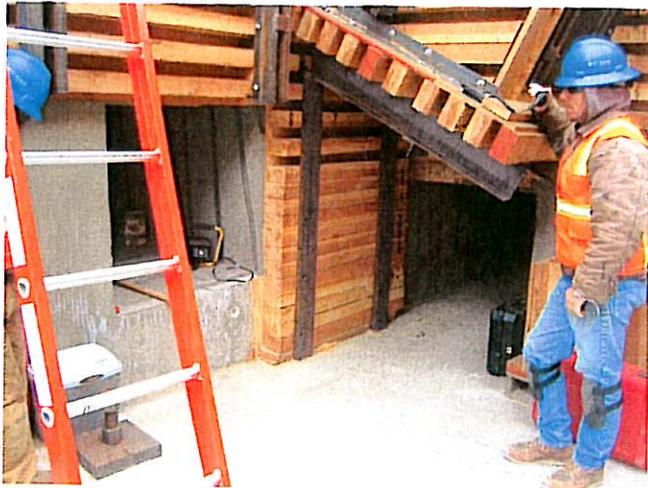
File Name:	July-21-2008 W2 Cap 003
Date:	07-21-08
By Int:	M Bruce

Description: Confined space opening mentioned in the Team Concrete meeting last week. The piledriver on the right side of the photo was seen coming out of the lower access opening before the picture was taken.

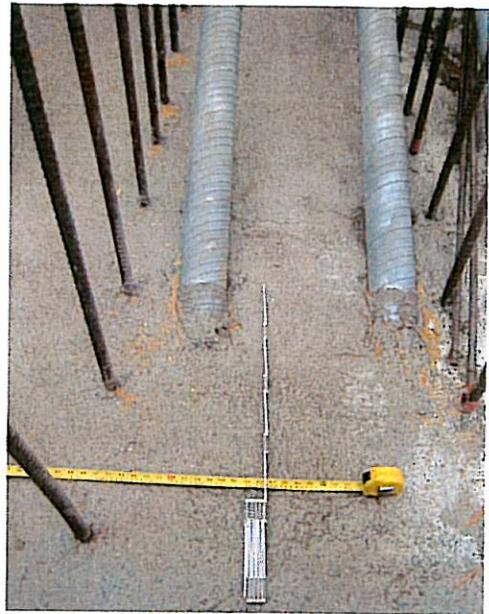
File Name:	July-21-2008 W2 Cap 005
Date:	07-21-08
By Int:	M Bruce

Description: While checking some of the transverse tendons CBT-34 near W2W was found to be out of tolerance. From the centerline of the W2 cap beam 2490mm was measured. The theoretical value is 2625mm, which is shown by the stick tape in the photo above. CBT-34 near W2E was found to be 2640mm. ABF has not yet been notified of this As-built condition.

- Continued placing T-bars in the center portion at the top of the pier W2W column cages.
- Foreman Bob Bogneas began to layout (using white spray paint) the #25 and #29 vertical bars to be spliced per RFI 1437R0.
- Began placing #25 horizontal ties, #25 vertical bars, and #36 bars in the northwest wall.
- See photos below for transverse tendons found to be out of tolerance.

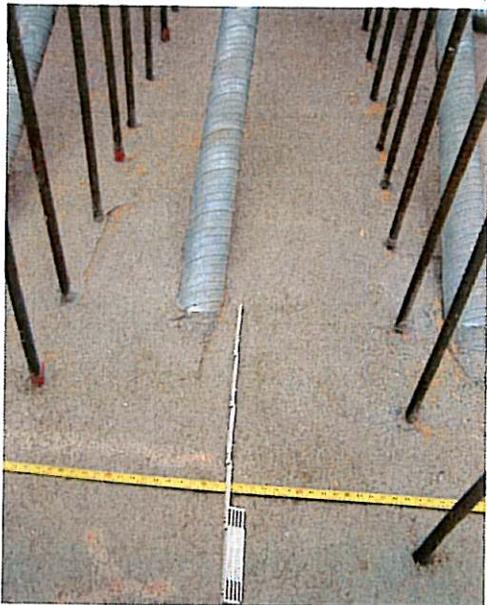
File Name:	July-21-2008 W2 Cap 006
Date:	07-21-08
By Int:	M Bruce

Description: CBT-33 near W2W was also found to be out of tolerance by a significant amount. The theoretical value for this tendon is 1875mm and the As-built of this tendon was found to be 1780mm. Other transverse tendons were measured and the values were closer to the ± 1 " tolerance. CBT-33 near W2E was found to be 1895mm.

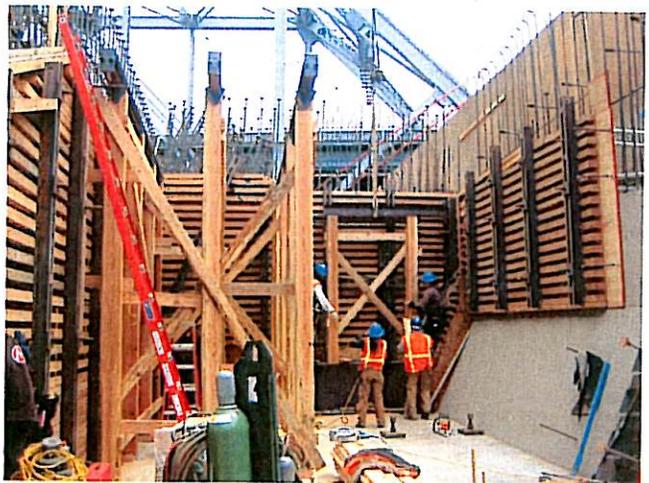
File Name:	July-21-2008 W2 Cap 008
Date:	07-21-08
By Int:	M Bruce

Description: The first day of erecting void area falsework in the northwest quadrant.

- Completed placing plywood and continued working on the chamfer on top of the pour 4 void area falsework in the southwest quadrant.
- Continued fabricating pour 3 vertical blockout forms on the ground.
- Began to erect void area falsework in the northwest quadrant, see photo below.
- Installed form ties in the northwest wall.
