Job Stamp 04-0120F4 SFOBB SAS

ASSISTANT RESIDENT ENGINEER'S **CONTRACTOR – ABFJV, Sub RPS**

Description of Operations @ W2 Cap Beam:

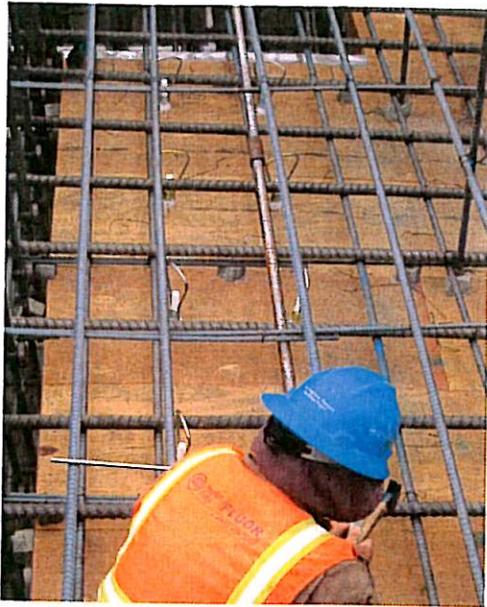
File Name:	Aug-5-2008 W2 Cap 001
Date:	08-05-08
By Int:	M Bruce

Description: ABF piledriver installing ferrules south of the longitudinal diaphragm.

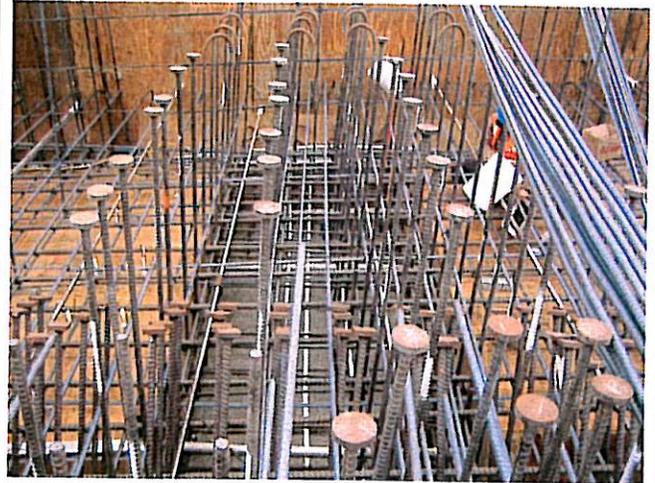
File Name:	Aug-5-2008 W2 Cap 007
Date:	08-05-08
By Int:	M Bruce

Description: The ironworkers placed 9 #25 hooked horizontal bars in the longitudinal diaphragm. The contract plans don't call out for this much reinforcement. Pamela, Ron, and myself confirmed this with TY-Lin designer James Duxbury later in the afternoon.

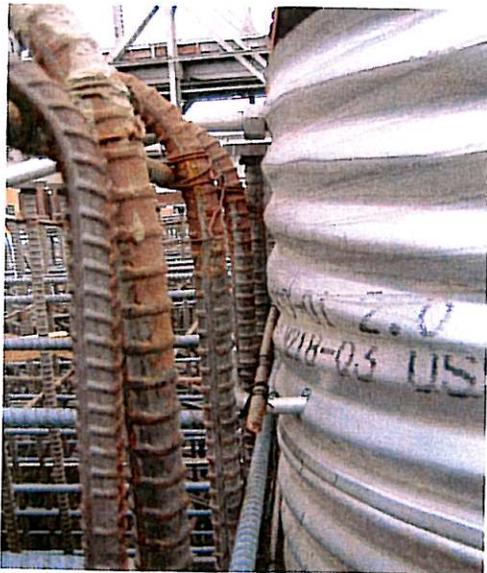
File Name:	Aug-5-2008 W2 Cap 008
Date:	08-05-08
By Int:	M Bruce

Description: Since a larger diameter CMP was placed there may be some issues with adjacent reinforcement cover. This photo was taken of the north access opening CMP looking south. There appears to be approximately 25mm cover between the blackout and the transverse diaphragm vertical bars.

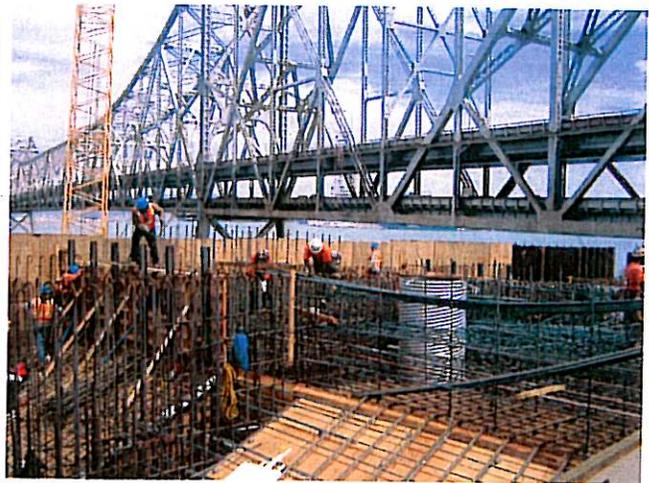
File Name:	Aug-5-2008 W2 Cap 010
Date:	08-05-08
By Int:	M Bruce

Description: Pour 3 progress to date with formwork being erected and horizontal rebar placement.
