Job Stamp 04-0120F4 SFOBB SAS

Assistant Structure Rep.'s Daily Report

Location & Description of Operation	SAS-Temporary towers, Tower A & B Erection
Weather	HI: 71 F Low: 56 F Partly cloudy

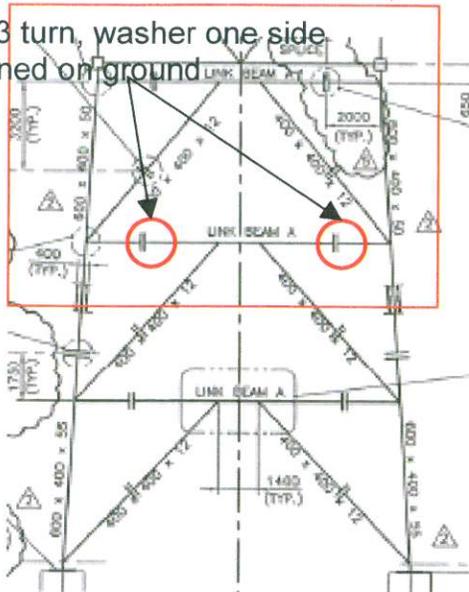
Fig 1

- Daily activity of contractors (ABF)
 - Continued to assemble upper portion of the tower AE and pretensioned bolts at splice zone circled in Fig. 1 on the ground. See Figs 1 through 3.
 - Erected the upper portion of the tower ^{AE}BE, which is shown in Figs 1. See Figs 4 through 7 for the erection sequences.
 - Pretensioned bolts at north column splice and two diagonal brace splices after the erection (see Figs 8 through 10).
 - See Art Pannu's diary for additional contractors' activities and comments.

Upper portion of the tower AE

4" bolt, 1/3 turn, washer one side
Pretensioned on ground

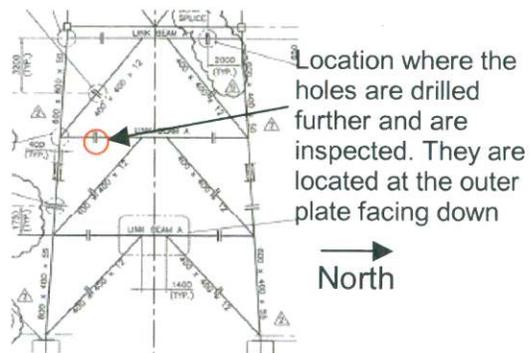
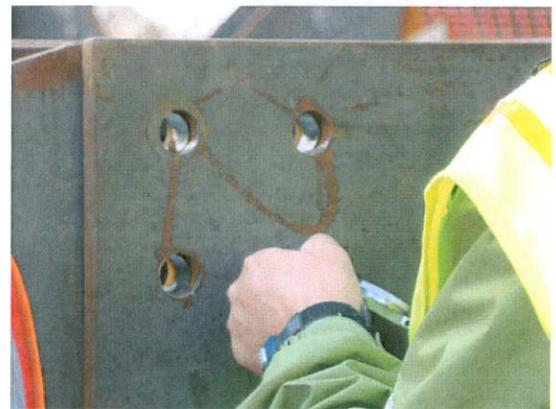
- Note
 - Superintendent Dan is on site from 10:30 to 11:30 and 13:30 to 14:00.
 - ABF iron worker drilled a hole little bit more. So, Tony and I checked the diameter of the hole (see Figs 11 and 12). It is within the tolerance.
 - Dan mentioned that Caltrans inspector couldn't use any contractor equipment. I informed Art regarding this issue.
 - Tony from SE company is on-site all day.
 - Attend T.T. design meeting from 15:00 to 15:30.
