Job Stamp:  
04-SF-80-13.2/13.9 04-0120F4  
SFOBB SAS  
San Francisco Co. in San Francisco  
Fm 0.6 km to 1.3 km East of Yerba Buena  
Tunnel East Portal

**ASSISTANT RESIDENT ENGINEER'S DAILY**

Location: W2 Cap Beam	Weather: cloudy
Remark: ironwork/manhole void	HI 68F/Lo 57F

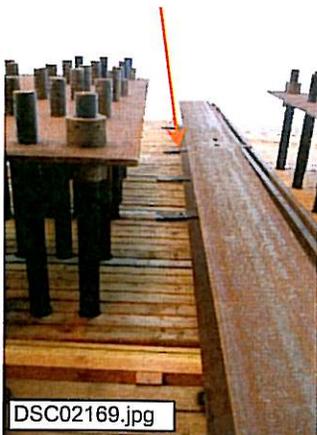
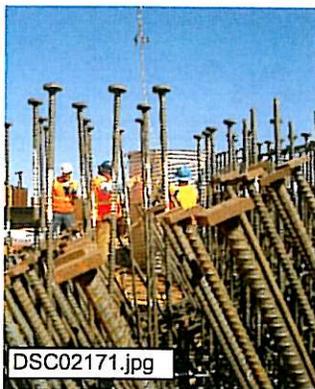
brackets used to tie forms to vertical member

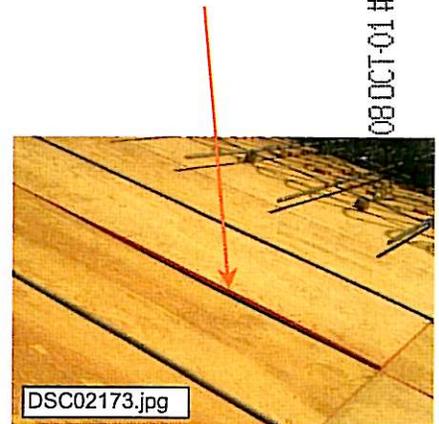
In the southwest void area, I noticed two panels that have excessive negative undulations (DSC02173). Normally, the weight of the ironwork would press these down but in this case the undulations were stiff enough to resist my weight. I notified Nigel (ABF foreman) and asked him to secure these panels. He acknowledged me and said that Jesse (ABF carpenter) has this as an item on his punchlist. 10:44  
ABF has set the manhole blockout - corrugated steel tube with shear lags at the top perimeter - for the northwest void (DSC02171).  
ABF has completed plumbing the external forms on the west face by the Hinge at the E-line - started yesterday (DSC02169).

excessive undulation
