Job Stamp 04-0120F4 SFOBB SAS

ASSISTANT RESIDENT ENGINEER'S **CONTRACTOR – ABFJV, Subs CMC-RS**

Description of Operations @ W2 Cap Beam:

EA	04-0120F4
Co-Rte-KP (PM)	SF-080-13.2/13.9 (8.2/8.7)
Structure Rep.	Rick Morrow

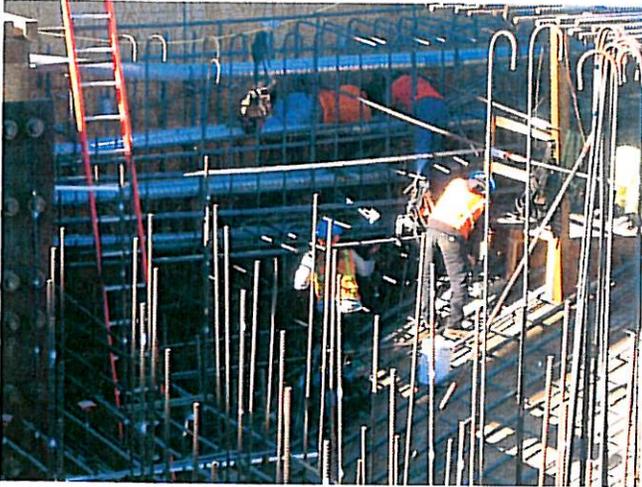
File Name:	Oct-21-2008 W2 Cap 004
Date:	10-21-08
By Int:	M Bruce

Description: Ironworkers placing #16 temperature steel at the E-1B through E-15B blockouts. Also ABF piledrivers installing ferrules on these same blockouts.

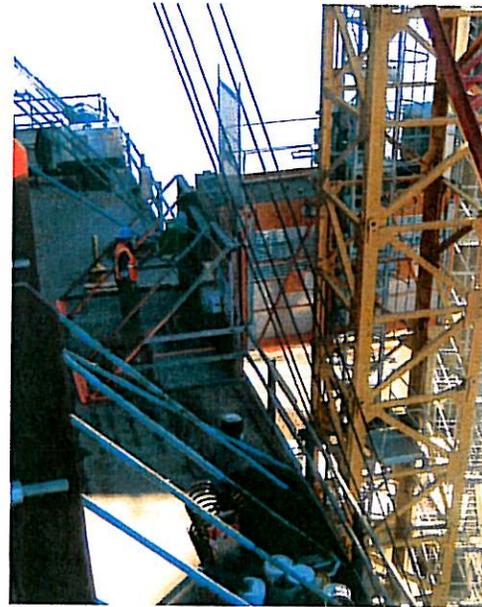
File Name:	Oct-21-2008 W2 Cap 005
Date:	10-21-08
By Int:	M Bruce

Description: ABF has implemented a new safety policy where the oiler goes to the top of the falsework and acts as the lookout when the crane comes close to the elevator frame. Apparently ABF spent an hour the other morning reviewing this policy with the operators, piledrivers, and ironworkers.

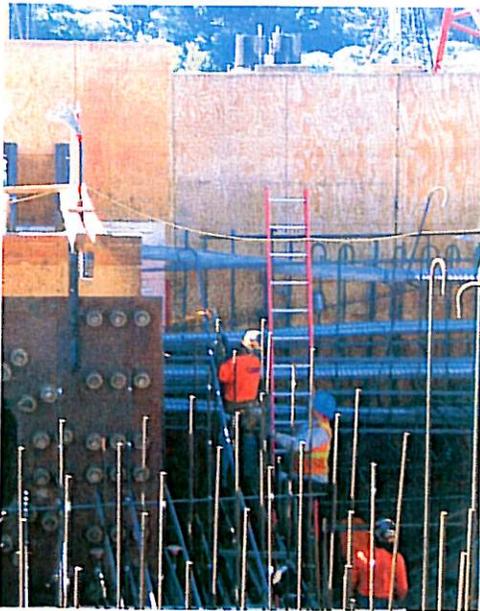
File Name:	Oct-21-2008 W2 Cap 007
Date:	10-21-08
By Int:	M Bruce

Description: Ironworker seen cutting the hooked portion of a #25 horizontal hooked bar. They are doing this to make it easier to place the longer portion of the bar then splice a shorter piece at the end.

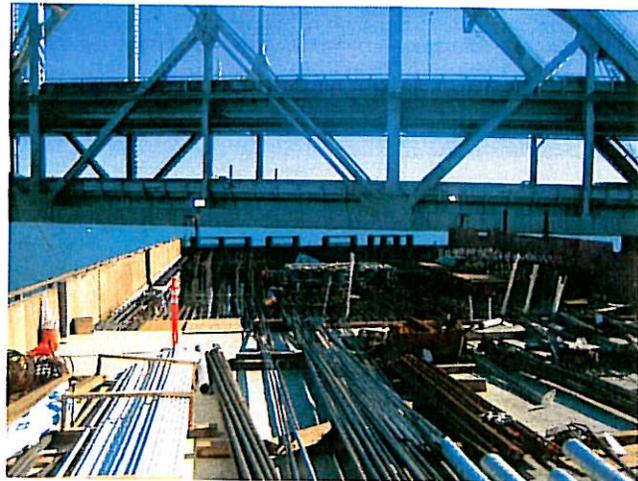
File Name:	Oct-21-2008 W2 Cap 019
Date:	10-21-08
By Int:	M Bruce

Description: Pour 4 construction to date.
