Job Stamp:
04-SF-80-13.2/13.9 04-0120F4
SFOBB SAS
San Francisco Co. in San Francisco
Fm 0.6 km to 1.3 km East of Yerba Buena
Tunnel East Portal

ASSISTANT RESIDENT ENGINEER'S DAILY

Location: W2 Cap Beam	Weather: cloudy most of day
Remark: sandblast/ironwork/cooling pipes	Hi 63F/Lo 55F

Description of Operation:
ABF - continue sandblasting top of concrete from pour 4
- continue placing cooling pipes
- continue welding at north end of cap beam
RPS - continue placing iron/ducts

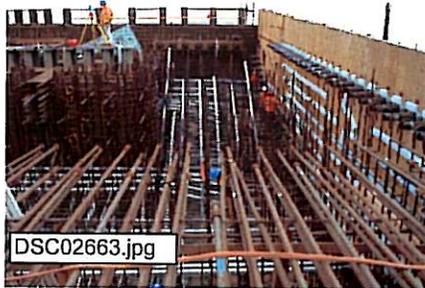
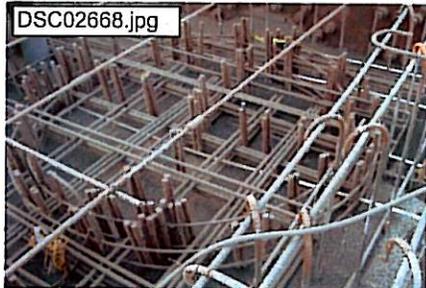
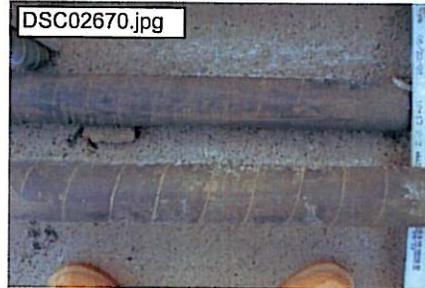
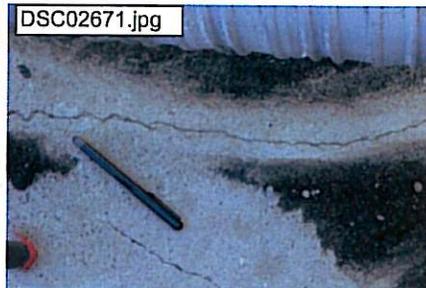
ABF's sandblasting operation continues. Their pass through the northeast column cage at W2E was thorough (DSC02668). I had a chance to take a look at the denso tape at the Hinge K assemblies. The tape does not appear to be damaged (DSC02670). The area is covered with about a half inch of sand so we are unable to survey cracks just yet. However, I did find one corner where they started blowing away the sand and brushed away sand for the length of a crack (DSC02671). I did not have a crack meter with me to measure the width. ABF continues to do welding at the north end of the cap beam on the exterior of the forms. ABF has caught up to RPS with cooling pipes. RPS is moving right along (DSC02663) with ducts and ironwork. ABF surveyors were present to locate points for RPS duct placers.
