Job Stamp 04-0120F4 SFOBB SAS

Date: 01/15/2009

ASSISTANT RESIDENT ENGINEER'S

Description of Operations @ W2 Cap Beam:

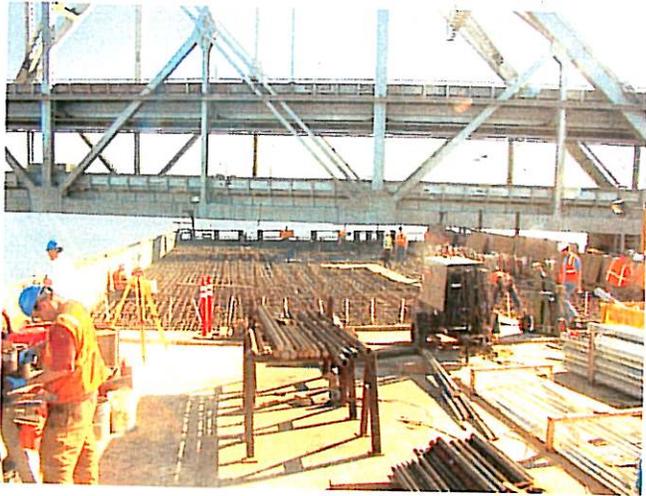
File Name: Jan-15-2009 W2 Cap 002

Description: Pour 6 south construction progress to date.

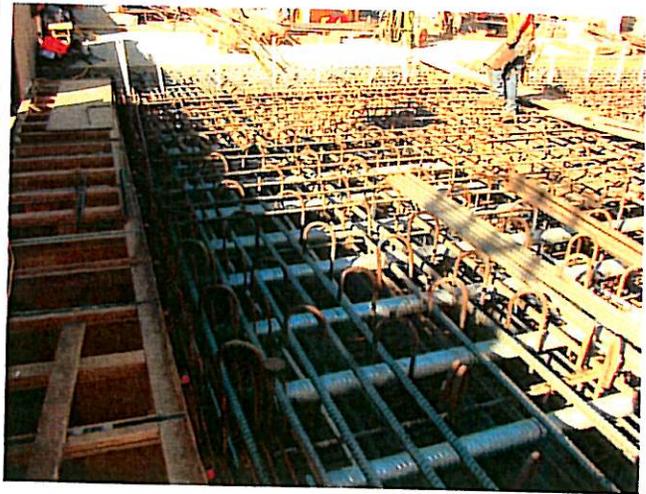
File Name: Jan-15-2009 W2 Cap 003

Description: Connected ducts from the trumpet of continuity tendons E-1A to E-11A to the duct placed just before the vertical PT bars and tendons. Also the the ironworkers are seen placing the #43 transverse rebar in this area.
