Job Stamp 04-0120F4 SFOBB SAS

ASSISTANT RESIDENT ENGINEER'S **CONTRACTOR – ABFJV, Subs CMC-RS**

**Description of Operations @ W2 Cap Beam:**

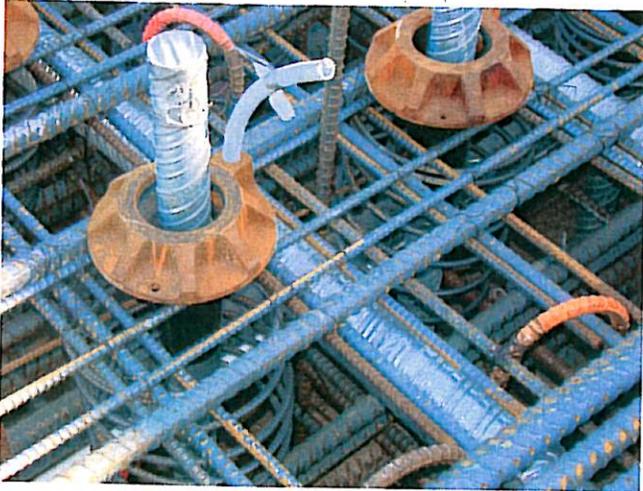
File Name:	Jan-16-2009 W2 Cap 002
------------	------------------------

Description: Spiral placement for the vertical PT tendons near the deviation saddle. Some of the spirals aren't concentric with the bearing plate due to continuity tendon ducts and rebar. The ironworkers need to try and adjust some of the spirals to match the shop drawings by SDI.

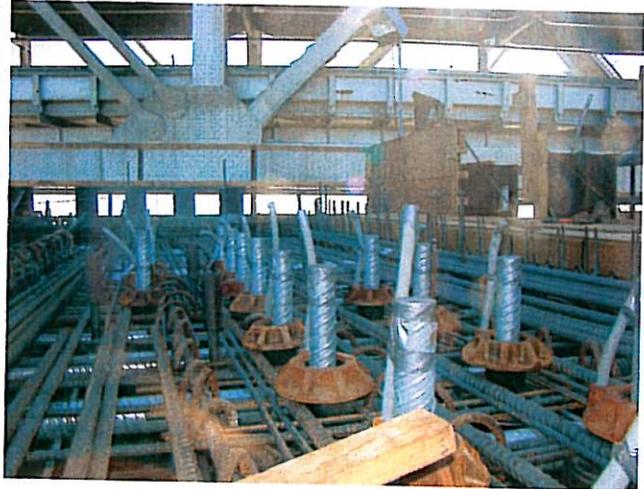
File Name:	Jan-16-2009 W2 Cap 003
------------	------------------------

Description: Some of the bearing plates for the vertical PT tendons need to be leveled prior to concrete placement.
