STATE OF CALIFORNIA	Job Stamp	7-day Const. Calendar	Day No. 762
DEPARTMENT OF TRANSPORTATION	SFOBB SAS	Project Work Day No.	Day No. 972
Form HC-10A (Rev. 6/80)	04-0120F4	Date	1/13/2009

Erect Temporary Towers: TTFN Pile Splicing and TTFS Pile Cutoff

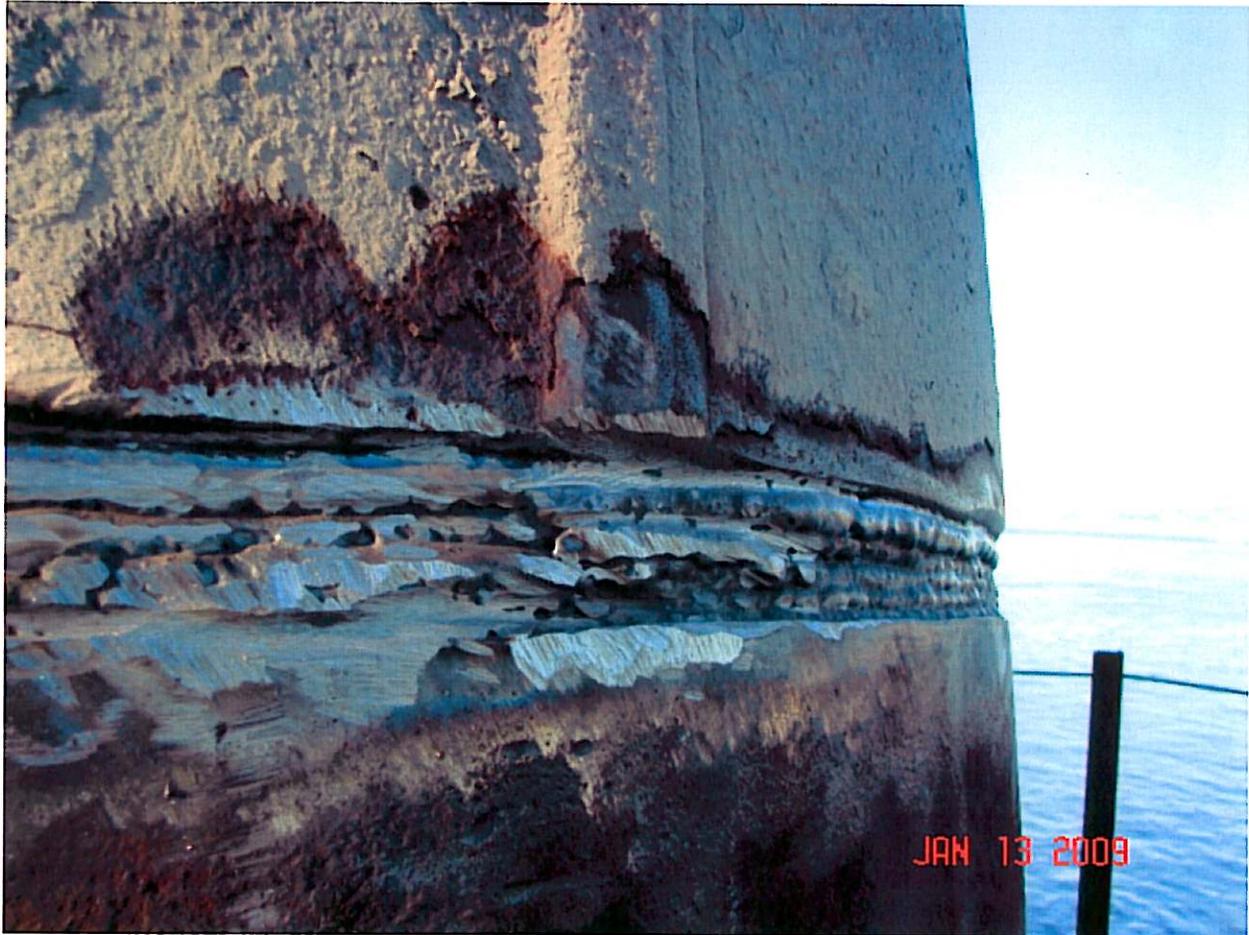
The first of the 48" battered piles was picked and placed this morning for splice welding, pile F104. Thanh Le observed this, but had to leave at lunch time for an appointment. I observed the operation for the afternoon. The Contractor is planning to splice piles F101, F104, F109, and F112 by Thursday morning. Of these, piles F101, F104, and F112 will be the last of the PDA piles for the North node of Tower F. There was one worker welding the seal welds on the pile tops that closes the gap between the backing bar and the back of the weld joint. These gaps are there due to imperfections in the fit up of the backing bar and the rolling process of the piles. By 1600 hours the new CWI Andrew Erthum performed the U/T inspection of the splice weld on F104 while Mike Johnson performed U/T after him in a QA role, testing about 50% of the weld. At this time the crane was detached from the pile top of pile F112, which had approximately 75% of the weld material on it.

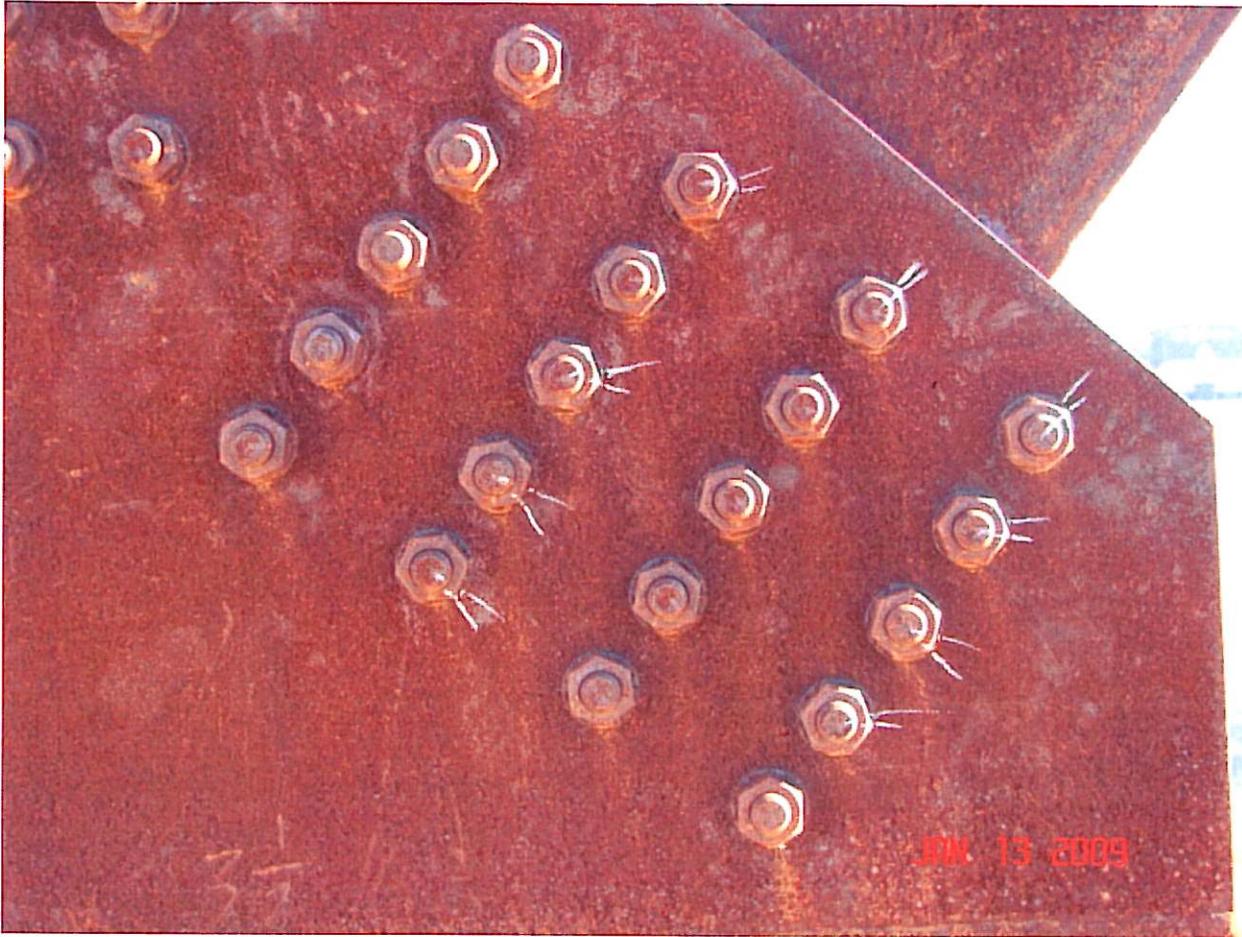
I accompanied Art Pannu and Mark Vilcheck to the field to torque test some bolts that are on the preassembled truss work that came in from China. There was no QC/QA reports or paperwork of any kind that came with the shipment to prove there was any approved procedure followed. The bolts were rusted from having been assembled upwards of a month ago, then shipped over the sea on a month journey going through shifting forces of the waves. Without having another wrench on the bolt side, the whole assembly would move at or around 1000 ft-lbs. Sometimes the nut would move and other times the bolt and nut would move independently of each other.
