Description of Operation:
Erect Temporary Towers: TTGS Pile Rehandling

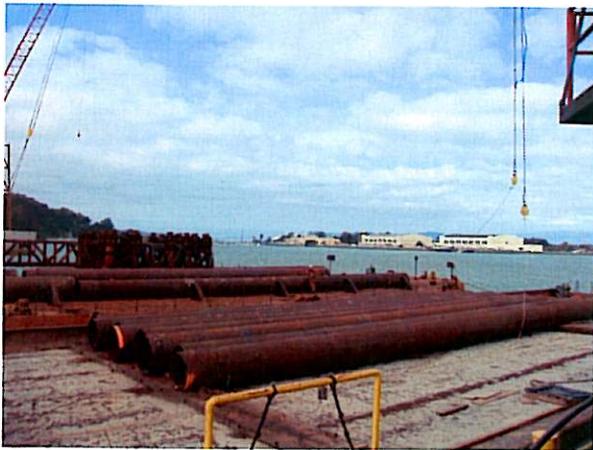
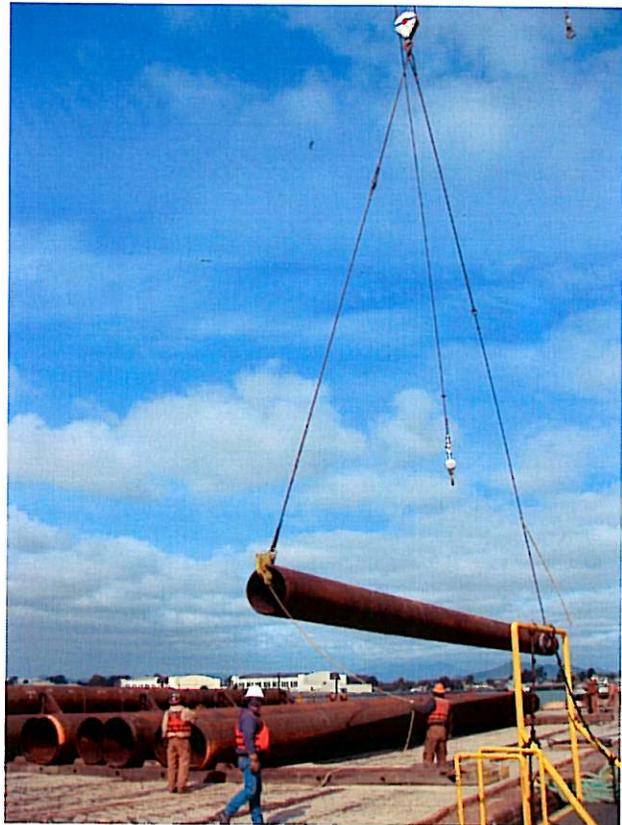
All day the crew of the DB-5 worked on rehandling the piles that are to be used as the top portions of the piles for Temp Tower G, South. They were able to finish all of the piles they wanted to finish by mid afternoon

Once the piles were in place and secured, a couple workers began welding the seal welds between the backing bar and the bottom of the pile top. There is a gap between the two pieces of steel because of the imperfect fit up of the two different rolled pieces of steel.

A couple workers were on the frame preparing the ares for splice welding which will begin tomorrow. Some of the welding platforms were placed and the tops of the first couple pile bottoms were ground in preparation of the welding.
