04-0120F4

SFOBB SAS

Date 05/22/2009

ASSISTANT RESIDENT ENGINEER'S

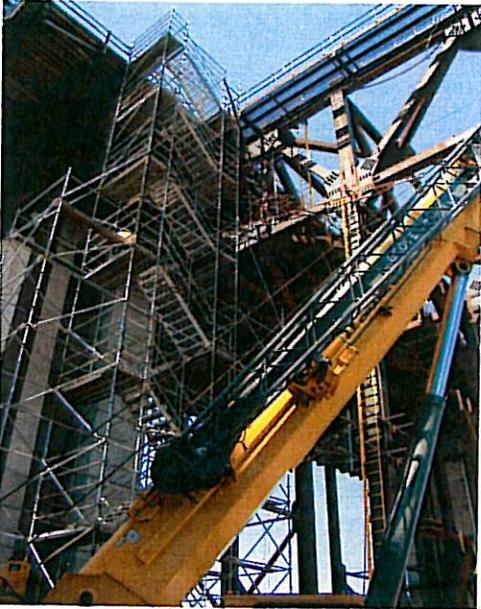
File Name:	May-22-2009 W2 Cap 002
Date:	05-22-09
By Int:	M Bruce
<p>Description: ABF ironworkers reassembled the horizontal bracing that was previously attached to the W2 falsework to temporary tower frame "A" south. The bracing is suspect as it is supporting the stairs at an angle not normal to wind loading. This may cause an adverse torsional effect to the stair tower structure under significant wind loads.</p>

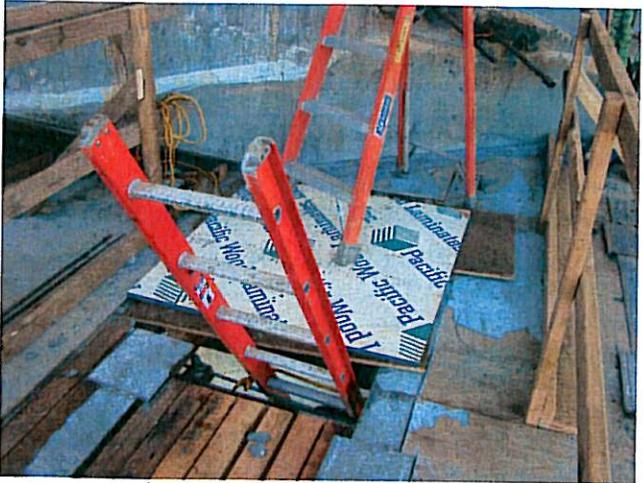
File Name:	May-22-2009 W2 Cap 006
Date:	05-22-09
By Int:	M Bruce
<p>Description: Access hole cut in the soffit near CBT-25 on the north end of the cap beam. This hole is presumably for working off of the horizontal column bracing W30x211 beams directly below.</p>
