04-0120F4
SFOBB SAS

ASSISTANT RESIDENT ENGINEER'S

Description of Operations @ W2 Cap Beam:

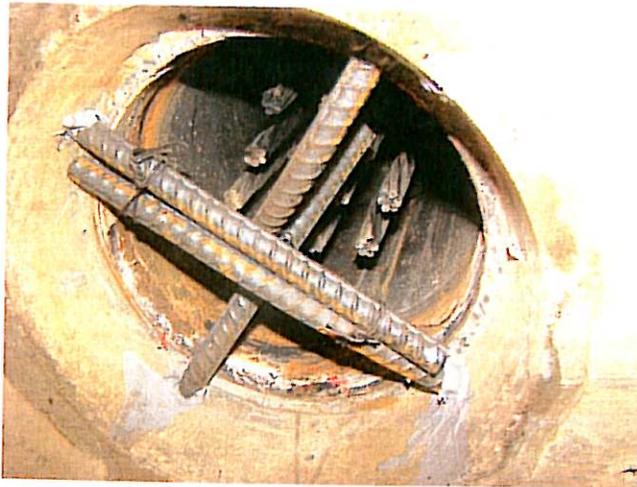
File Name:	Sept-14-2009 W2 Cap 003	File Name:	Sept-14-2009 W2 Cap 004
Date:	09-14-09	By Int:	M Bruce
Description: Photo of the proposed #4 reinforcement grid at the bottom of the vertical PT dead end pipe sleeve at W2E. Per Nigel they drilled 6" into the existing concrete for the dowels. The epoxy used per Nigel is Simpson Set 22, which is on the Caltrans approved list. I told Nigel that TY-Lin has tentatively approved this detail however we would like something in writing from ABF. I also told Nigel to achieve 2" cover on the rebar in addition to cleaning the holes thoroughly.		Description: Upper dresser coupler used to connect the HDPE to the embedded pipes in the W2 cap beam.

- Continued to remove the formwork in the northeast quadrant of the W2 cap beam void area, see David Bradd and Lalit's diaries for details as this is force account work.
- Assisted SDI hoisting the HDPE pipes into place using their forklift.
- Began to drill and epoxy holes in the W2E vertical PT dead end pipe sleeve blockout. It's ABFs responsibility per plan sheet 508R2 note 6 to provide a detail for this blockout.

- Wrote last Thursdays and today's diary.
- Discussed the vertical PT pipe dead end pipe blockout details with TY-Lin designer James Duxbury and sent email to Jim Davidson regarding this issue.
- Gave the elongation summary sheets for the vertical PT tendons to Lalit to check.
- Prepared grouting checklist for the vertical PT tendons.
