Daily Diary Report by Bid Item

Contract No.: 04-0120F4

Diary #: 036 Const Calendar Day: 190 Date: 17-Mar-2010 Wednesday

04-0120F4
 04-SF-80-13.2/13.9
 Self-Anchored
 Suspension Bridge

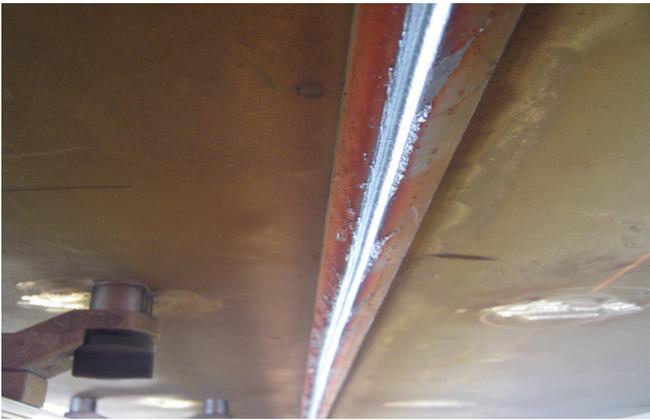
1E/2E Bottom Plate backing bar removal

- Backgouging the backing bar on the Bottom Plate weld. See picture.
- Remove pins and bolts from the lower portion of the North Side Plate stiffeners.
- Pretensioning continues at center U-ribs.

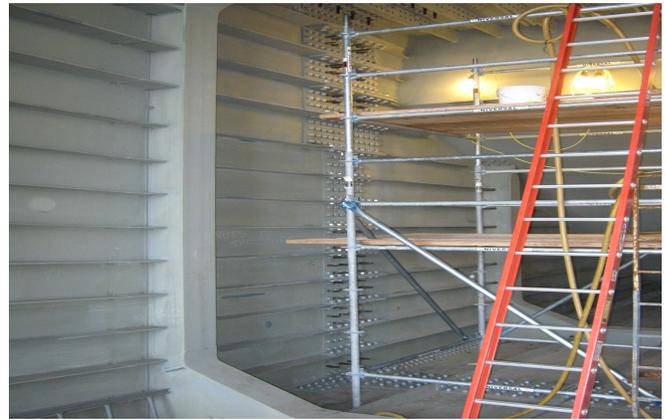
CB1/2E East Exterior web and Bottom web status

As of this morning, aside from the pins needed to satisfy Condition 2 & 3, all of the bolt holes for the CB1/2E splice have permanent bolts in them. Not all are tightened, but most are snug tight. See pictures.

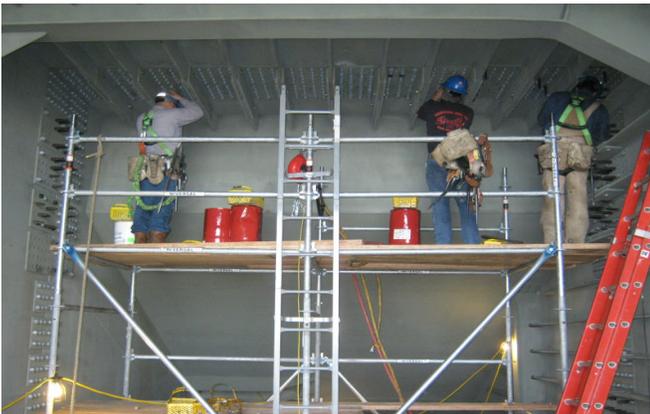
CB1/2E West cell bolt installation

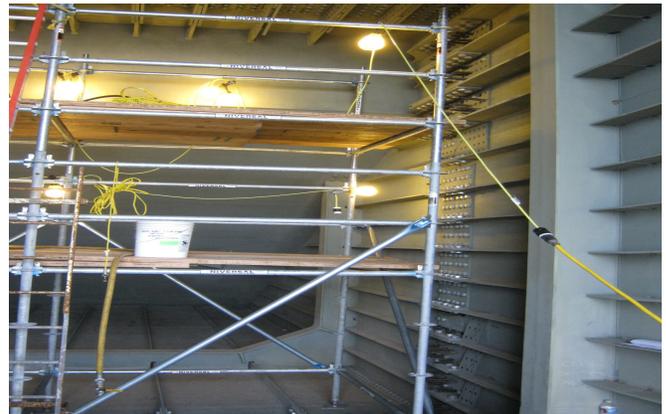
CB1/2E Interior web status
