**Daily Diary Report by Bid Item**

Contract No.: 04-0120F4

04-0120F4  
 04-SF-80-13.2/13.9  
 Self-Anchored  
 Suspension Bridge

04-0120F4 Bid Item: 034 X-W2C-BCT.034 E-W Line Cross Over W2 Cap Cap Beam Continuity Tendons

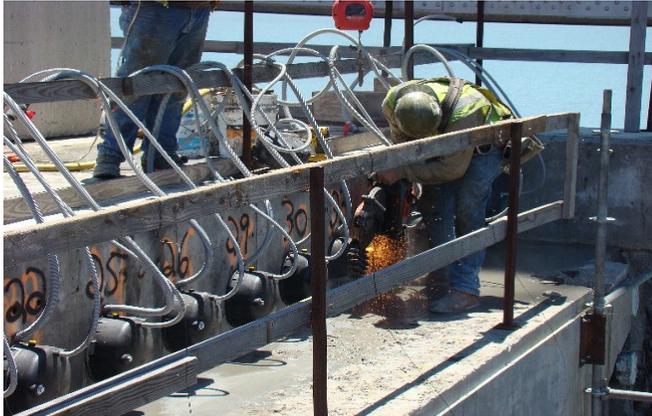
The continuity tendons grouted today along the E-Line were 17A to 42A for a total of 26 done. Details of the grouting operation today were consistent with yesterday. Overall the grout appeared to look acceptable, was mixed consistently, and no leaks at the dead end were reported or observed to my knowledge. There was one leak at the live end of continuity tendon E39A due to the strand tails being too long which prevented a good seal between the grout cap to bearing plate, see photo below.

Recutting the live end strand tails for continuity tendon E39A during the grouting operation before completing recharge of this tendon.
