**Daily Diary Report by Bid Item**

04-0120F4  
 04-SF-80-13.2/13.9  
 Self-Anchored  
 Suspension Bridge

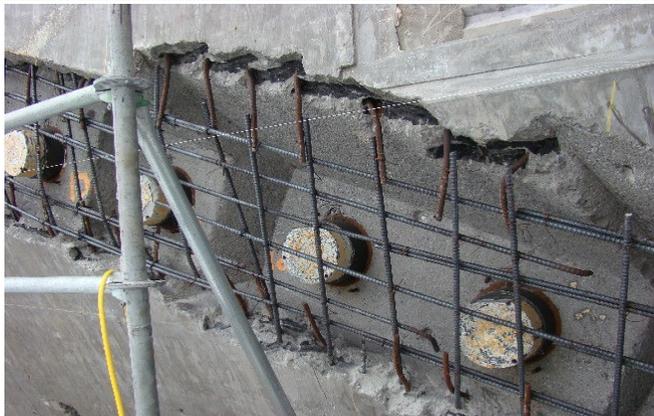
Grease seen on the EB continuity tendon grout caps and residual black foam used for the #16 dowels on the concrete that need to be cleaned.

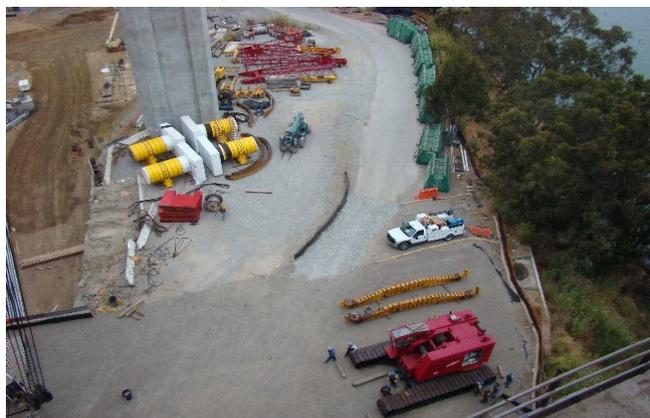
ABF continuing to mobilize the Manitowoc Ringer near W2 for saddle erection.
