Daily Diary Report by Bid Item

Contract No.: 04-0120F4

04-0120F4
 04-SF-80-13.2/13.9
 Self-Anchored
 Suspension Bridge

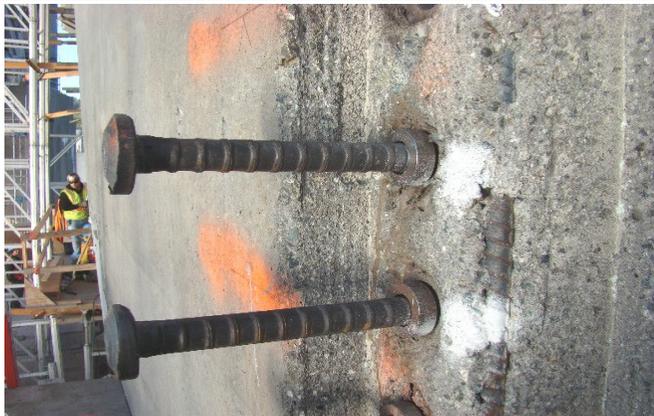
Closeup of completed installation of #25 T-Head bars in the lower southeast bikepath pedestal blockout.

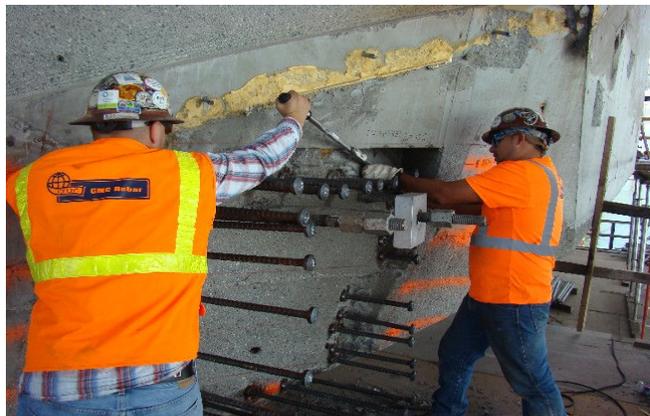
CMC-RS ironworkers using the torque wrench to tighten a #25 T-Headed bar in the lower bikepath pedestal blockout at the southwest end of the W2 cap.

- Used torque wrench #2010/156605 calibrated 05/19/10 to couple all of the #25 T-Heads ensuring a torque value of 200lb-ft per the HRC manufacturers recommendation. Lance Gage was the ironworker who torqued all of the bars using the aforementioned wrench.
